# Metallurgical & Corrosion Evaluation of the USS Arizona

Research Experience for Undergraduates 2009 (REU)

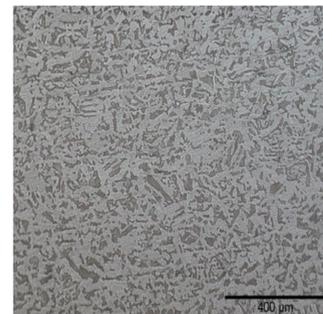
Figure 2: Micrograph of Plate A-1. 100 X.

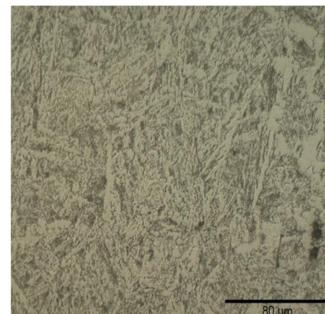
Figure 3: Micrograph of Plate A-2. 500 X.

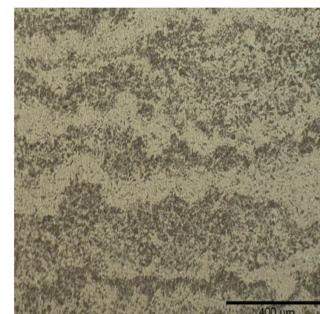
Figure 4: Micrograph of Plate A-3. 100 X.

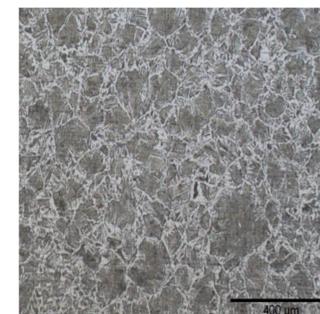
Figure 5: Micrograph of the Rivet. 200 X.

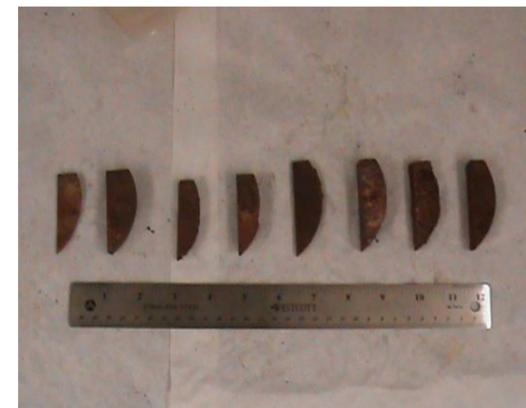
Figure 6: Photograph showing the core samples taken from the U.S.S. Arizona.

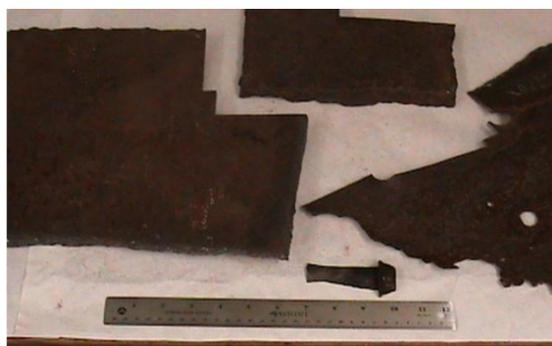
Figure 1: Photograph of the selected steel pieces from the U.S.S. Arizona at Waipio Point. Left: Plate A-1. Top: Plate A-2. Right: Plate A-3. Bottom: Rivet.
