Metallurgical and Corrosion Evaluation of the U.S.S. Arizona

Prepared by: Nathan Saunders and Elliot Hamilton

South Dakota School of Mines and Technology

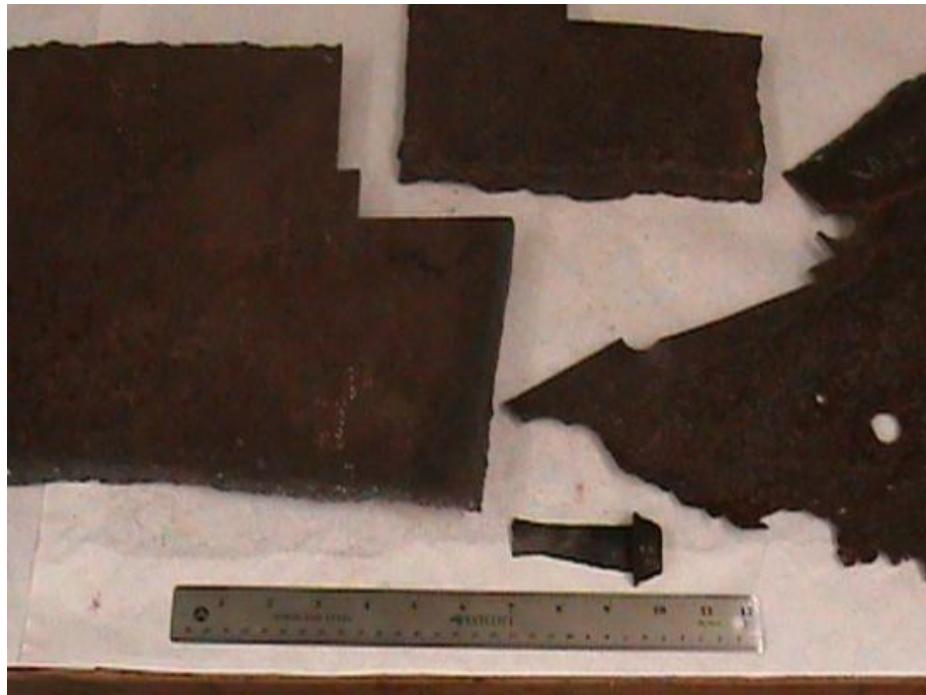
Figure 1: Photograph of selected steel pieces from the U.S.S. Arizona at Waipio Point. Left: Plate A-1. Top: Plate A-2. Right: Plate A-3. Bottom: Rivet.

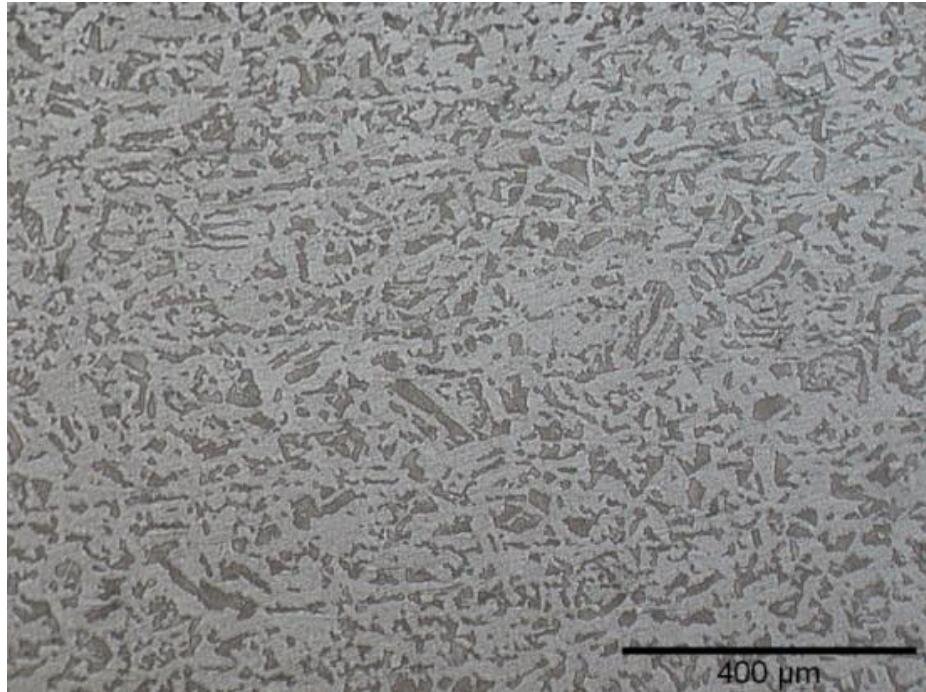
After taking sections from different pieces of plate, it was found that there were three microstructural varieties of plate. A photograph showing the plate is shown in Figure 1. The different plates shown will be referred to as plates A-1, A-2, and A-3, respectively. The microstructure of A-1 shows a lower carbon condition than the rest of the plate. The matrix largely consists of ferrite (white) with some resulting pearlite (dark). The microstructural condition of A-2 indicates an acicular fine ferrite-pearlite-like matrix. The microstructure of A-3 was found to be heavily banded with a low to medium-carbon ferrite-pearlite matrix. The banding is likely the result of ingot casting solidification practices of the time. Segregated microstructures form when solidifying, and are forced into a parallel structure when rolled. Micrographs of the plates can be seen in Figures 2, 3, and 4.

Figure 2: Microstructure of Plate A-1. 100 X.

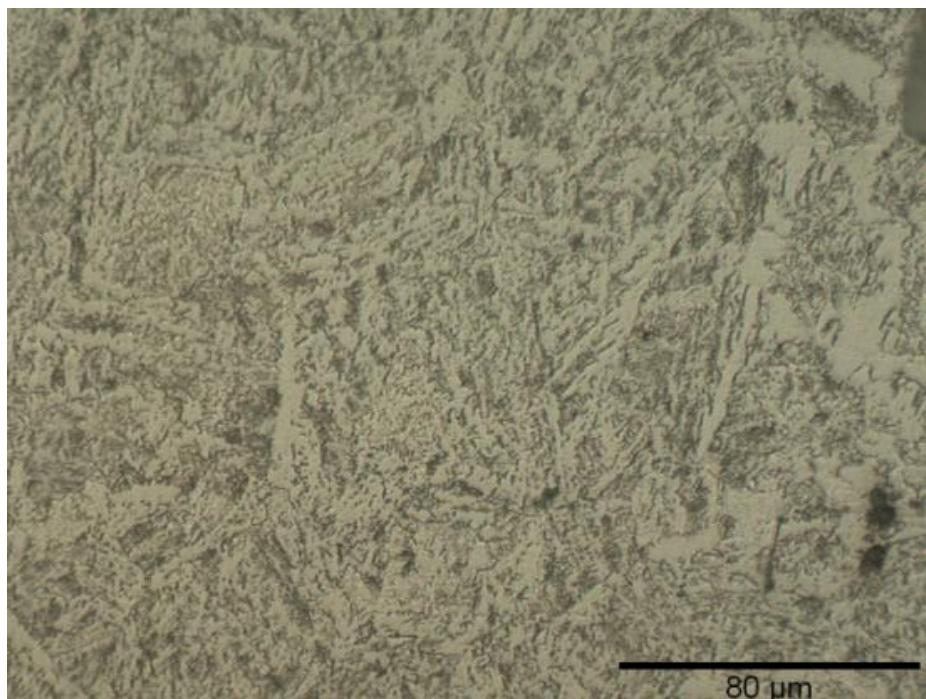
Figure 3: Microstructure of Plate A-2. 100 X.

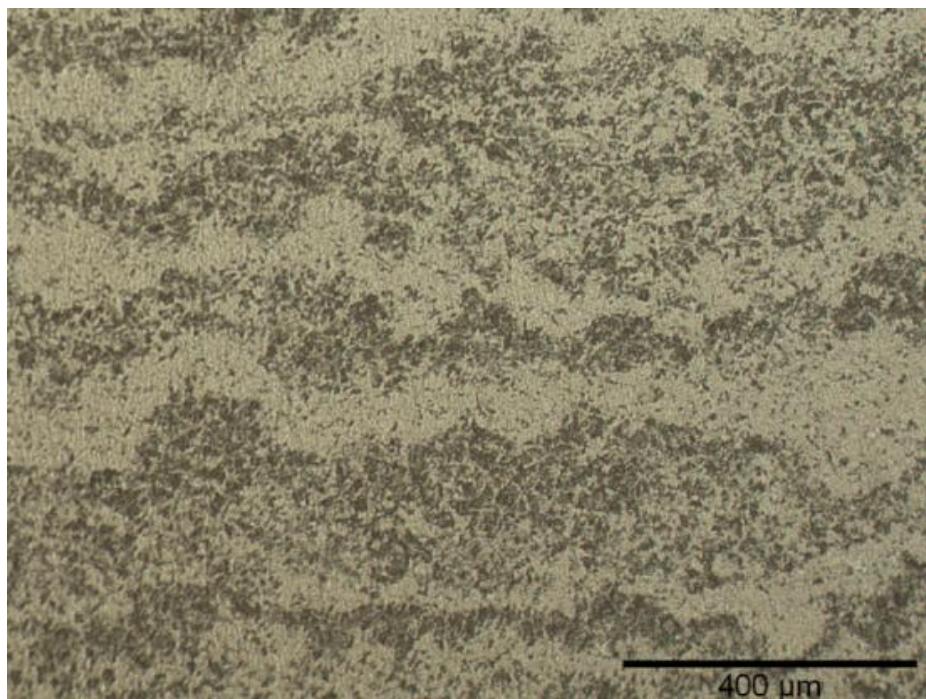
Figure 4: Microstructure of Plate A-3. 100 X

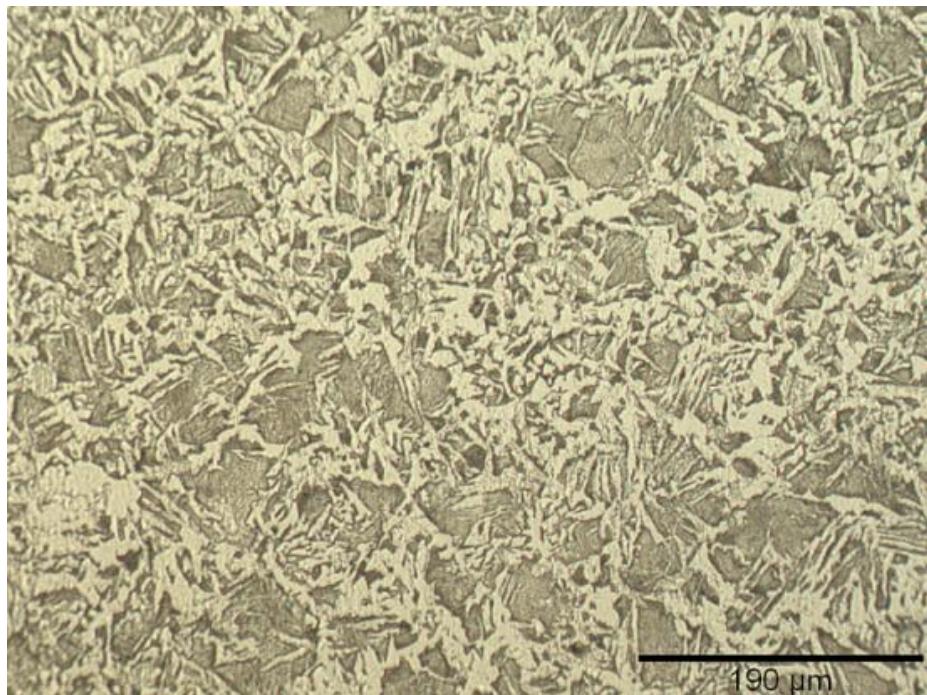
Plates A-1 and A-2 were found to be similar to those found in "Metallographic Studies of the U.S.S. Arizona", having the banded low-carbon appearance (2). The rivets analyzed from Waipio Point were also found to have similar microstructure to the Waipio Point rivet in "Metallographic Studies of the U.S.S. Arizona." The rivets had the appearance of being cooled quickly from austenitic temperatures, grain boundary pro-eutectoid ferrite, Widmanstatten ferrite, and fine-pearlite (2). The appearance of being cooled quickly is explained by the riveting methods of the time, where rivets are heated to red hot temperatures and forged into place. The head of the rivet, however, showed more deformation and indications of carbon loss (decarburization). The decarburization likely occurred because the rivet was heated to temperatures in which diffusion of carbon can take place. The carbon diffuses toward the surface of the part and is oxidized in the atmosphere resulting in the loss of carbon near the surface of the heated material. This is seen by the increased amount of ferrite (white) near the surface of the material. Figure 5 shows a micrograph of the rivet head.

Figure 5: Microstructure of Rivet Head. 100 X.

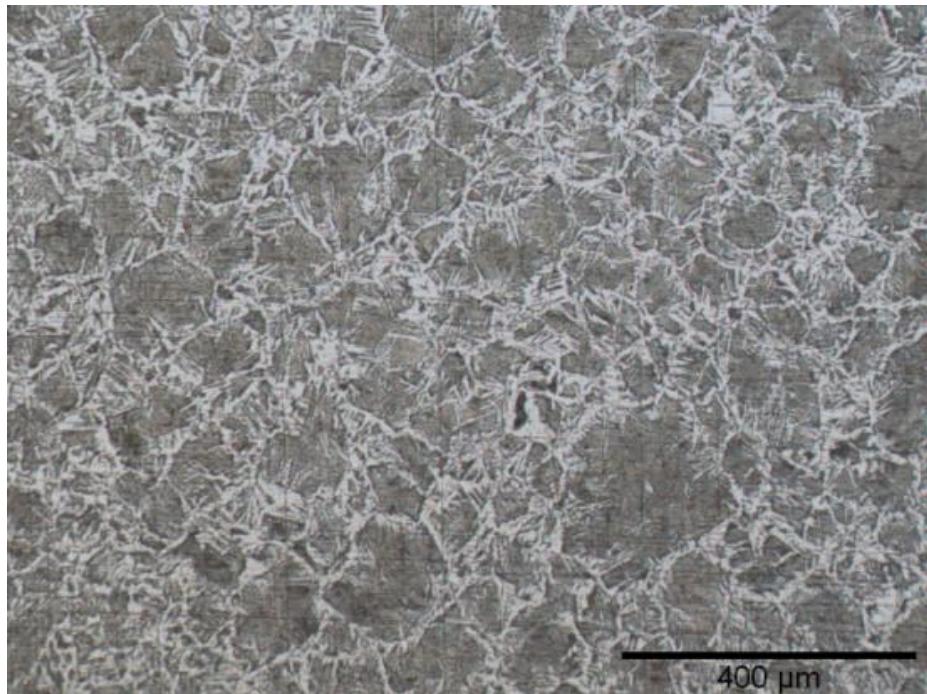
Figure 6: Microstructure of Rivet Shaft. 200 X.

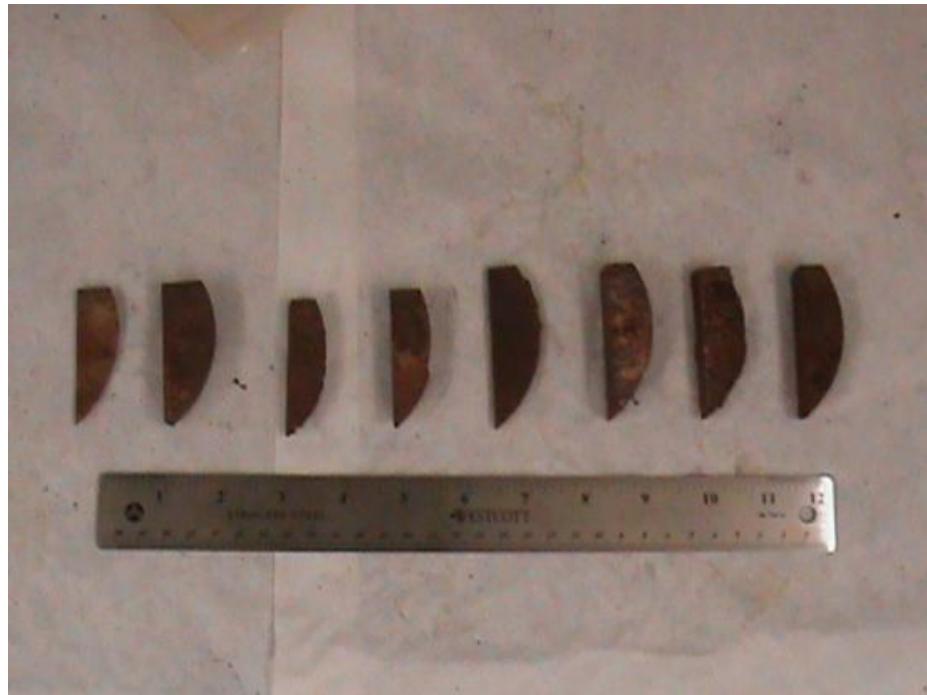
Figure 7: Photograph of Core Samples from the U.S.S. Arizona. The Core Samples from Left-to-Right are: 02-001, 002, 003, 004, 007, 008, 009, and 010.

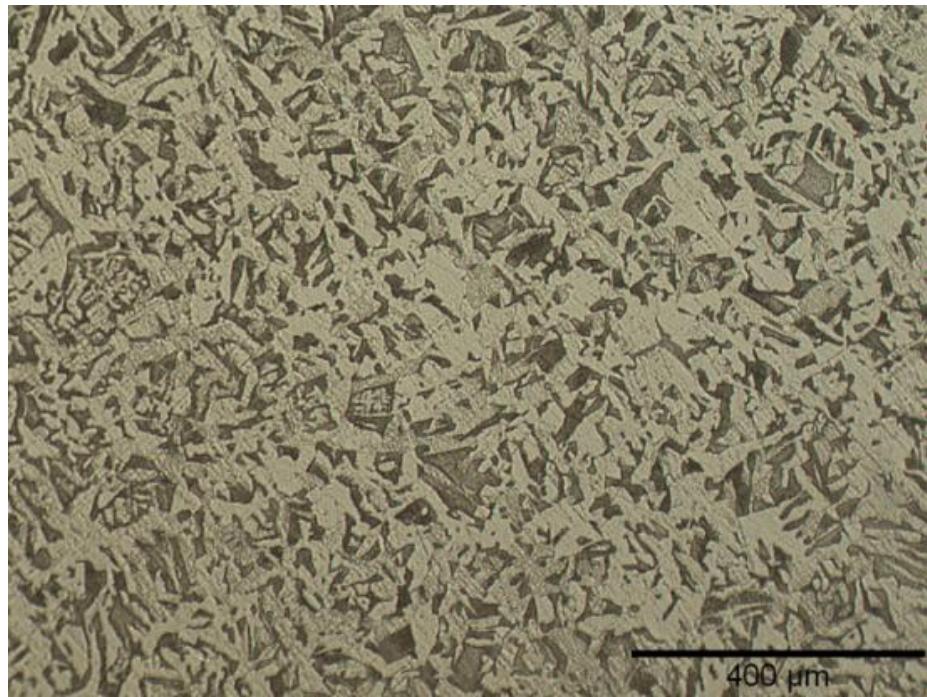
Figure 6 shows a micrograph of the rivet shaft. A photograph of the core samples is shown in Figure 7. The core samples were found to have a similar microstructure to plate A-2, although some of the core samples indicated lower carbon content in some cases. Figure 8 shows a representative micrograph of the similar microstructure, and Figure 9 shows a representative micrograph of the lower carbon sample. The micrographs of the rest of the core samples are shown in Appendix A.

Figure 8: Microstructure of U.S.S. AZ Core Sample. 100 X.

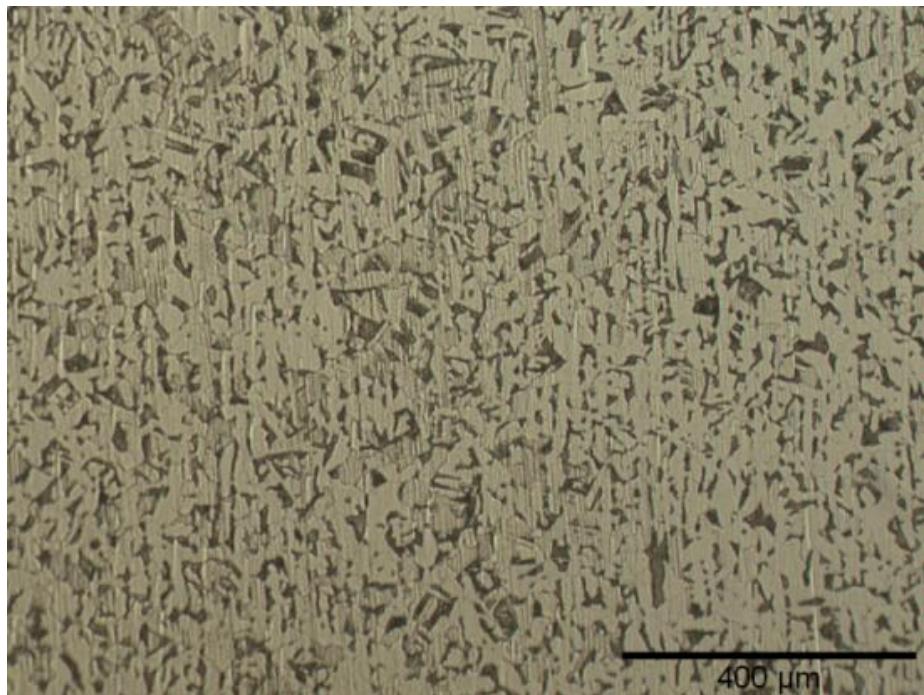
Figure 9: Microstructure of Low-Carbon Type Cutting. 100 X

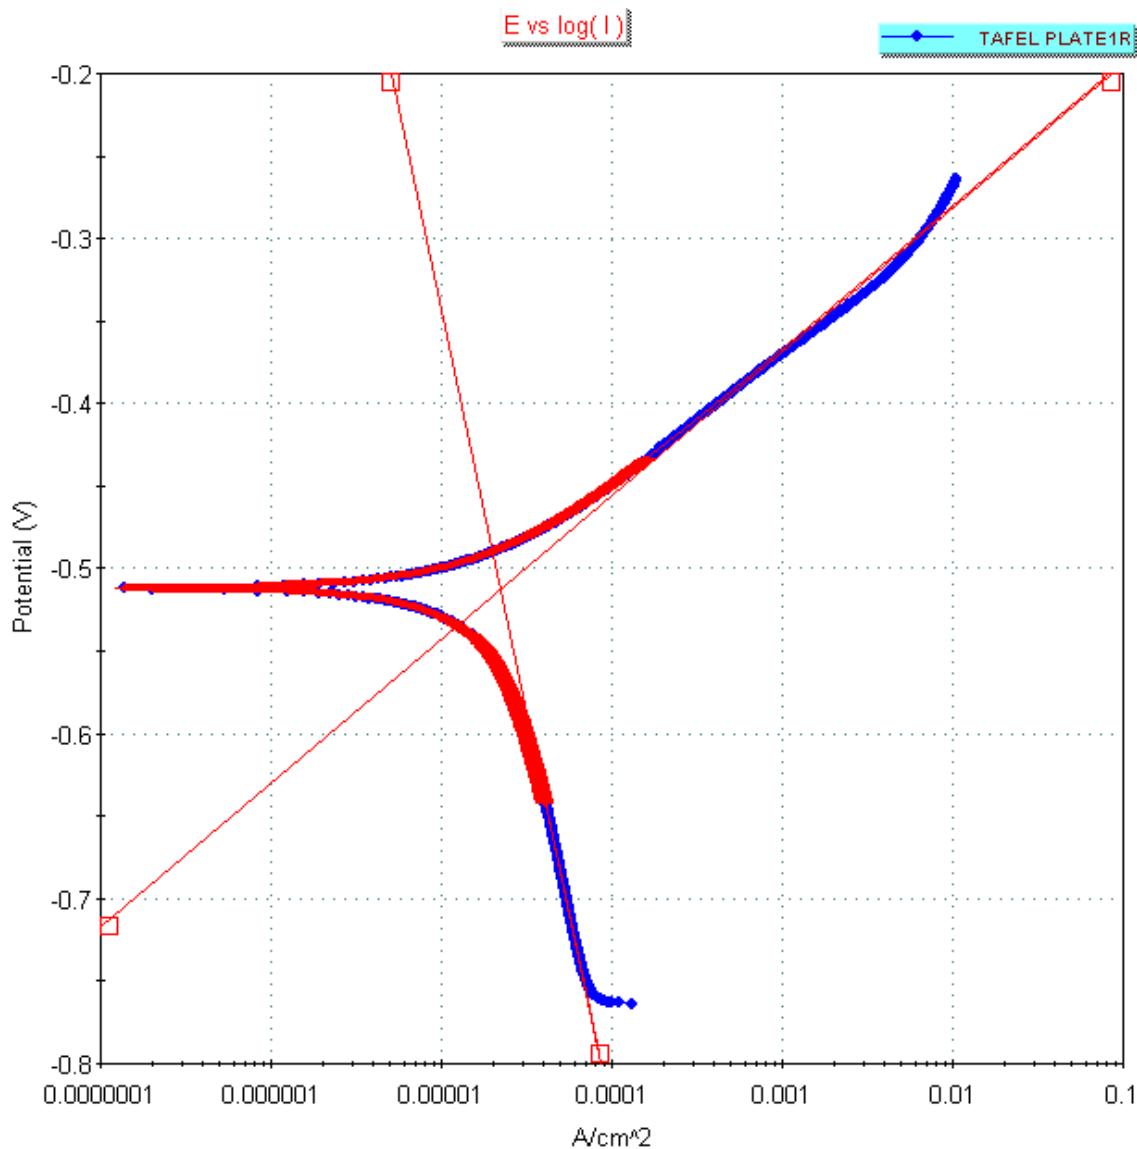
Figure 10: Exemplar Tafel Plot Showing the Results of Plate A-1.

The results of the linear polarization experiments show higher corrosion rates for Plate A-1, A-3, and the rivet head. This data compares within reason to corrosion rates found in “Recent development and application of Concretion Equivalent Corrosion Rate (CECR) Methodology” (4). This research found corrosion rates from 0.5 mpy to 3 mpy. There are several possibilities of phenomena that may be causing the difference in corrosion rates. First, several different steels were used to construct the ship. Testing different steels would most certainly yield different corrosion rates for the respective steels. Also, the method of determining corrosion rates, in that paper, was by concretion chemistry analysis instead of measuring rates with PAP testing.

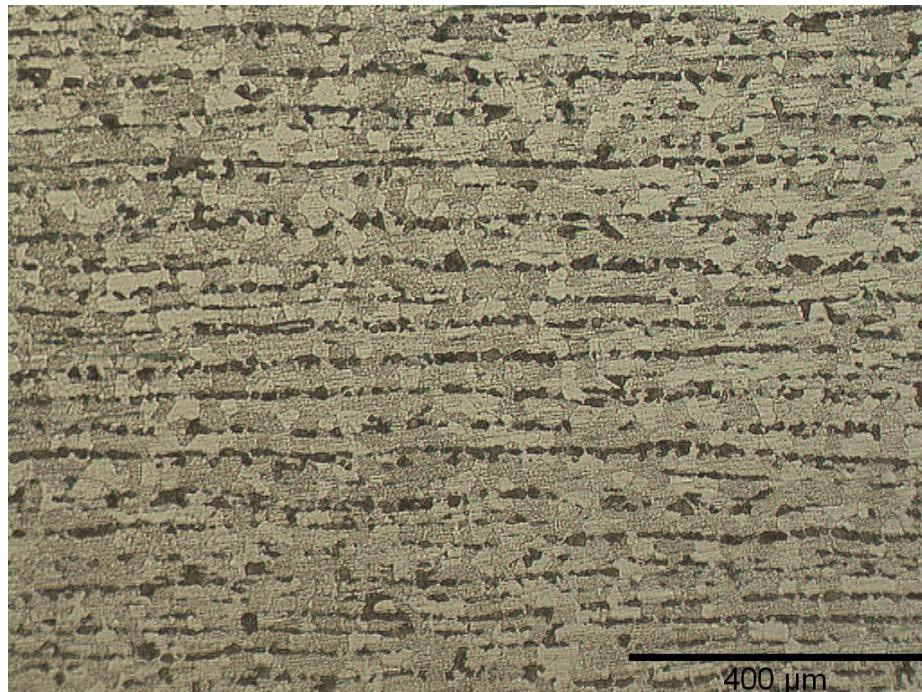
The data obtained from this experiment compares well with the chemical analysis found in “Metallographic Studies of the U.S.S. Arizona.” Slow-cooled plate A-1 showed evidence of heavy banding. Plate A-2 showed evidence of heavy banding after the slow-cooling. For this reason, the analysis used to find the carbon content did not work well on this specimen. A micrograph of the slow-cooled plates is shown in Appendix B.

Figure B-1: Micrograph of Slow-cooled Plate A-1. 100 X.

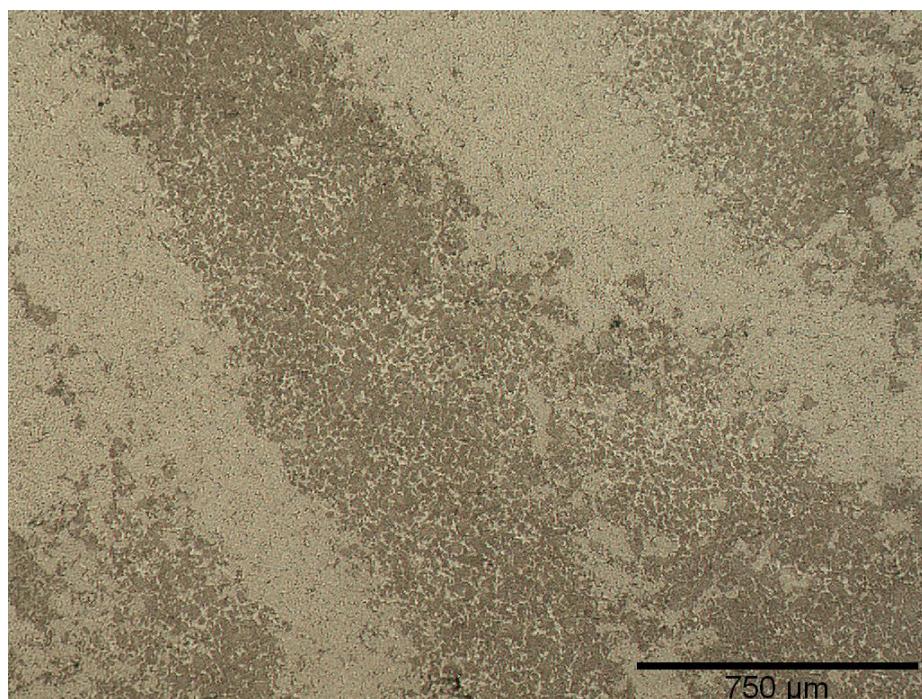
Figure B-2: Micrograph of Slow-Cooled Plate A-2. 50 X.

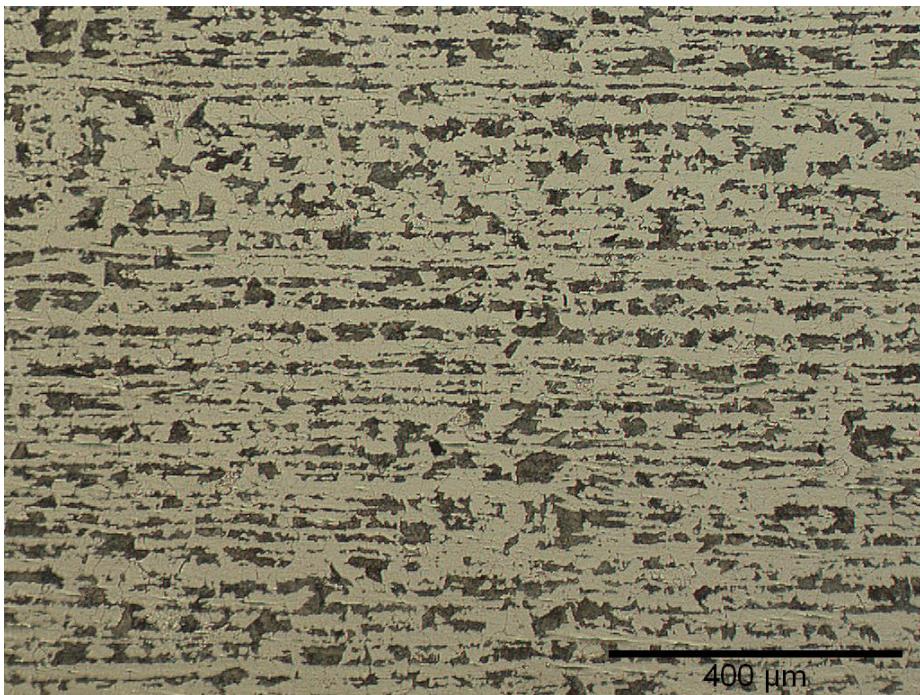
Figure B-3: Micrograph of Slow-cooled Plate A-3. 100 X.

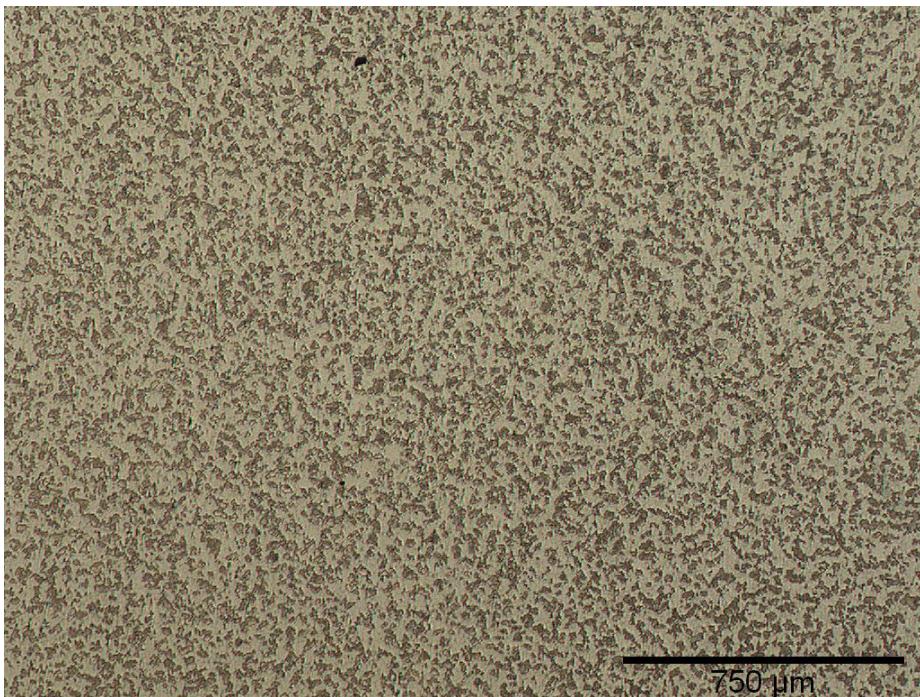
Figure B-4: Micrograph of Slow-cooled Rivet. 50 X.

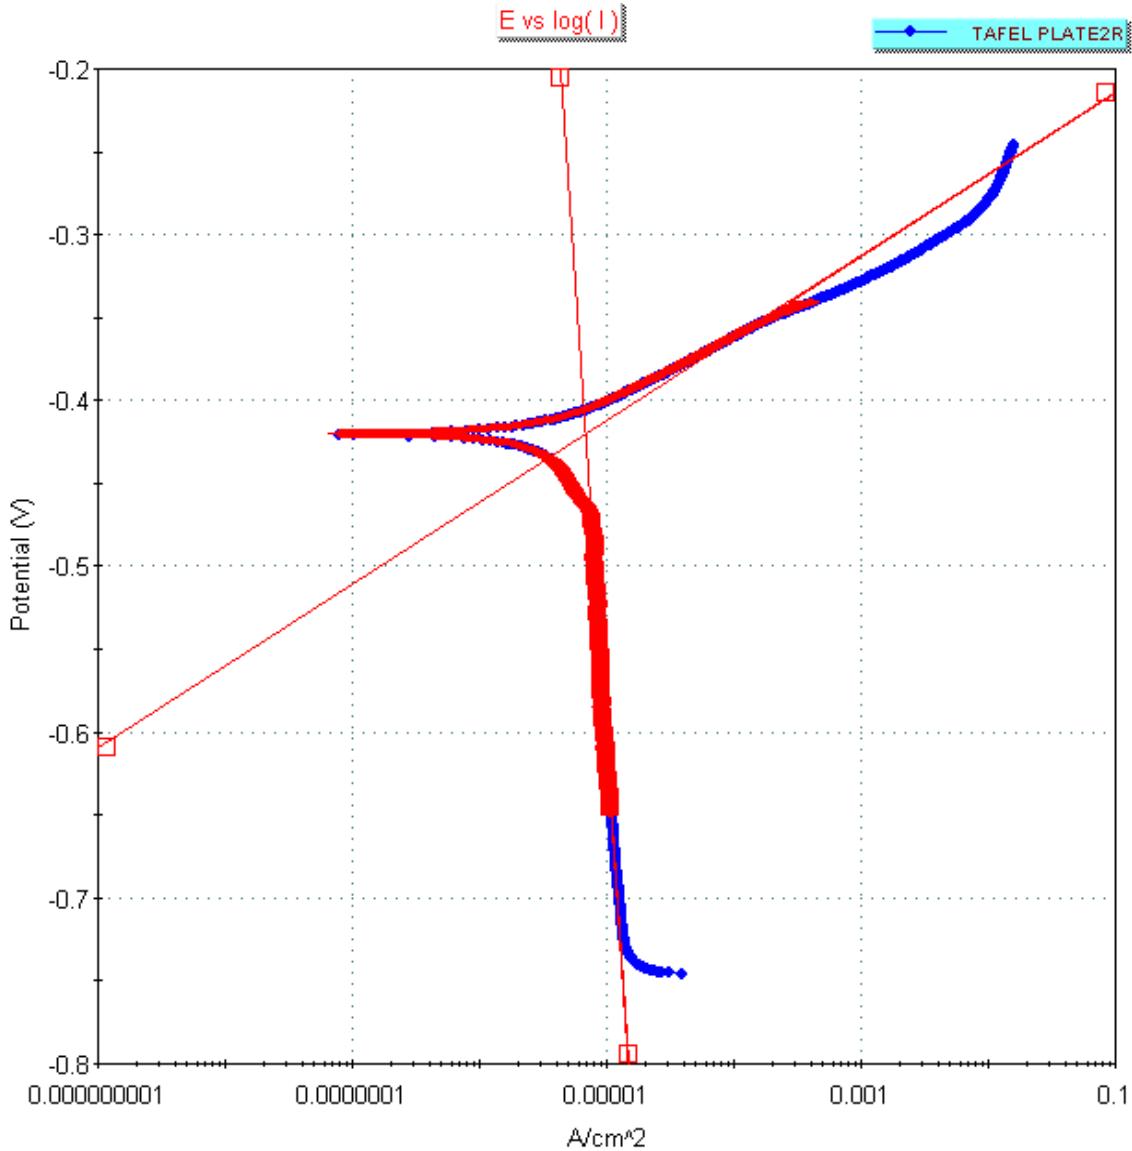
Figure C-1: Tafel Plot Showing the Results of Plate A-2.

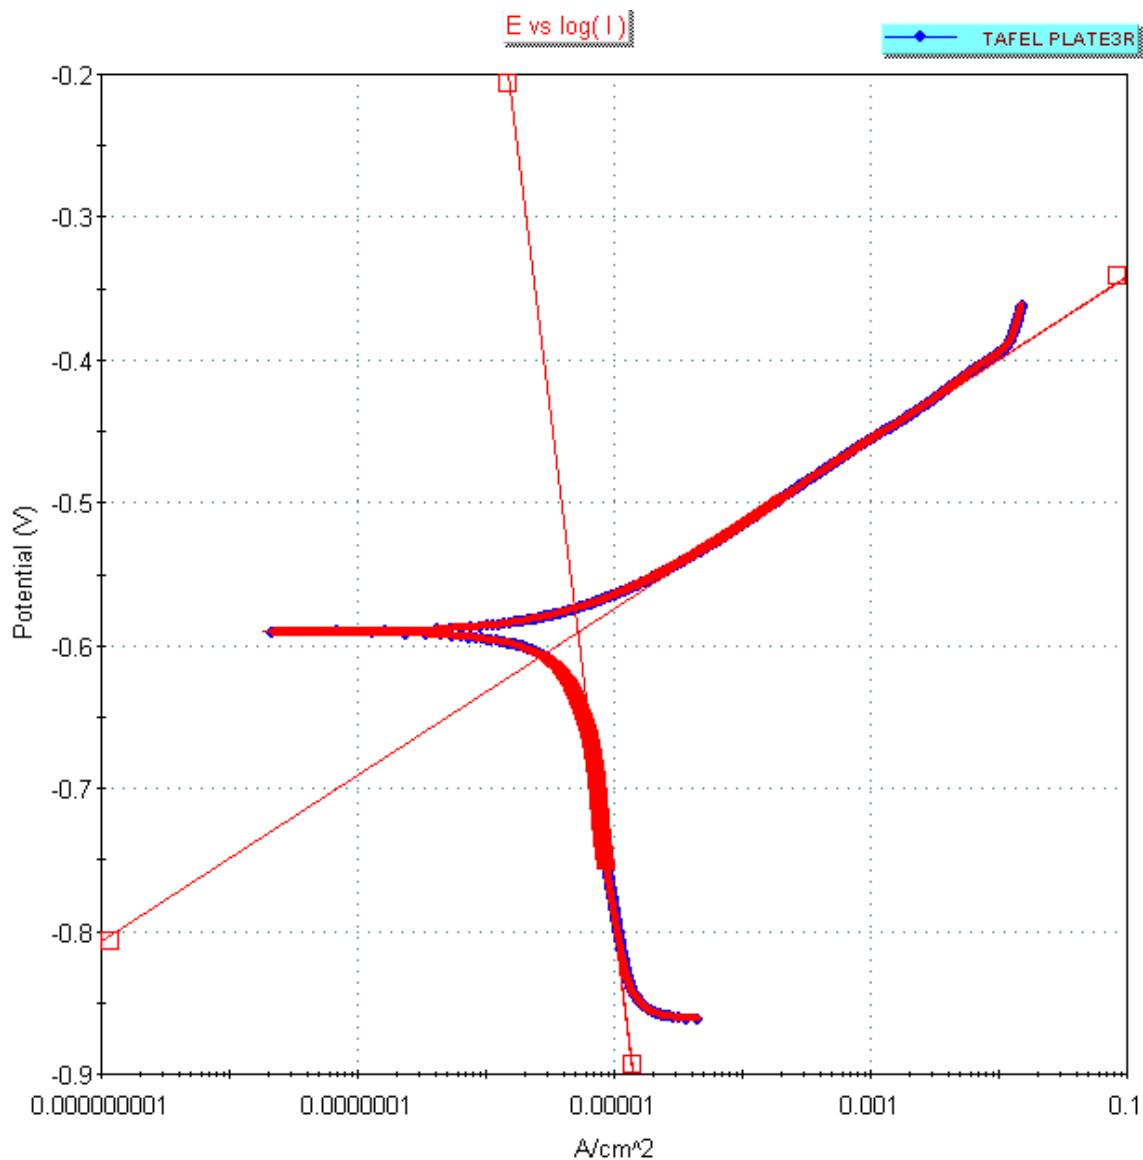
Figure C-2: Tafel Plot Showing the Results of Plate A-3.

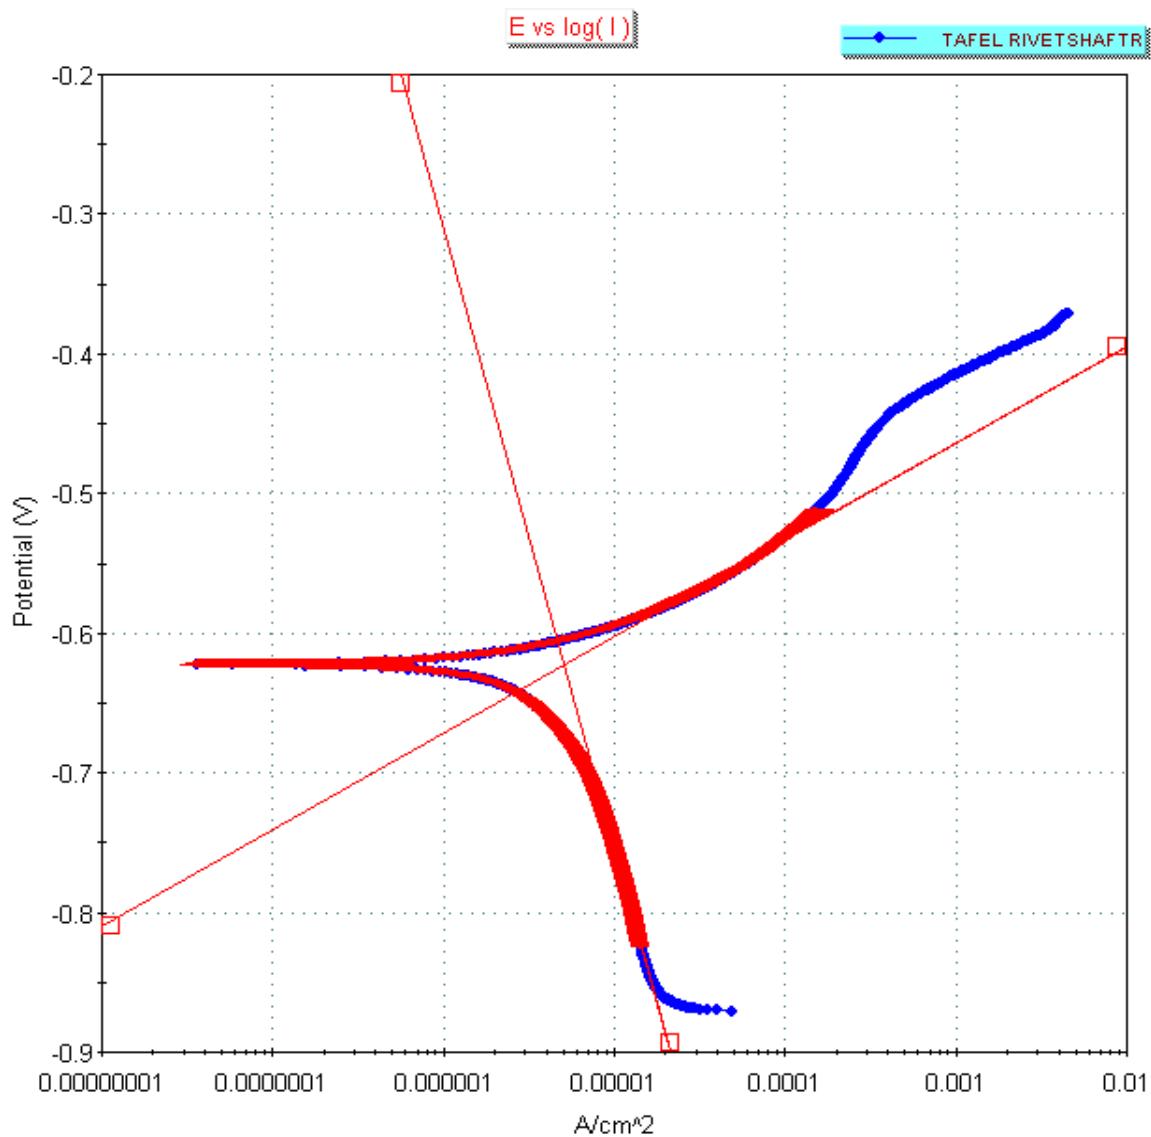
Figure C-3: Tafel Plot Showing the Results of the Rivet Shaft.

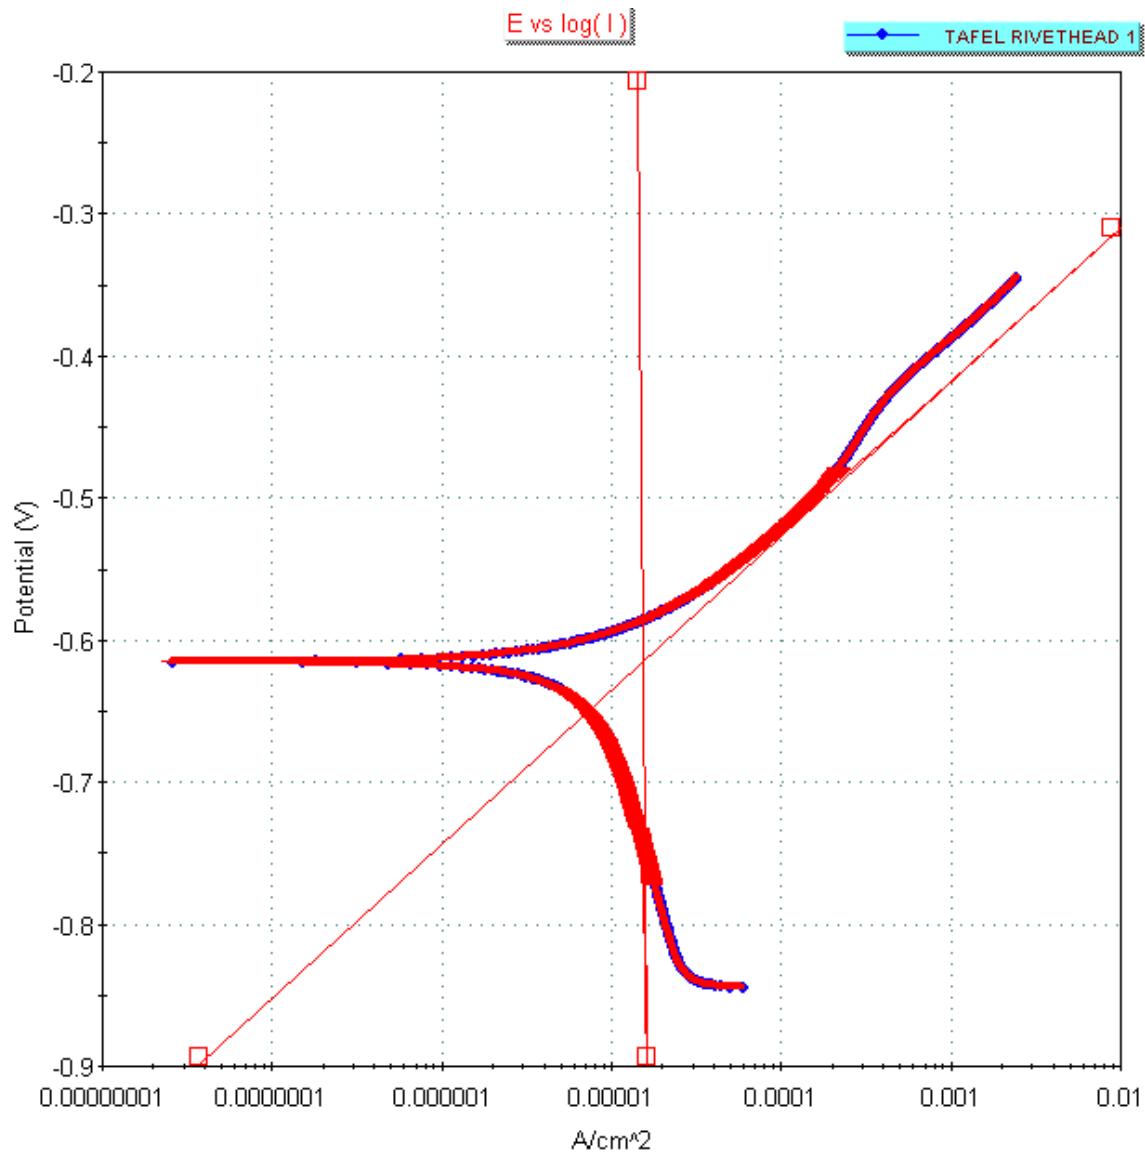
Figure C-4: Tafel Plot Showing the Results of the Rivet Head.
