## Objectives

## Abstract

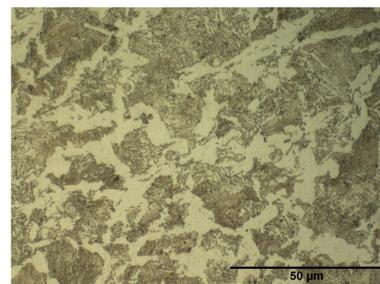
Figure 3: Micrograph of Plate A-5

- Table 1 shows the results of the corrosion rate analysis.
- The steel samples from the USS Arizona were confirmed to be medium carbon steel with a high amount of inclusions.
- The optical micrographs showed that the steels samples were hypoeutectoid in carbon content. Fine and coarse pearlite were observed in the structure along with proeutectoid acicular ferrite at the prior austenite grain boundaries.
- Macroetching showed that the rivets from plate A-6 had plastic deformation near the bottom and top of the rivet and the shaft of the rivet showed vertical banding.
- From the crevice corrosion analysis, we confirmed there was magnetite and goethite present in the oxidation samples from the rivet-plate interfaces (Figure 5.)
