**Metallurgical and Corrosion-Based Analysis of the USS Arizona: The Effects of pH and Crevice  
Corrosion Mechanisms on Corrosion Rates**

*Prepared by:* Chase Remington Blazek

Research Experience for Undergraduates

Summer 2010

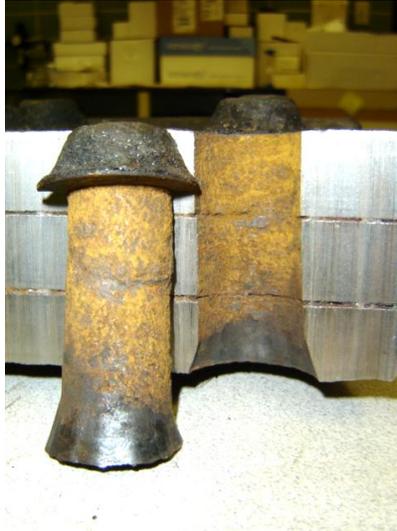
**Figure 1: Source of Oxidation Samples**

Plate A-6 was cut in a fashion that split the rivets which were connecting three steel plates together in half. The crevices between plates and the rivets (Figure 1) were observed with the naked eye and a 10x zoom spy glass for areas of noticeably accelerated crevice corrosion. The rivets were then hammered loose from the plates and the oxidation from the plate-rivet interfaces was scraped off. These oxidation samples were pulverized and then analyzed using XRD to analyze the oxidations' compositions. Lastly, weight percentages of goethite and magnetite were taken to determine how prevalent the crevice corrosion mechanism was.

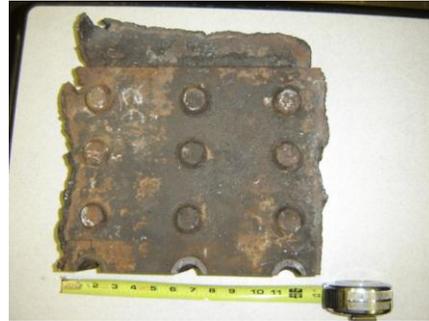
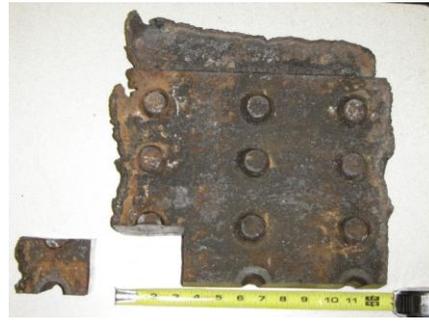
Plate A-6

We didn't find concrete evidence of many corrosion rate patterns between and among samples of metal. We found some evidence based off of pH 4 tests that the top of the rivet in plate A-6 may be corroding faster than the pieces of steel around it, however the results of pH 2 and 7 testing on these same pieces suggested different trends.

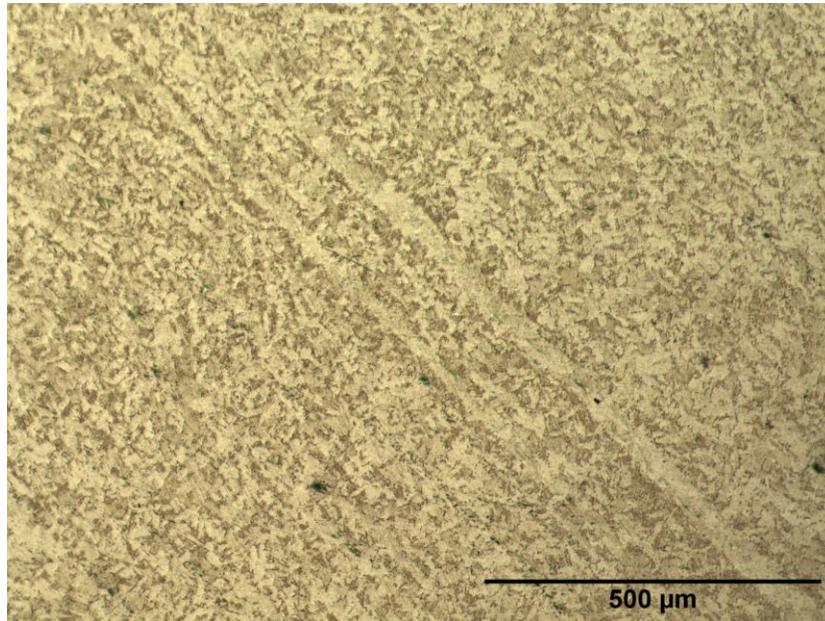
**Figure 5: Micrograph of Plate A-4**

They were all hypoeutectoid in carbon content with fine and/or coarse pearlite observed in the structure and proeutectoid acicular ferrite at the prior austenite grain boundaries. We observed banding in the microstructure of a plastically deformed piece of plate A-4. Banding usually prompts higher corrosion rates, but how much higher is something we don't know.

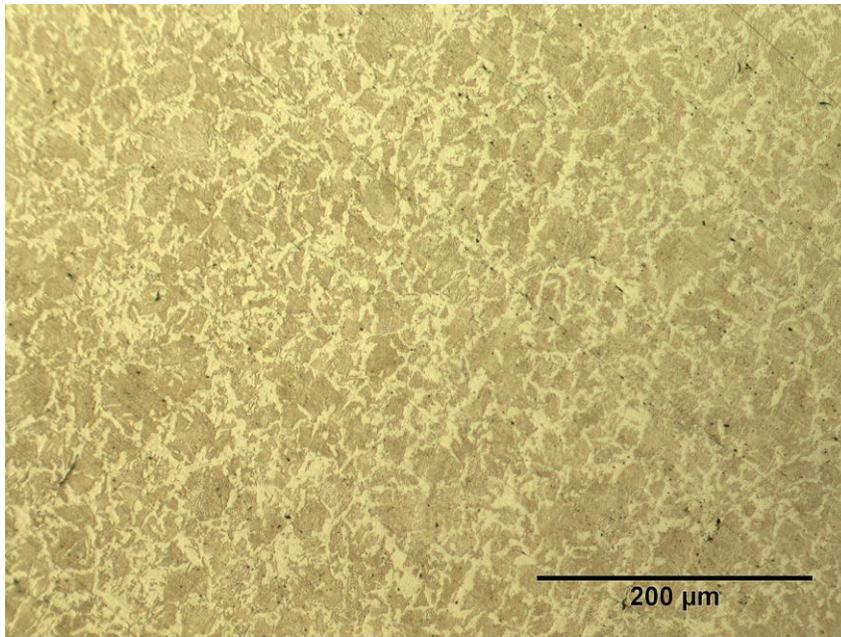
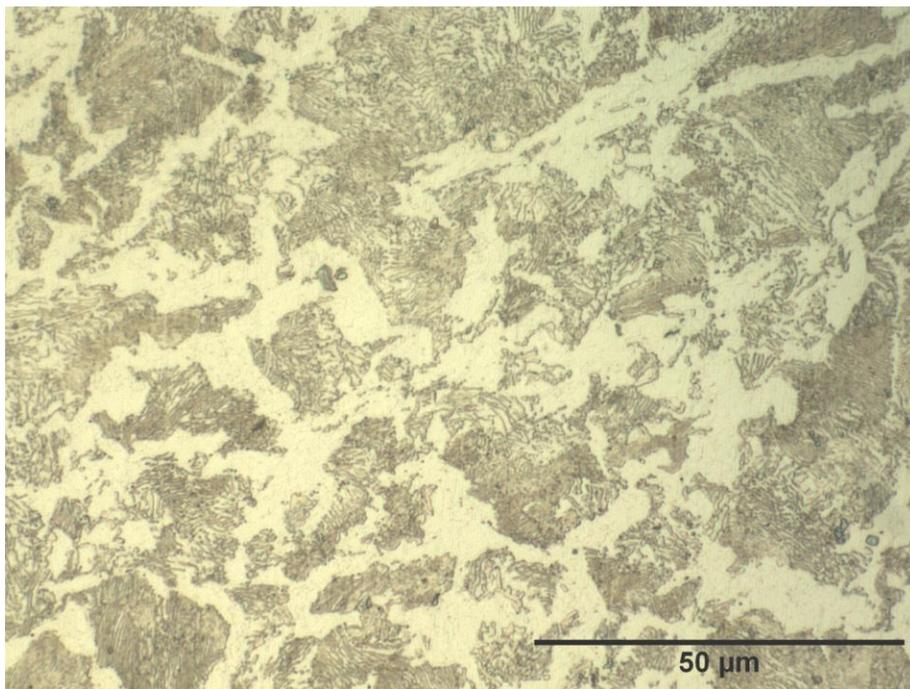
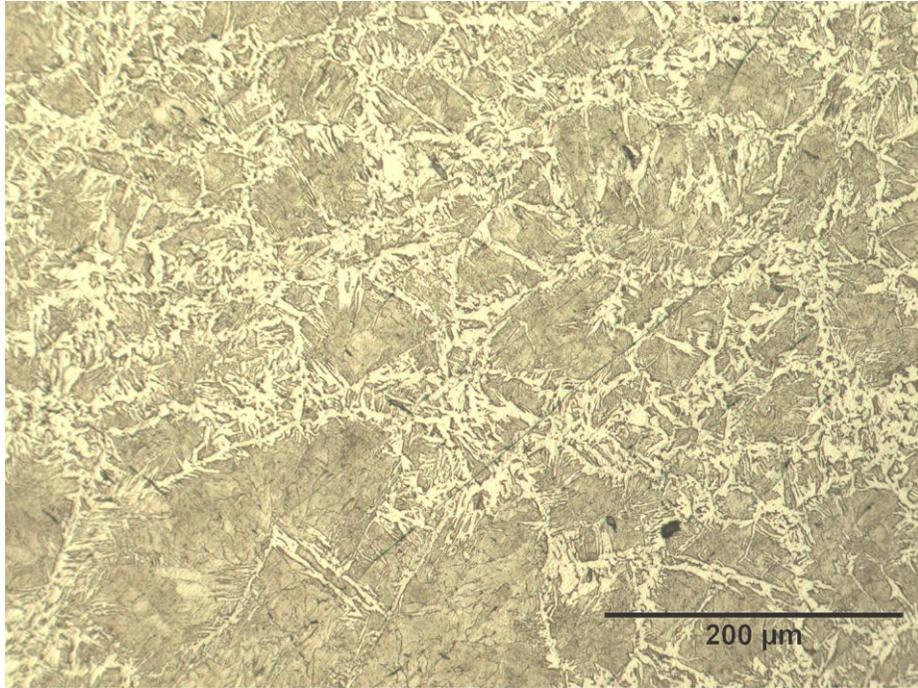
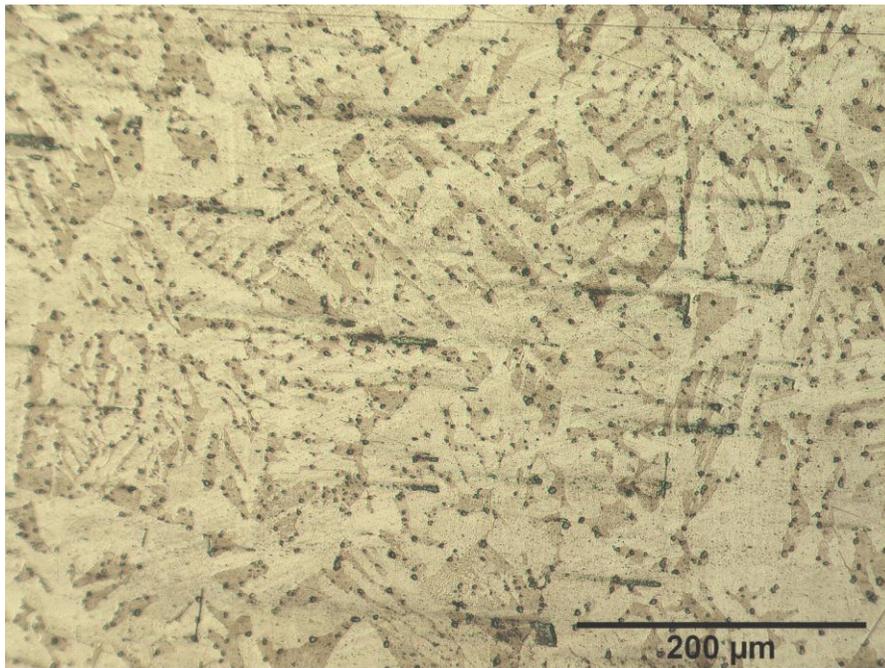
The microscopy showed us that there are a high amount of inclusions in the steel samples from the USS Arizona. This helps us characterize the steel that was used to make the ship. Seeing as the ship was built in 1915, it can be expected that inclusions would be significantly more prevalent than they are in steel today. There was little out of the ordinary in terms of observations on the microstructure of the USS AZ samples, as is shown in Figures 5-9.

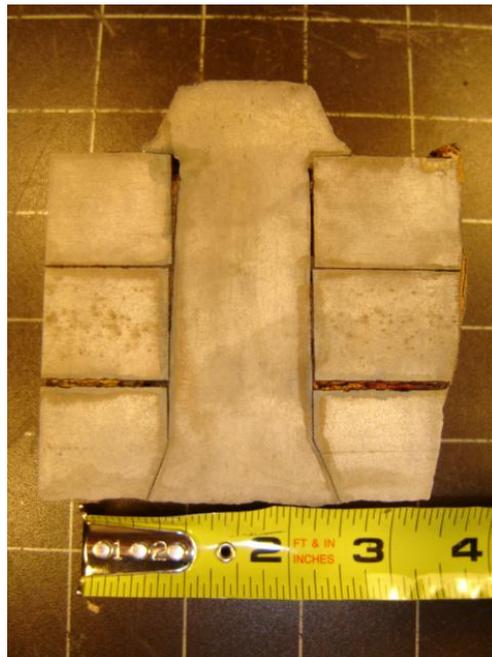
Figure 10- Macroetch of Plate A-6 Sample

The HCl acid bath showed us the basic macrostructure of the sample from plate A-6 which consisted of three steel plates attached by one rivet. The top of the rivet seemed to be plastically deformed around the part where the shaft of the rivet meets the lip of the head. This leads us to believe that the rivets of plate A-6 have a higher propensity to corrode at a faster rate than the steel plates around them based on the plastic deformation of the rivets. However, we can't make any solid conclusions based solely off of this qualitative data. The etching seemed to reveal the grains of the shaft of the rivet were arranged in a parallel vertical fashion; while the bottom of the rivet seemed to be plastically deformed like the top, except the bottom was flayed outward from the center of the rivet instead of bent around an edge like the top of the rivet was. The middle plate showed a sign of carbon segregation as is shown by the specks in the middle of the second plate on both sides of the rivet in Figure 10.

The results from the crevice corrosion analysis tests made us hopeful for future work. The macroetching displayed the surface characteristics of the steel, as visible by the naked eye, which were, in addition to those listed in the prior paragraph, that the interface between the top of the rivet and the top plate showed the most evidence of corrosion, possibly crevice corrosion. The XRD testing on the samples showed that both of the oxidation samples included magnetite and goethite. Below are the XRD mineral analysis results for the first and the second samples respectively.

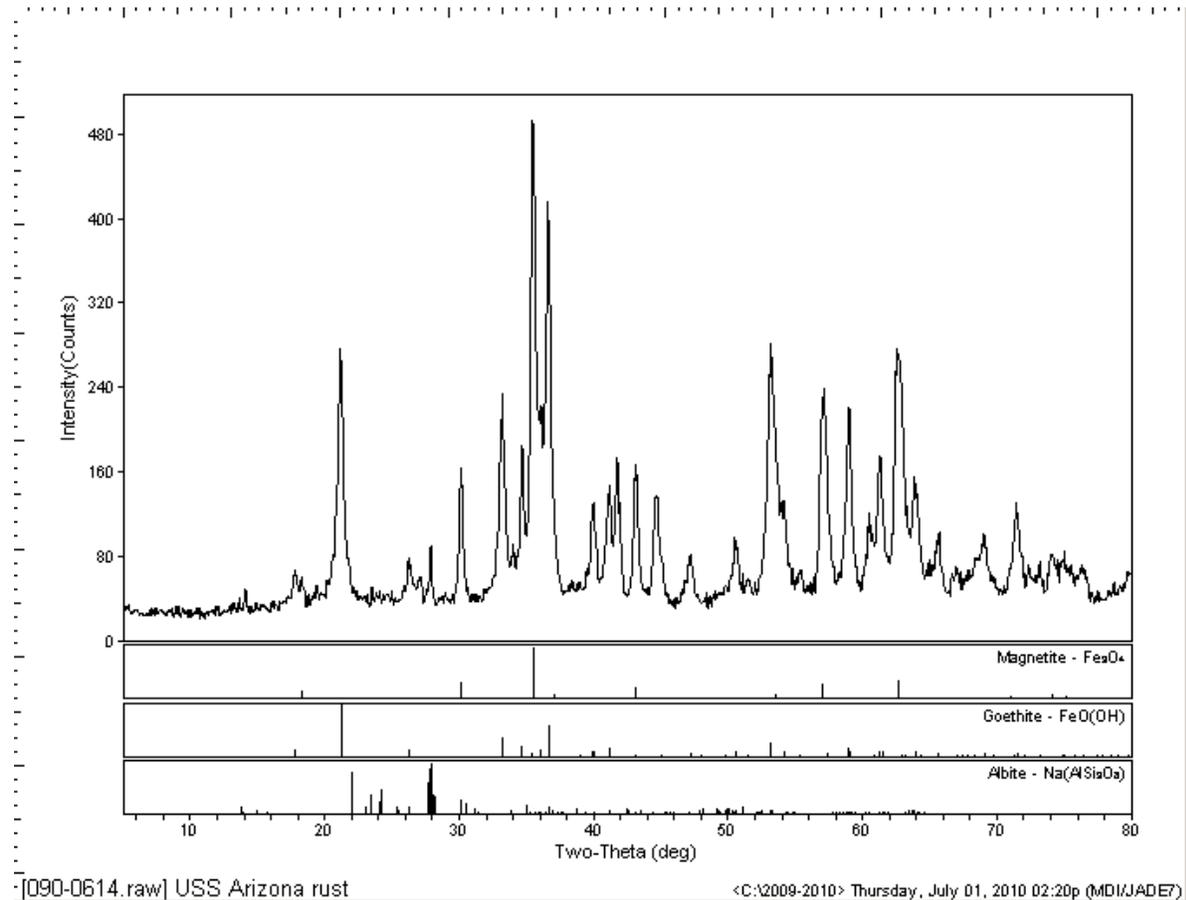
Figure 11: XRD Results from Sample 1

These results show that there is or was crevice corrosion occurring because goethite, an iron oxide hydroxide, is known to be a product of a self-sustaining crevice corrosion mechanism which occurs in the presence of aerated water.

The weight percentage testing showed us that the first oxidation sample was approximately 65% goethite and 35% magnetite and the second oxidation sample was approximately 54.5% ringwoodite, 27% goethite, and 18.5% magnetite, keeping in mind that both samples' percentages are based off non-amorphous mineral percentages. This ringwoodite, an iron silicate with substituted magnesium, was an unexpected product in the

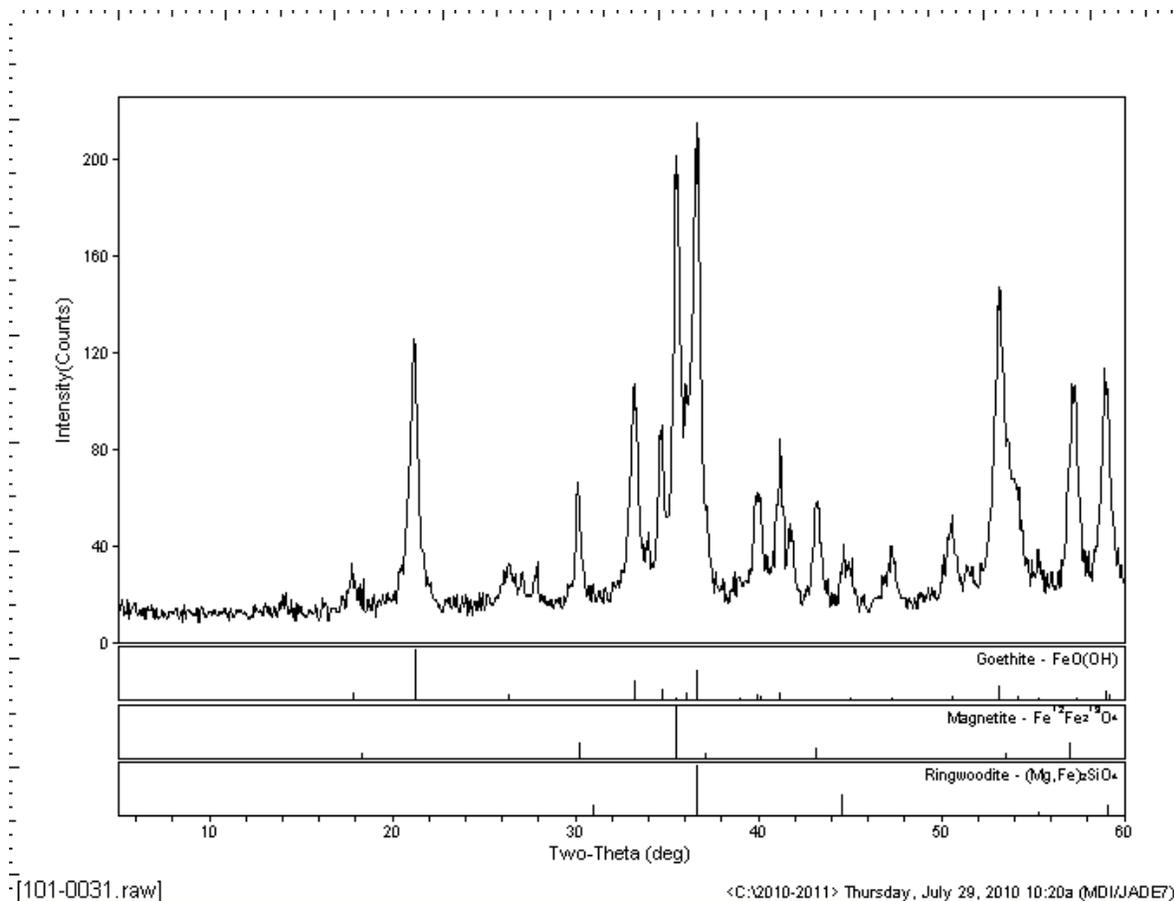
**Figure 12: XRD Results from Sample 2**

oxidation sample. The relevance of the test data, however, is that both samples showed a significant percentage of goethite. Based off of the goethite, it can be said that the rivet-plate interfaces on plate A-6 did seem to be experiencing crevice corrosion. My advisors and I have made the educated guess that the ringwoodite could have formed on the beach at Waipio Point, HI due to the contamination of plate A-6 by sand, a silicate. Therefore, the ringwoodite may or may not be affecting the corrosion of the portion of the USS Arizona still under water in Pearl Harbor.
