# Metallurgical & Corrosion Evaluation of the USS Arizona

Research Experience for Undergraduates 2009 (REU)

Research Undergraduates: Nathan Saunders & Elliot Hamilton

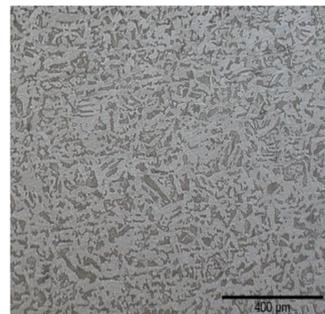
Figure 2: Micrograph of Plate A-1. 100 X.

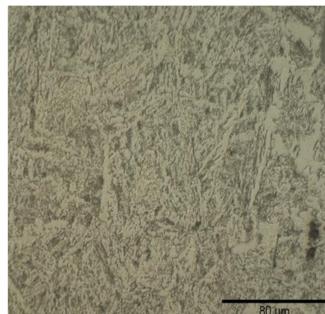
Figure 3: Micrograph of Plate A-2. 500 X.

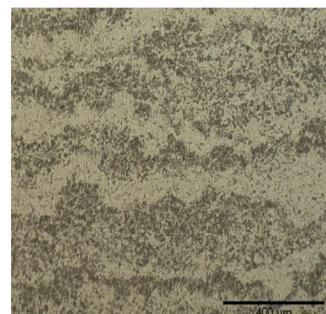
Figure 4: Micrograph of Plate A-3. 100 X.

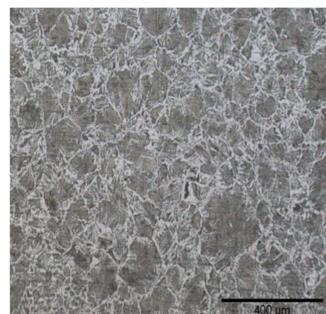
Figure 5: Micrograph of the Rivet. 200 X.

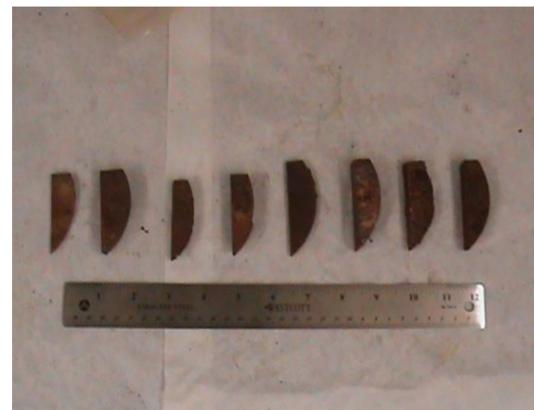
- Core samples recently taken from the U.S.S. Arizona's hull were also analyzed with an optical microscope.
- A photograph of the core samples is shown in **Figure 6**.
- The core samples were compared to the other specimens.
- If the core sample has similar microstructure, it can be assumed that it also has similar chemistry and corrosion-susceptibility given the same conditions.
- A chemical analysis for the carbon content of the steel was performed on the selected samples of plate and rivet.
- The results of the carbon content analysis are shown in **Table 1**.

Figure 6: Photograph showing the core samples taken from the U.S.S. Arizona.

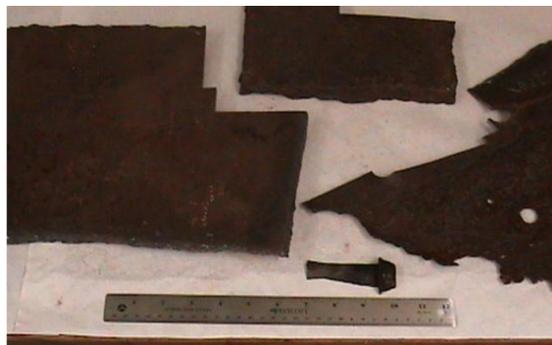
Figure 1: Photograph of the selected steel pieces from the U.S.S. Arizona at Waipio Point. Left: Plate A-1. Top: Plate A-2. Right: Plate A-3. Bottom: Rivet.
