Refill Friction Stir Spot Weld Repair of a Fatigue Crack

Program Information:

Summer 2009

South Dakota School of Mines and Technology

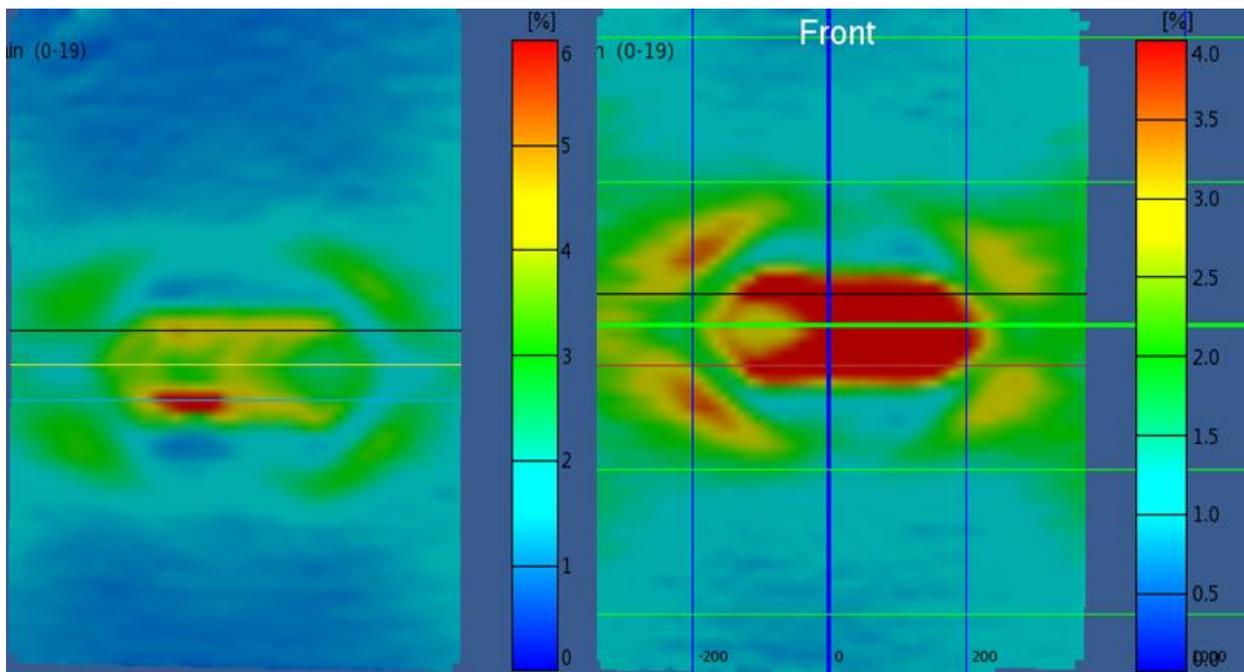
Figure 3: DCI Image Showing Stress in Tension/Tension Tensile Test

From the tensile test we could tell that this would be a favorable stitch configuration for the repair. The major strain field from digital image correlation camera image for 6 welds per inch can be seen on the left with 5 welds per inch on the right. The ending weld present on the side where strain is relieved. The strain field flows like water and moves outward and around the final weld.

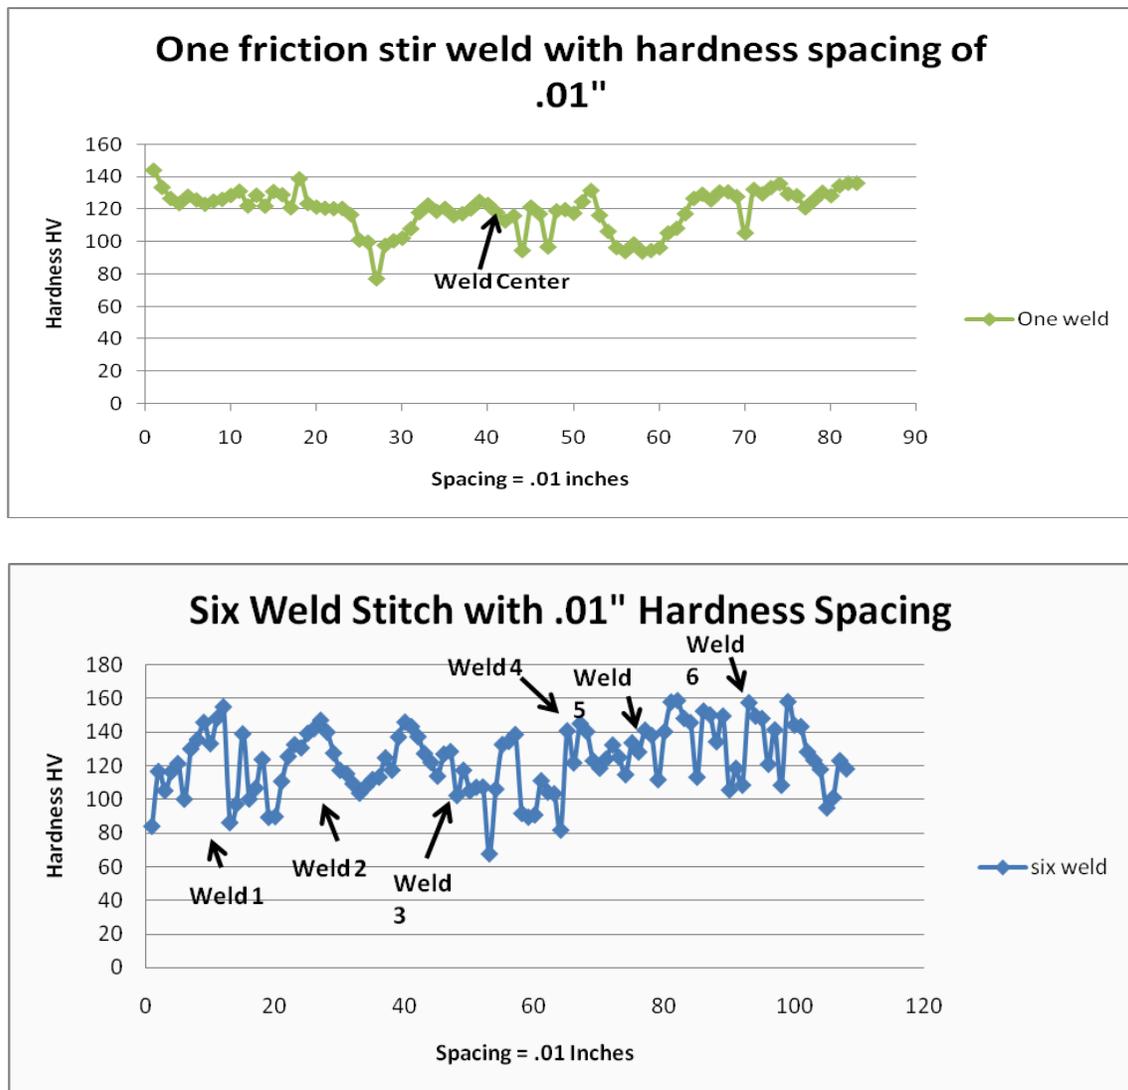
Figure 4: Hardness Data Plots

In the case of the six weld per inch stitch weld we see an increase in the hardness of the center of the welds. This explains why we see a lower strain on the final weld. The final weld is harder and thus transfers the strain field around and to the outside of the final weld. This may indicate how or where a fatigue crack may form. Once the stitch weld was studied we could now make repairs.

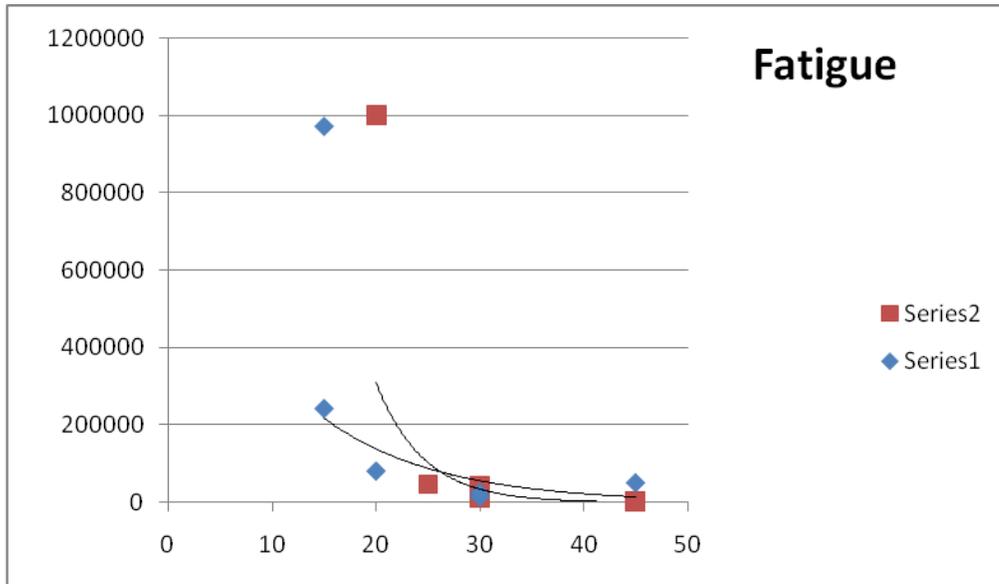
Figure 5: Plot of Cycles to Failure vs Flow Stress %

These repairs did not show a large improvement to the fatigue life of the sample. The following chart shows the repaired samples as series 1 (blue), and the unrepaired as series 2 (red). We can see that most of the data points show improvement, however, the low flow stress

levels show a trend of being worse than the original crack. This was not expected and a failure analysis was performed on the fatigue samples.

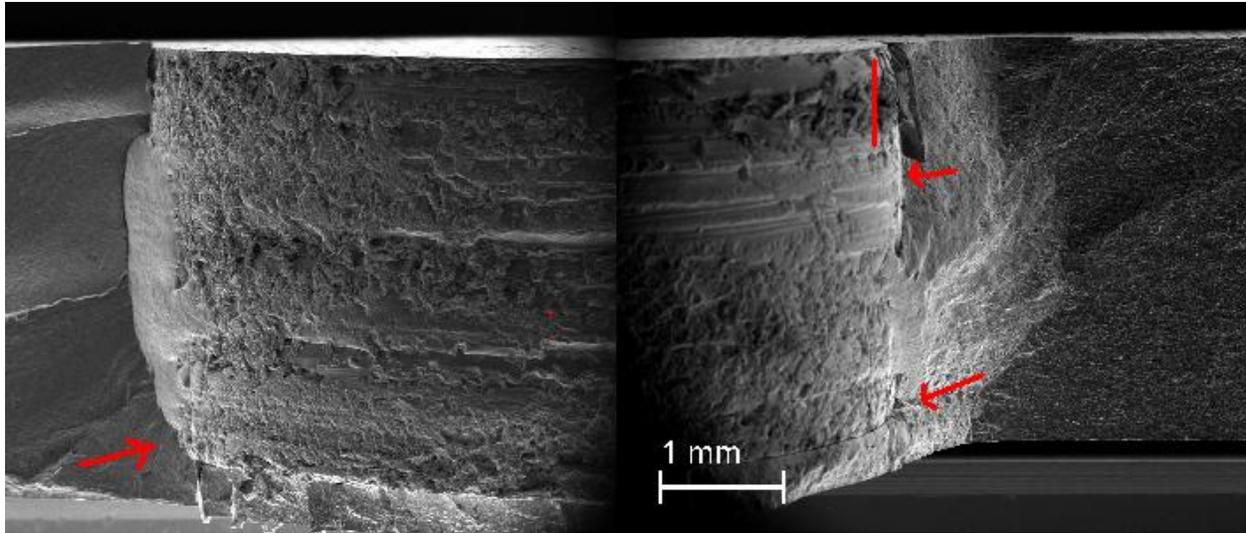
Figure 6: SEM Photo at 15kV and 40x (Bad Repair)

The samples were not giving the expected fatigue life so an explanation was needed. In order to show how and why these repairs failed we used our SEM to gain high magnification pictures. The picture below shows a bad repair. The weld showing is the final weld in the stitch. The arrows indicated multiple points of initiation. Each is related to a defect that is reducing the fatigue life of the repairs.

First we see a crack begin in the upper right hand side of the picture. This is the point where the outer wall of the last weld meets the parent metal. Here the defect that is present is a lack of consolidation. The surface stamp has created an interface that is not bonded to the surrounding metal. At the bottom of the weld there are two initiation points. The one on the right is the outer edge of the last weld and the left is the inner edge where two welds overlap. There is a lack of penetration along the entire bottom of weld. This seems to be due to an error in the spot welder. The last defect that was observed can be seen along the surface. It is a lack of surface consolidation. This is expressed by the red line. Here the surface is not flush and there is an indentation in the surface. Essentially it is a crack around the weld and thus initiates the fatigue crack.

There are several elements that will improve repairs from the ones made in this project. The first is to use a thinner material. Our machine is nearly at the maximum depth for a weld. This may very well be causing the lack of penetration along the bottom of the weld. Second, the amount of material removed in the pre-cracking process may be too great. The pre-crack volume has to be replaced in order to ensure a good weld. A thicker peel strip could work, however, the further apart the starting condition and the plate's surface are the greater the chance of an indentation on the surface. The best option would be to minimize the volume loss in the pre-

cracking process. Lastly, the way the original pre-cracks were made may have involved too much stress and created a plastic region around the crack. When performing the final fatigue test, the plastic region may reinforce the crack and not allow it to grow as fast. This would mean that our pre-crack procedures may have somewhat slowed the crack from propagating past the plastic region. The next set of samples should be pre-cracked at a lower stress level.

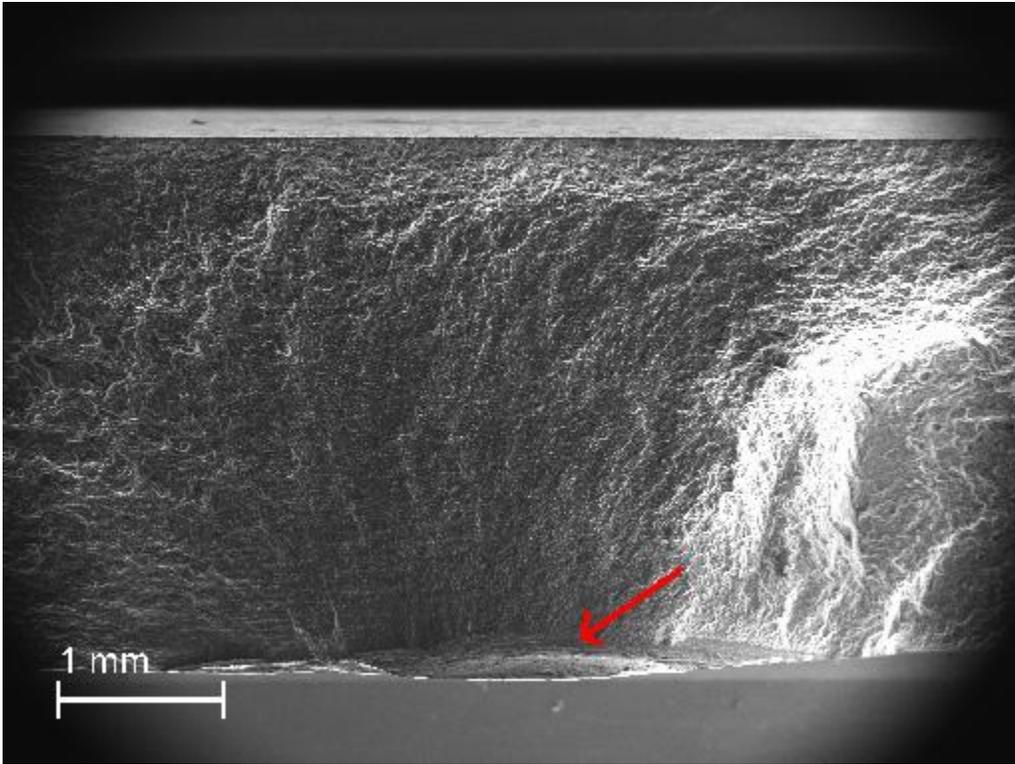
Figure 7: SEM Photo at 15kV and 40x (Good Repair)

We also looked at the fractured surface of a good repair. The repair is shown above with an arrow showing the point of initiation. The dotted line indicates the orientation of the final weld. We can see that the crack began in the final weld region as in the others. There are no exposed defects to indicated a bad repair. The crack began along the top edge and outside edge of the weld and continued to progress in the heat affect zone of the weld before reaching overload and failing in the parent metal.
