Metallurgical and Corrosion Evaluation of the U.S.S. Arizona

Prepared by: Nathan Saunders and Elliot Hamilton

Research Experience for Undergraduates

Summer 2009

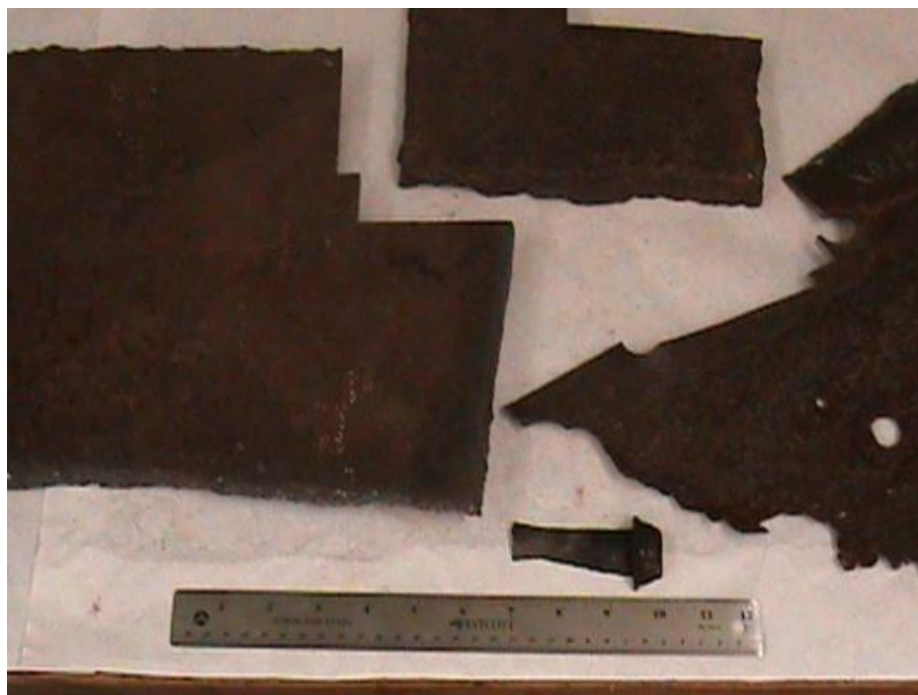
After taking sections from different pieces of plate, it was found that there were three microstructural varieties of plate. A photograph showing the plate is shown in Figure 1. The different plates shown will be referred to as plates A-1, A-2, and A-3, respectively. The microstructure of A-1 shows a lower carbon condition than the rest of the plate. The matrix largely consists of ferrite (white) with some resulting pearlite (dark). The microstructural condition of A-2 indicates an acicular fine ferrite-pearlite-like matrix. The microstructure of A-3 was found to be heavily banded with a low to medium-carbon ferrite-pearlite matrix. The banding is likely the result of ingot casting solidification practices of the time. Segregated microstructures form when solidifying, and are forced into a parallel structure when rolled. Micrographs of the plates can be seen in Figures 2, 3, and 4.

Figure 1: Photograph of selected steel pieces from the U.S.S. Arizona at Waipio Point. Left: Plate A-1. Top: Plate A-2. Right: Plate A-3. Bottom: Rivet.

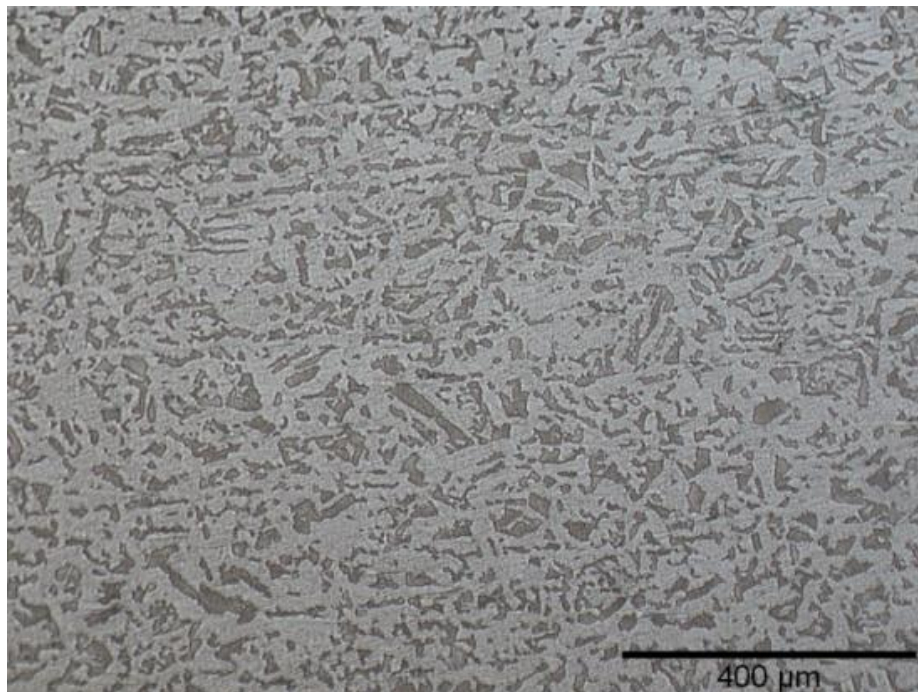
Figure 2: Microstructure of Plate A-1. 100 X.

Plates A-1 and A-2 were found to be similar to those found in “Metallographic Studies of the U.S.S. Arizona”, having the banded low-carbon appearance (2). The rivets analyzed from Waipio Point were also found to have similar microstructure to the Waipio Point rivet in “Metallographic Studies of the U.S.S. Arizona.” The rivets had the appearance of being cooled quickly from austenitic temperatures, grain boundary pro-eutectoid ferrite, Widmanstätten ferrite, and fine-pearlite (2). The appearance of being cooled quickly is explained by the riveting methods of the time, where rivets are heated to red hot temperatures and forged into place. The head of the rivet, however, showed more deformation and indications of carbon loss (decarburization). The decarburization likely occurred because the rivet was heated to temperatures in which diffusion of carbon can take place. The carbon diffuses toward the surface of the part and is oxidized in the atmosphere resulting in the loss of carbon near the surface of the heated material. This is seen by the increased amount of ferrite (white) near the surface of the material. Figure 5 shows a micrograph of the rivet head.

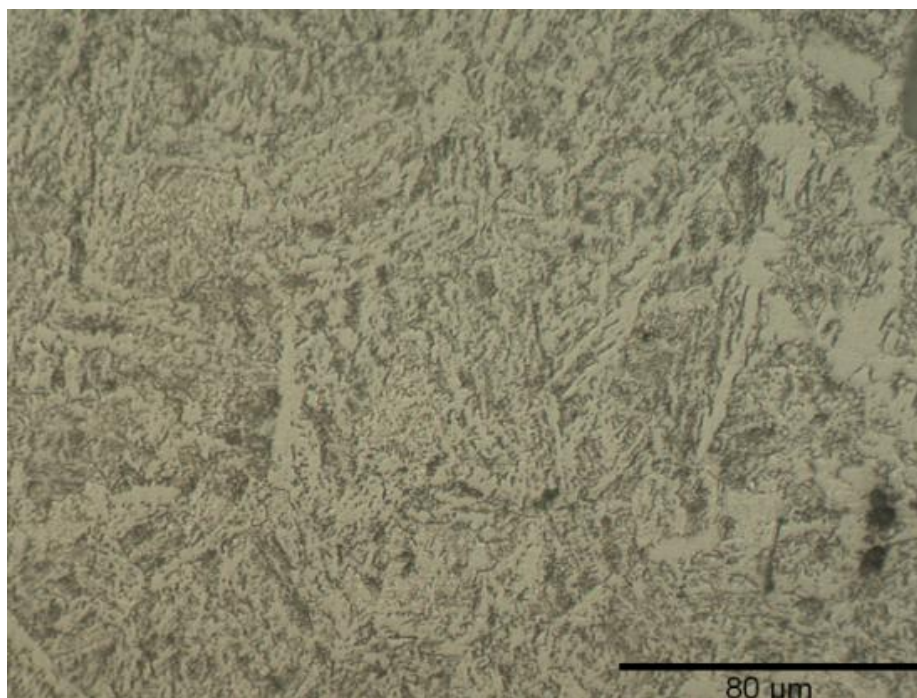
Figure 3: Microstructure of Plate A-2. 100 X.

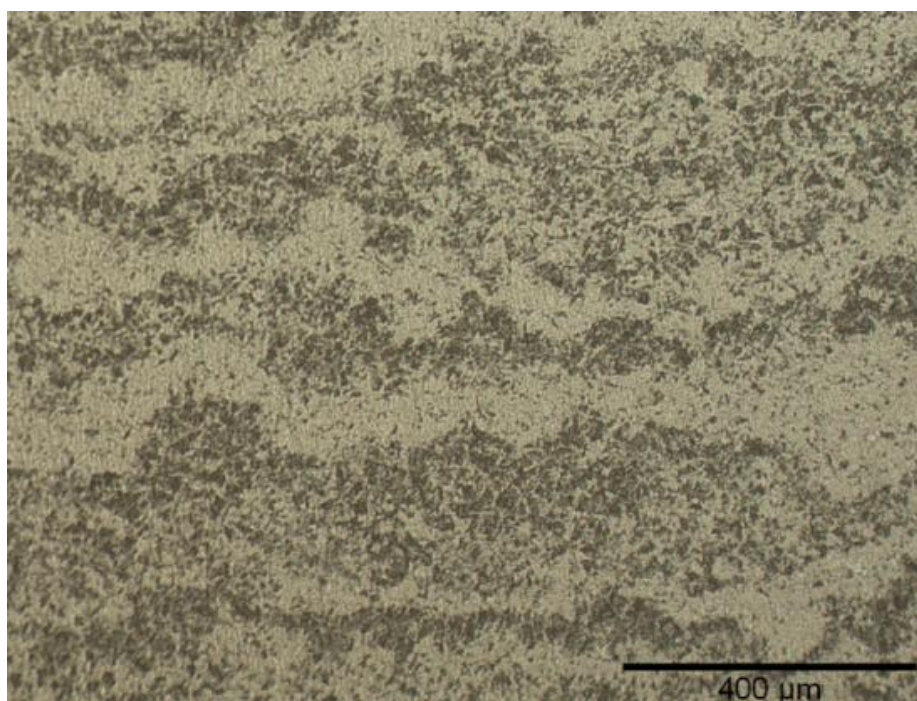
Figure 4: Microstructure of Plate A-3. 100 X

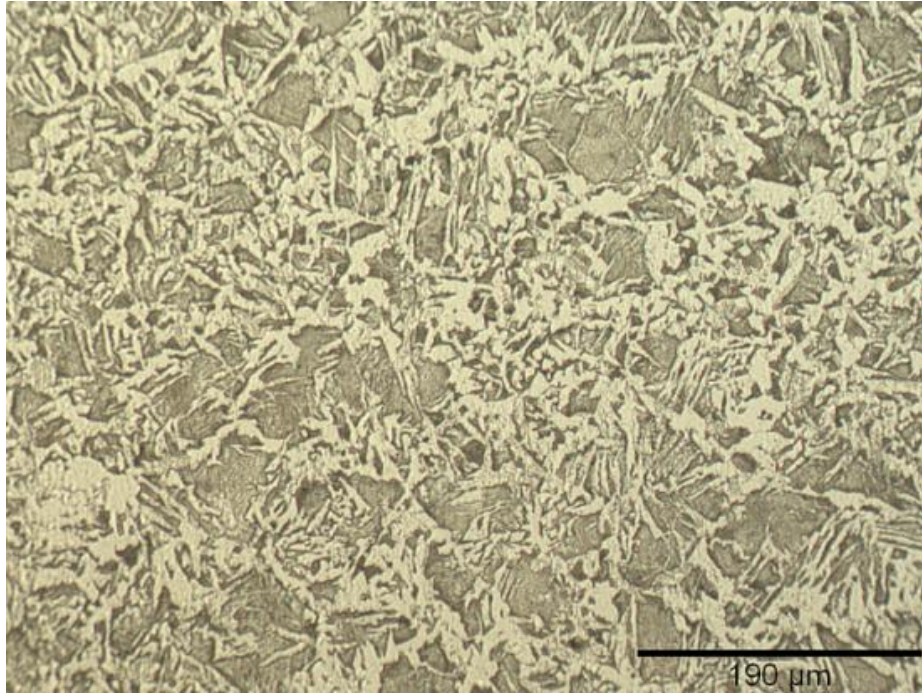
Figure 5: Microstructure of Rivet Head. 100 X.

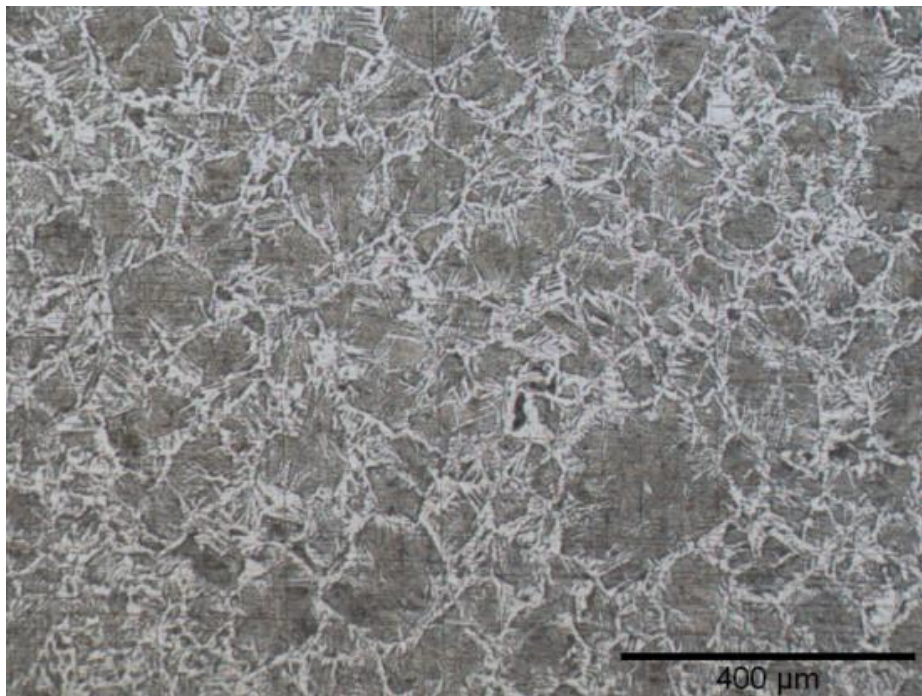
Figure 6: Microstructure of Rivet Shaft. 200 X.

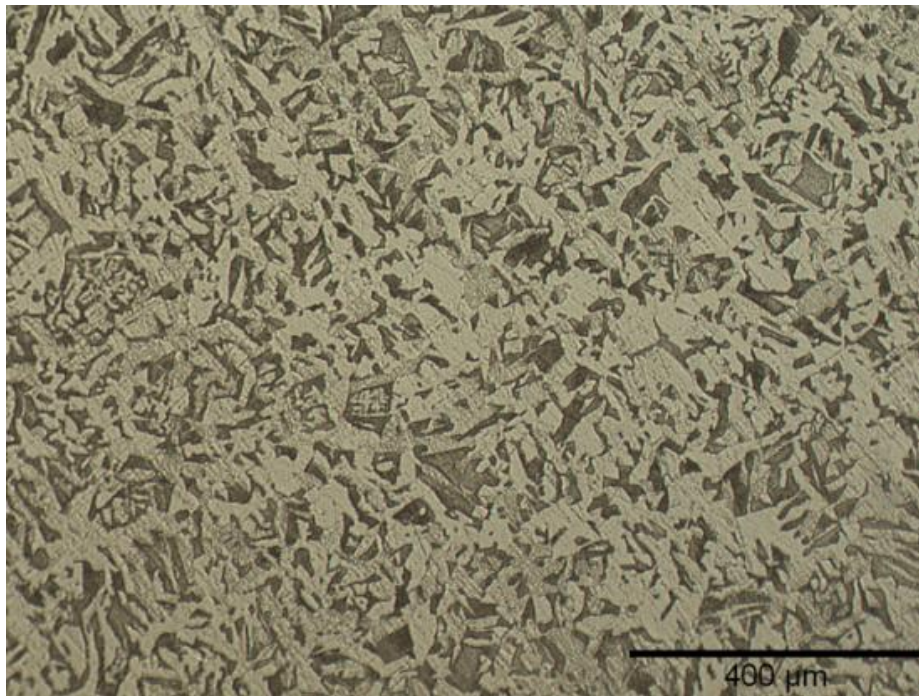
Figure 6 shows a micrograph of the rivet shaft. A photograph of the core samples is shown in Figure 7. The core samples were found to have a similar microstructure to plate A-2, although some of the core samples indicated lower carbon content in some cases. Figure 8 shows a representative micrograph of the similar microstructure, and Figure 9 shows a representative micrograph of the lower carbon sample. The micrographs of the rest of the core samples are shown in Appendix A.

Figure 8: Microstructure of U.S.S. AZ Core Sample. 100 X.

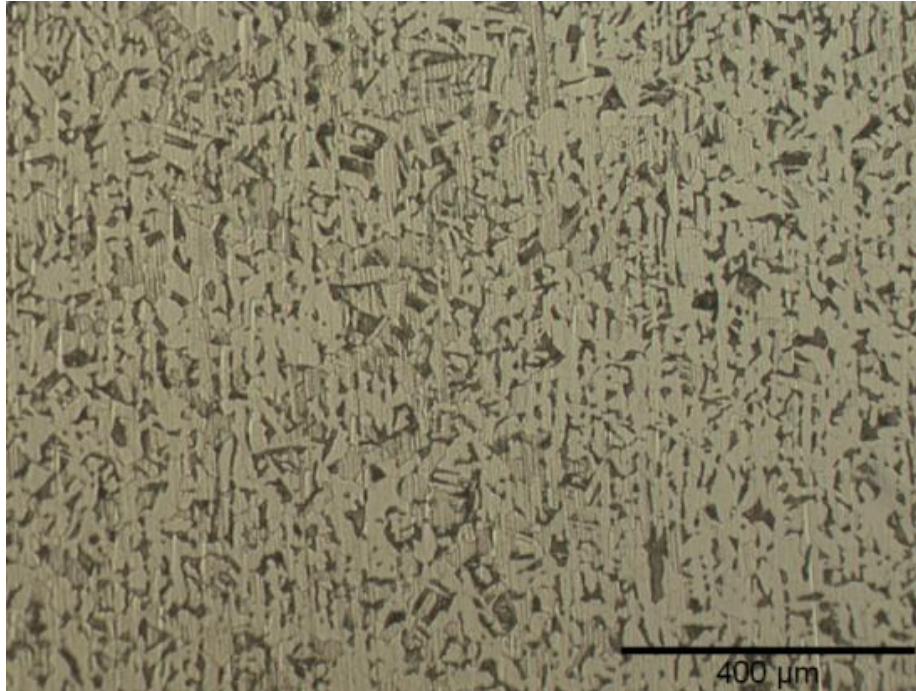
Figure 9: Microstructure of Low-Carbon Type Cutting. 100 X

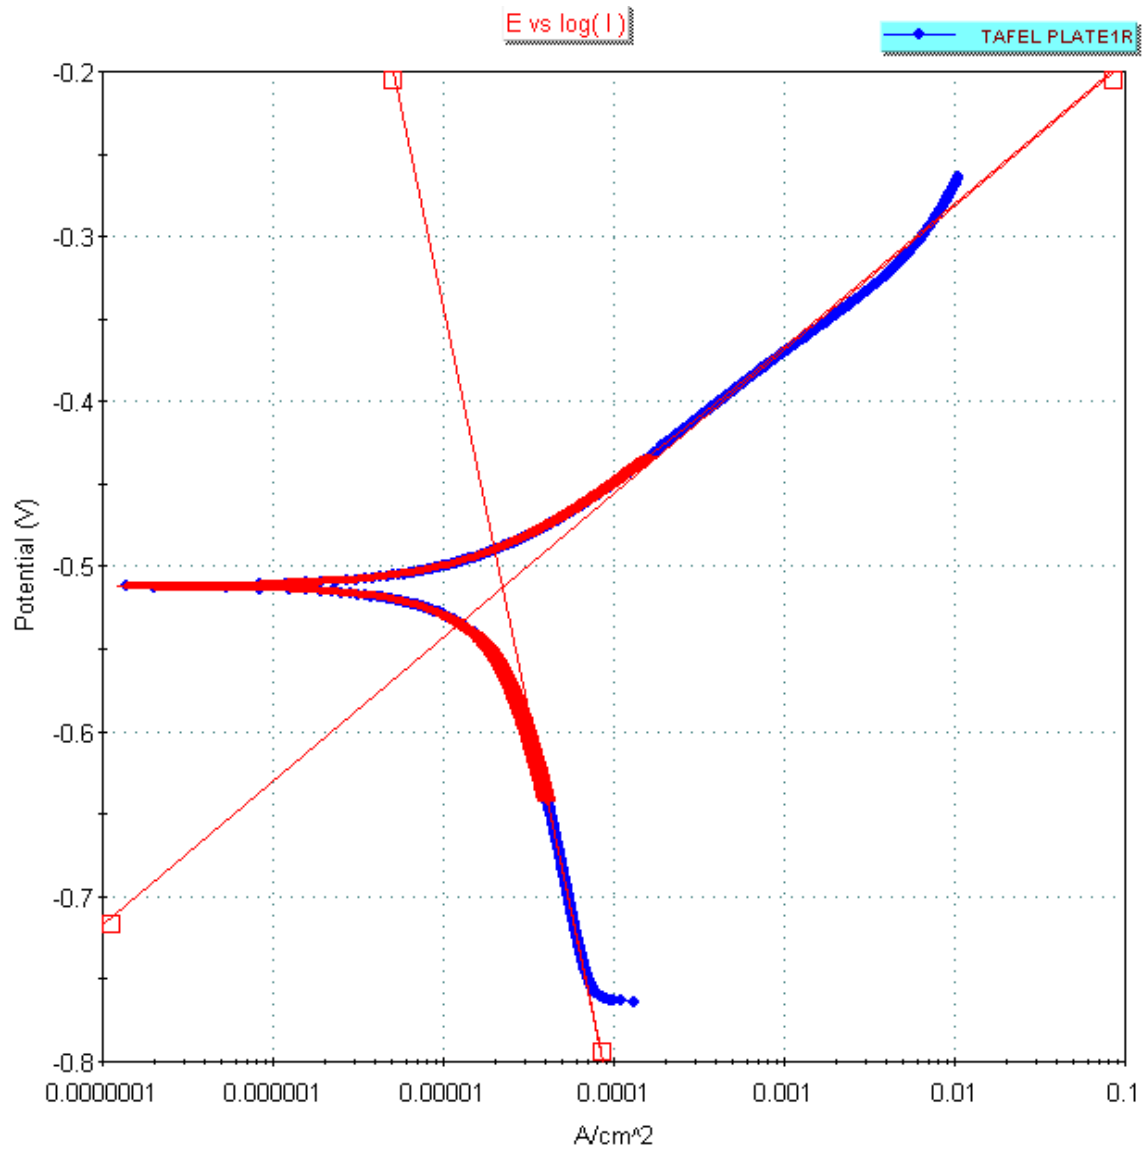
Figure 10: Exemplar Tafel Plot Showing the Results of Plate A-1.

The results of the linear polarization experiments show higher corrosion rates for Plate A-1, A-3, and the rivet head. This data compares within reason to corrosion rates found in “Recent development and application of Concretion Equivalent Corrosion Rate (CECR) Methodology” (4). This research found corrosion rates from 0.5 mpy to 3 mpy. There are several possibilities of phenomena that may be causing the difference in corrosion rates. First, several different steels were used to construct the ship. Testing different steels would most certainly yield different corrosion rates for the respective steels. Also, the method of determining corrosion rates, in that paper, was by concretion chemistry analysis instead of measuring rates with PAP testing.

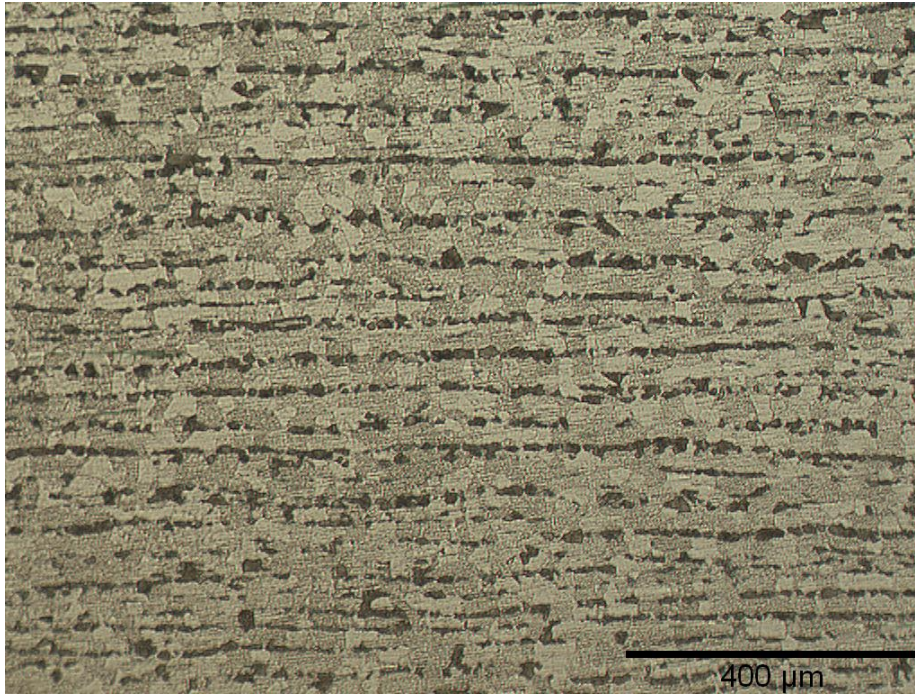
The data obtained from this experiment compares well with the chemical analysis found in “Metallographic Studies of the U.S.S. Arizona.” Slow-cooled plate A-1 showed evidence of heavy banding. Plate A-2 showed evidence of heavy banding after the slow-cooling. For this reason, the analysis used to find the carbon content did not work well on this specimen. A micrograph of the slow-cooled plates is shown in Appendix B.

Figure B-1: Micrograph of Slow-cooled Plate A-1. 100 X.

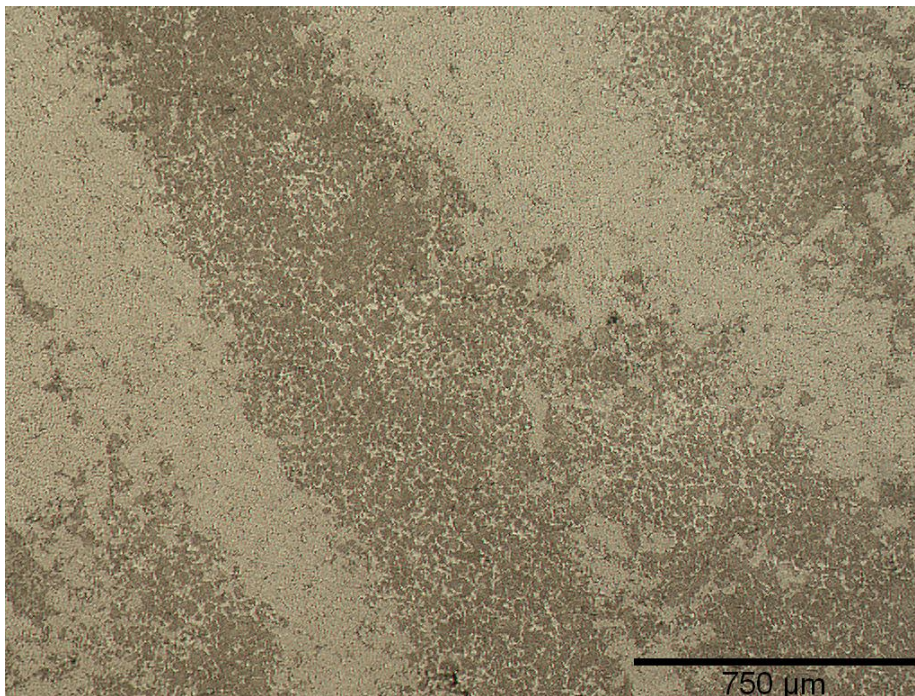
Figure B-2: Micrograph of Slow-cooled Plate A-2. 50 X.
