Student(s):
 Sean Long Fox
 Nick Smith
 Isaac Williams
 Vince Walker

Refill Friction Stir Spot Weld Repair of a Fatigue Crack

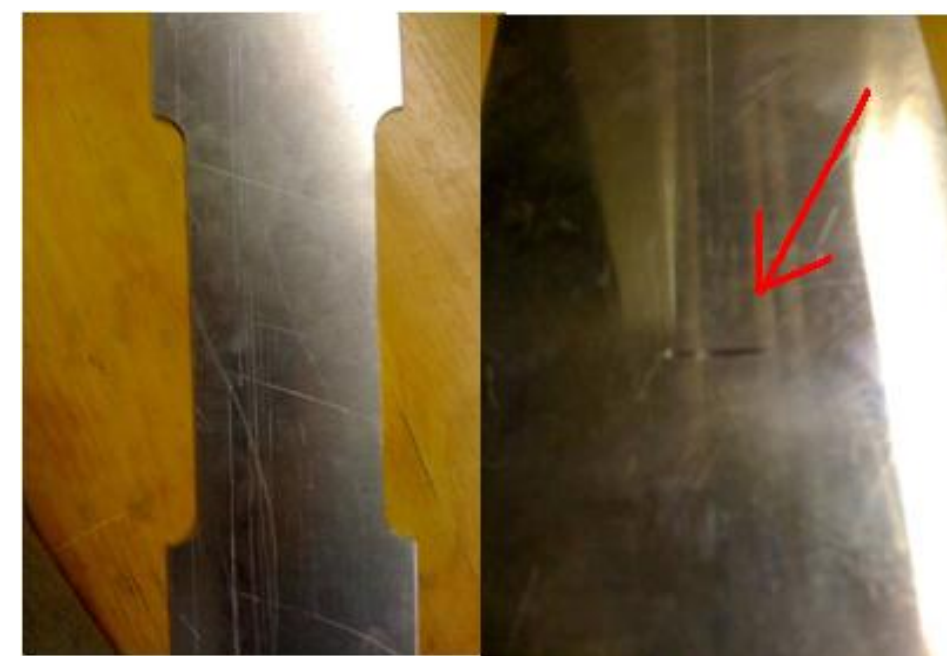
Figure 1 shows a dog boned sample with an arrow pointing to a fatigue pre crack.

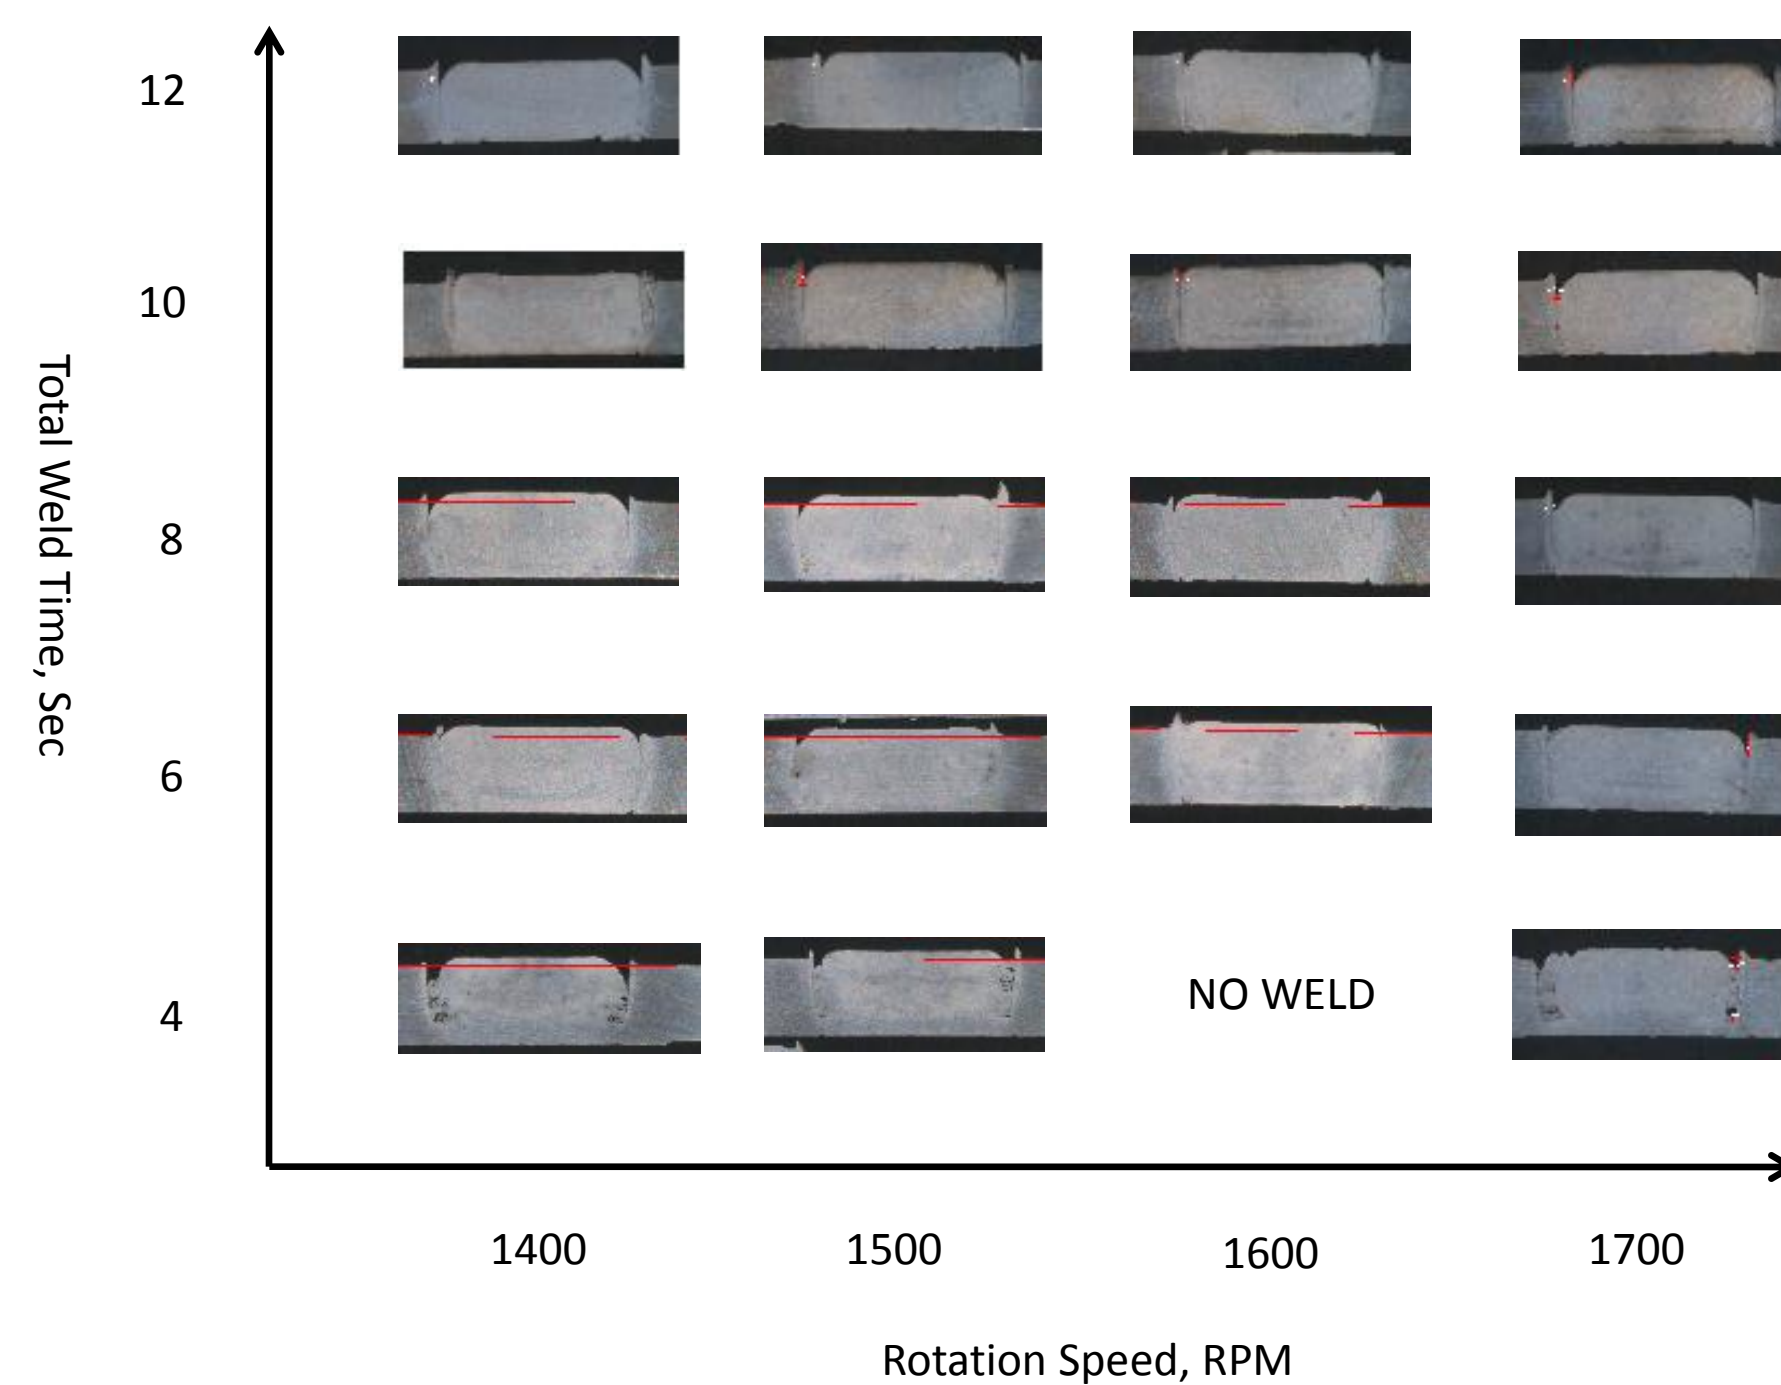
- Optimize the parameters for 2024 Al T3 .125 inches thick by modifying the rotation speed and weld time. This process is detailed in figure 2. 1600 rpm at 12 sec. were the optimized parameters.

Figure 2 is a matrix showing the parameter development. Rotation speed and Weld time were changed to show the trends in metallurgy. The weld time determines plunge rates.

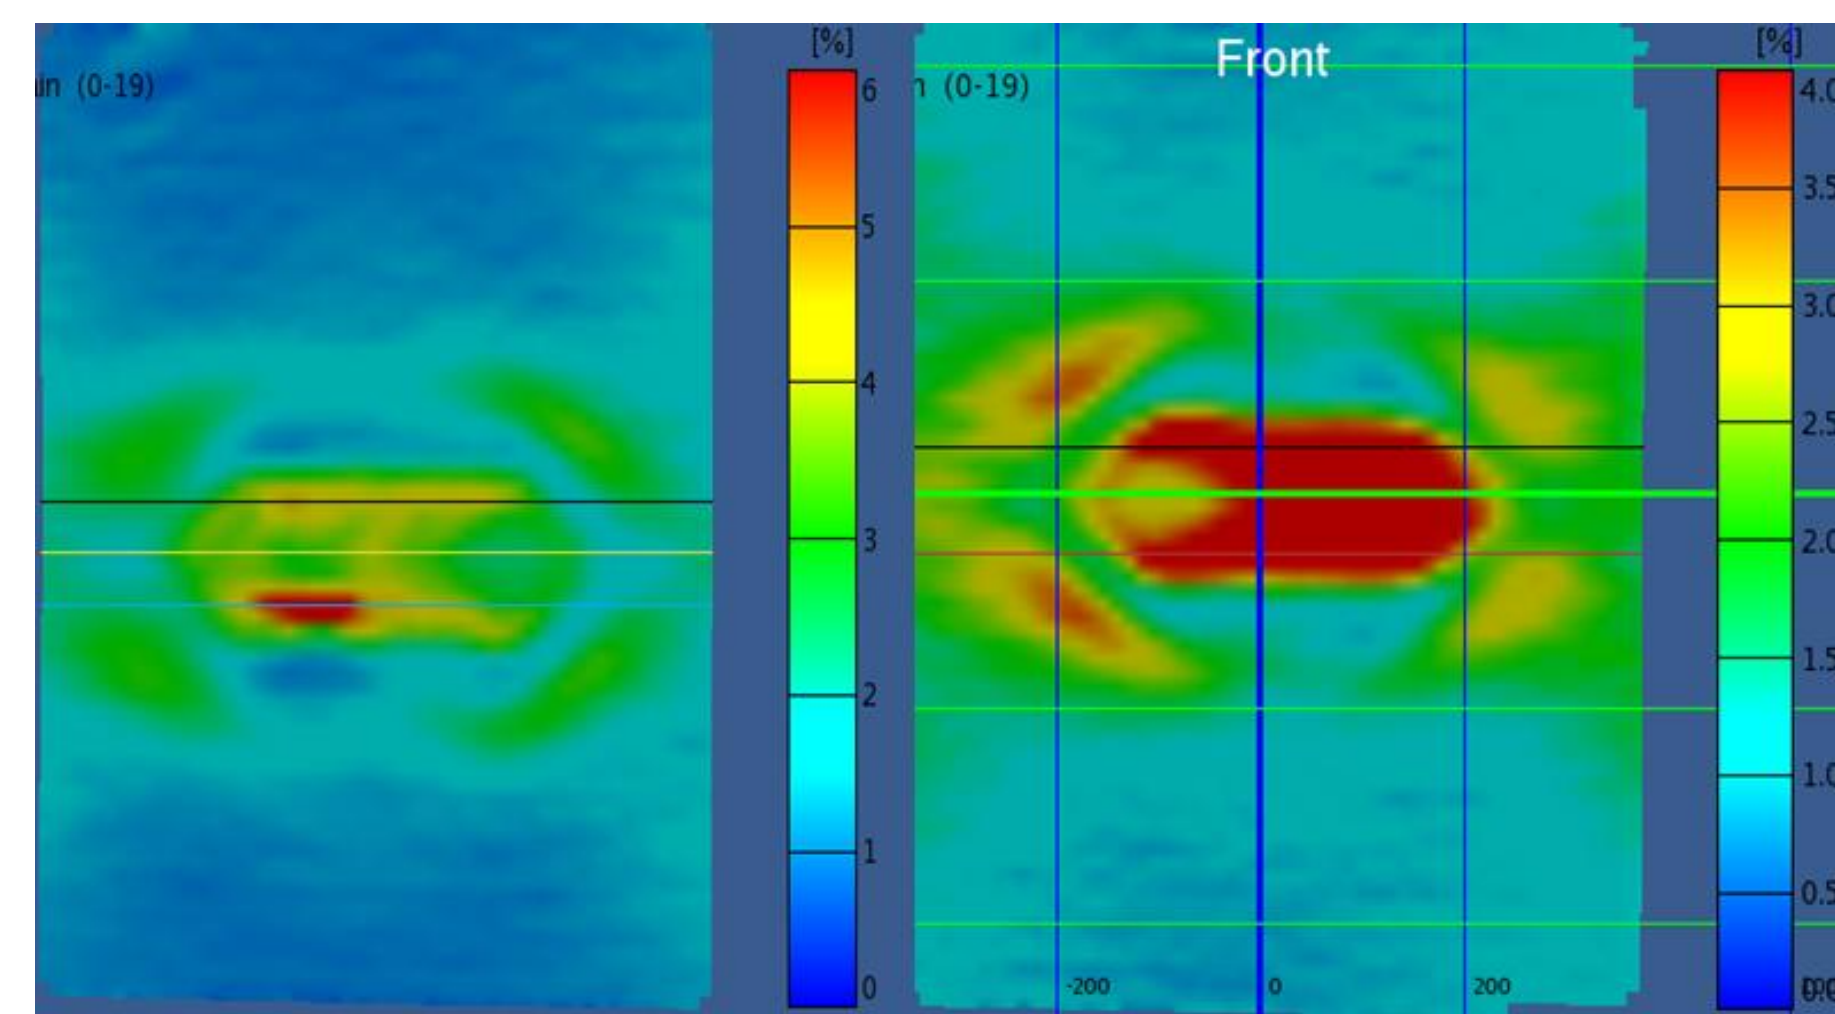
Figure 4 shows strain fields as seen by our DIC cameras as the samples are pulled in tension. On the left is a 6 welds/inch and the right is 5 welds/inch. The ending welds have least strain.

- It was determined by tensile strength that 4 welds/inch was not enough. There was little difference between the 5 welds/inch and the 6 welds/inch samples. At least 5 welds/inch would be needed.
- Micro hardness was also performed to show how the hardness changed along the overlapping welds. This is shown in figure 5 and 6.

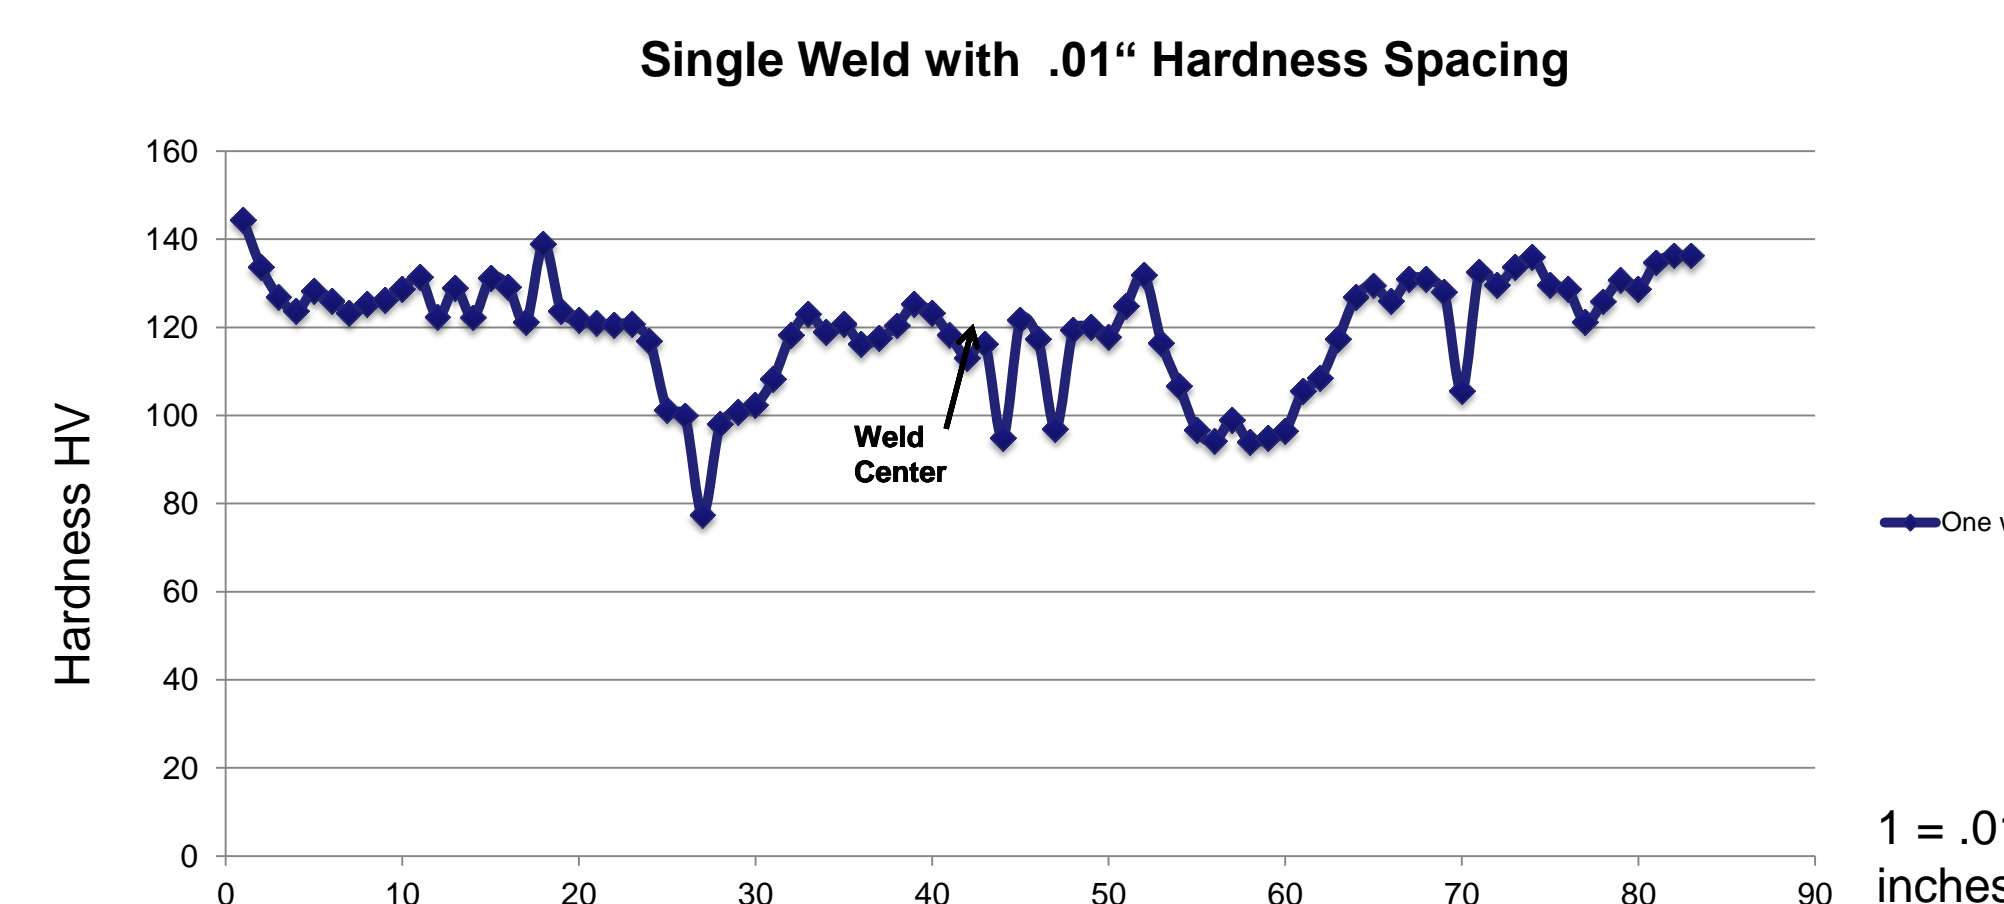
Figure 5 shows a Vickers micro hardness test on a single weld.

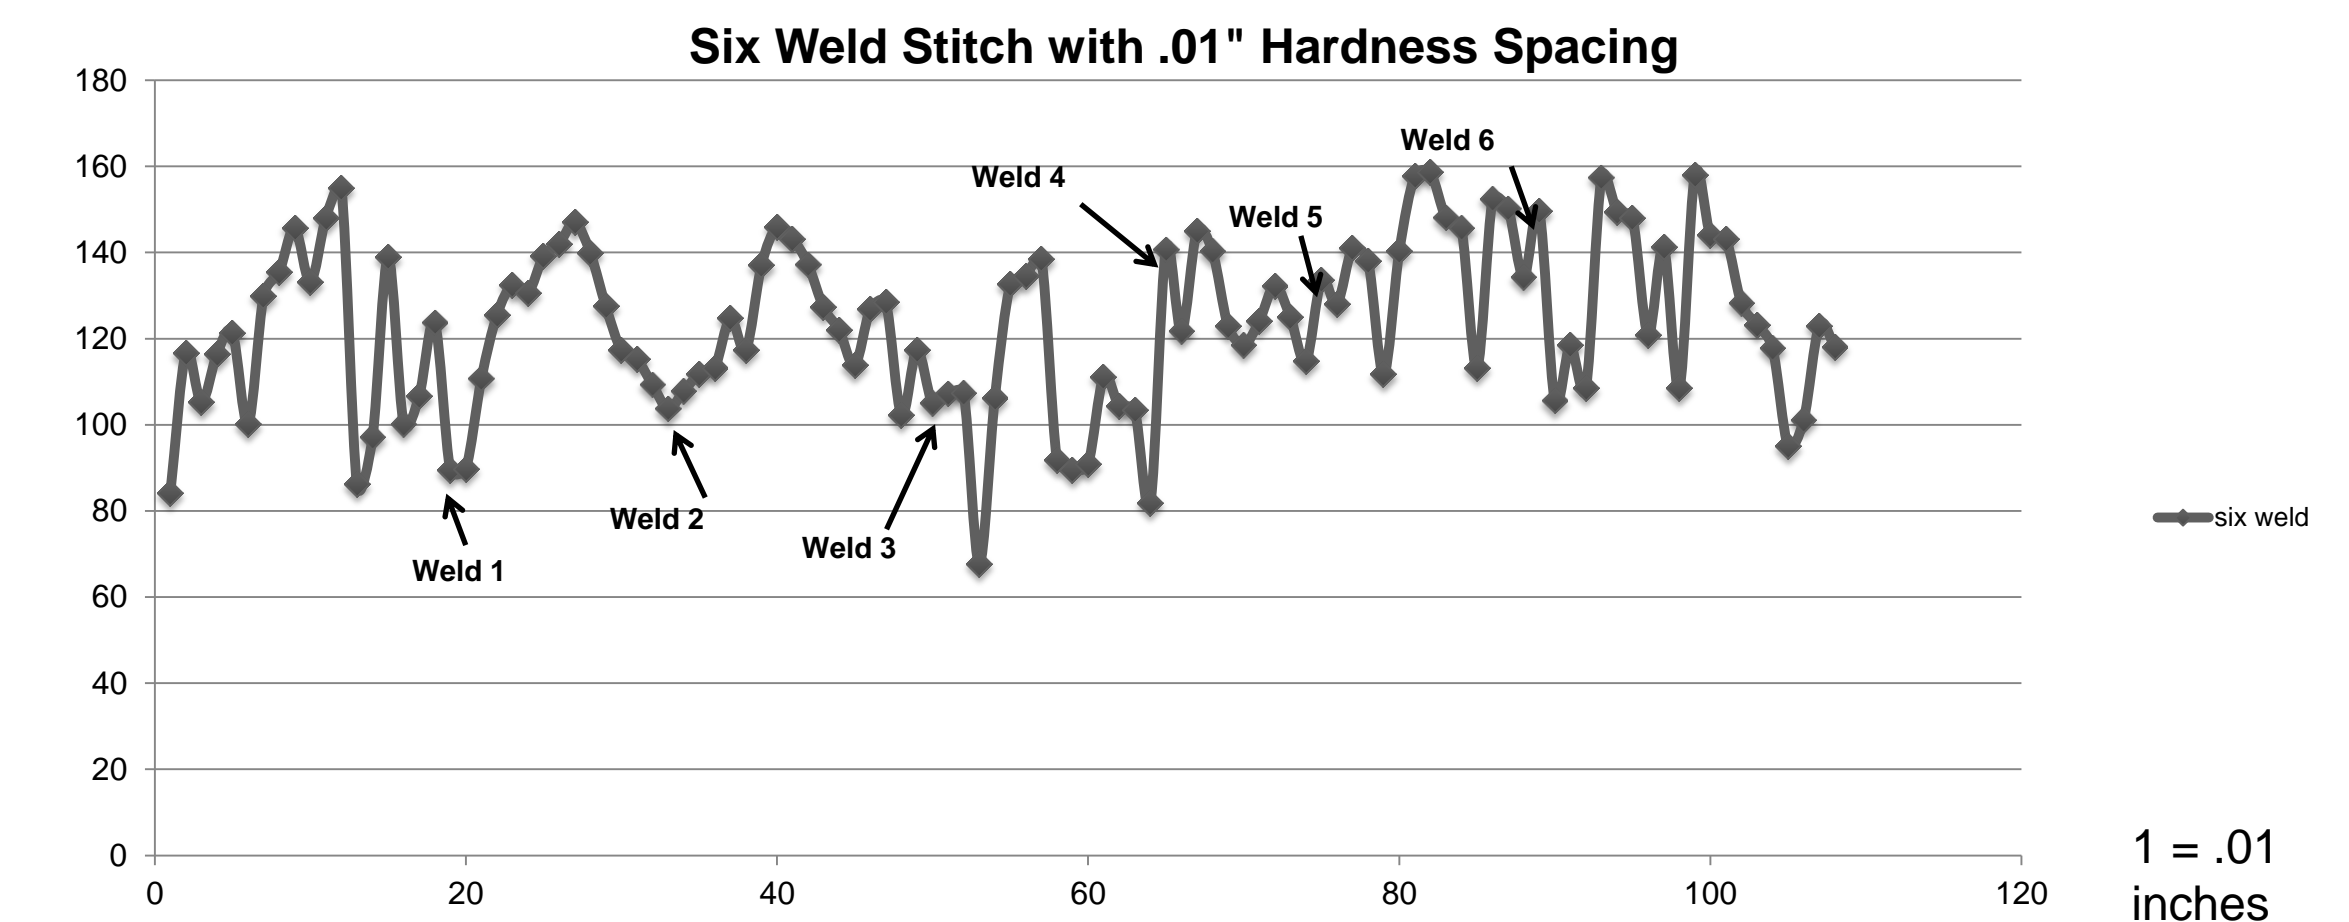
Figure 6 shows a six weld stitch weld. The harness increases as the welds progresses. Weld 6 is the last weld in stitch.

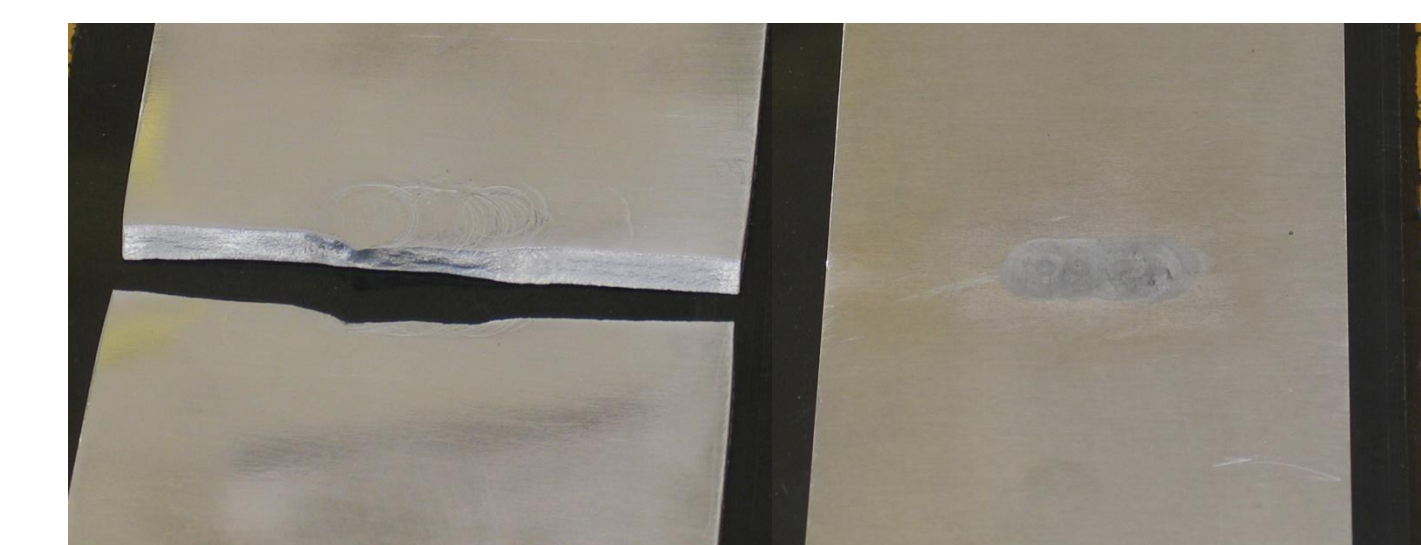
Figure 7 on the left shows a repair failure during a fatigue test. On the right is the bottom surface of a repaired crack.
