Repairing Cracks in Cast Iron using Friction Stir Welding

Research Experience for Undergraduates

Summer 2010

South Dakota School of Mines and Technology

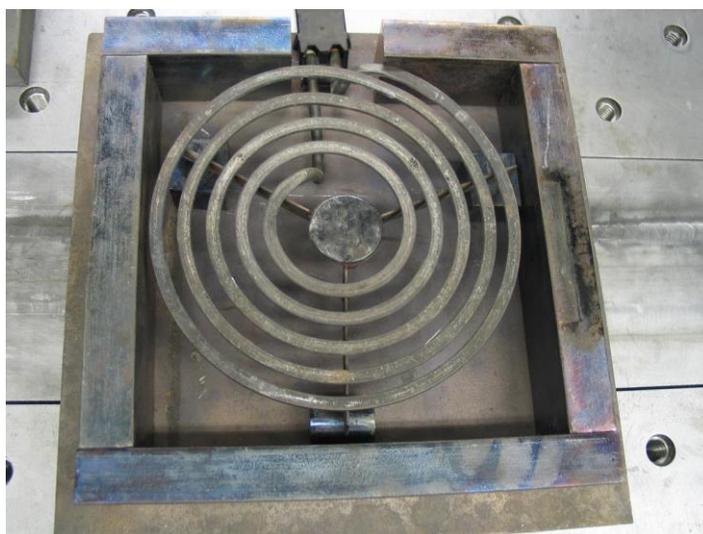
Fig. 3: Heating anvil [3]

Before welding a heating anvil is placed on the welding table and heated up to approximately 200° C in order to have the cast iron heated uniformly. The anvil is made of a range heating element surrounded by one inch steel walls all around. The steel is used for support during welding. The anvil uses conduction heating to heat the cast iron above it.

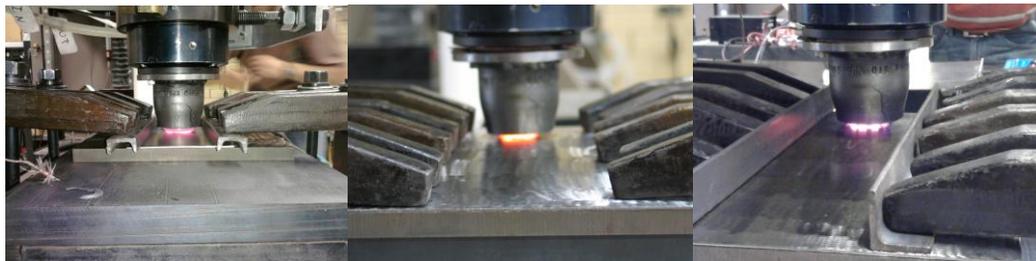
Fig. 11: Cast iron welds with different clamping methods

In the above figures the welds done using figures 11b and 11c were unsuccessful. The steel cover plate would bow continuously during the welding. We decided to look at previous welds and see how the issue was solved. Instead of having a steel cover plate to cover the entire material, a smaller cover plate was used and both the steel and cast iron plates were clamped simultaneously.
