## **Analysis of Boiler Steel from 1880 Historic Train**

Research Experience for Undergraduates  
Summer 2013

South Dakota School of Mines and Technology  
501 E Saint Joseph Street  
Rapid City, SD 57701

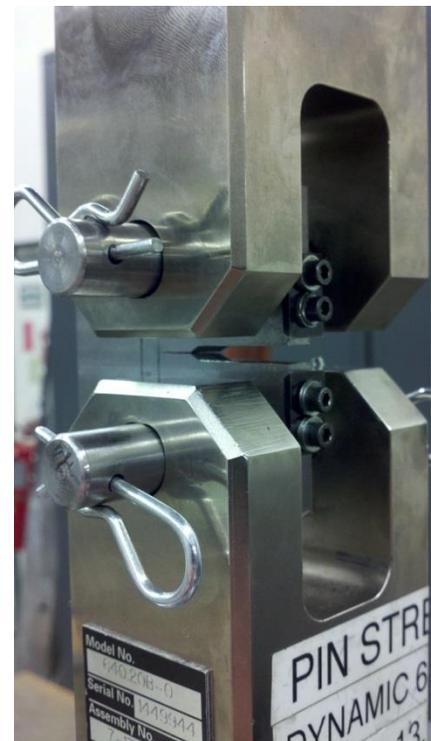
The fracture toughness testing for all four samples, two from each direction, was conducted at room temperature using the same machine as the tensile testing. Several practice samples were tested before testing the boiler steel so that the procedure could be confirmed. For the first sample the pre-crack was initiated by a fatigue test cycling at first between a load 550 +/- 450 lbs., with a frequency of 15 Hz, then increasing the loading by 15% every 10,000 cycles until crack initiation was observed, or the loading reached 1100 +/- 900 lbs. For subsequent samples the same procedure was followed except the initial loading was increased to 825 +/- 675 lbs., to

**Figure 2: Fracture toughness testing setup**

speed up the process. When the crack reached its minimum required length the loading was lowered to 825 +/- 675 lbs. and cycled for another 10,000 cycles. The fracture toughness test itself was conducted immediately after the fatigue pre-cracking, without removing the samples from the testing fixture. The loading rate of for the fracture toughness testing was 2000 lbs./min.

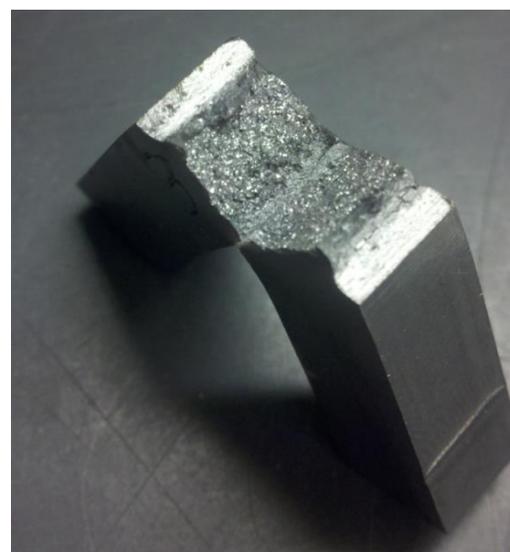
Impact testing results show significant scatter, but clearly indicate decently tough steel with an average of 28.25 ft-lbs. The visual inspection of the broken specimens indicates that the fracture was approximately 50% brittle for all 4 specimens.

**Figure 7: CVN specimen 3**

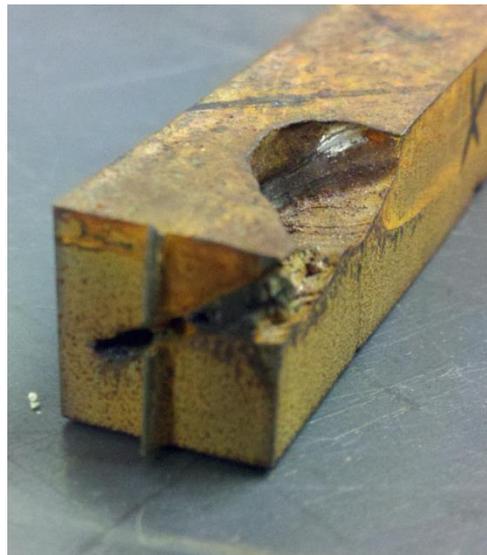
of which can be attributed to repeated welding, and patching. In fact it was documented that several pressure gauges had been removed from the plate, and their holes filled in with weld material. Figure 10 shows a cross section of what appears to be an accidental cut with a plasma torch that penetrates about two thirds the way through the material. This is of course nearly the exact parameter that the fracture toughness characterizes, so an imminently useful analysis can be conducted.

**Figure 10: Boiler plate surface gash**

In the interest of making practical suggestions for safety and maintenance a rough estimate of critical flaw size can be made by conducting a brief analysis. Since this is by no means an exhaustive analysis, but rather a simple application of the fracture toughness results several simplifications shall be applied: the boiler shall be assumed to be a cylindrical thin walled pressure vessel, the weight of the water is negligible, and the only significant stresses on the boiler are due to the pressure of the steam, which shall be assumed to be 200 psi. The boiler would be under stress around its circumference (hoop stress), and its length (longitudinal stress), however since there is no shear stress, these stresses represent the principal stresses, and thus only the greater of the two, the hoop stress, need be considered. Hoop stress is defined in eqn 3.

This is an overestimation because the experimental  $K_Q$  was used instead of a  $K_{IC}$ , and the  $K_{IC}$  is always lower than a  $K_Q$ . A crack this large should be easily detected by eye, or if necessary by magnetic powder, dye penetrant, or eddy current inspections, which are carried out regularly by the maintenance staff.
