Prevention of Liquation Cracking In Alloy 718 Laser Depositions Using Friction Stir Surface Processing

Prepared by:
Levi Lange

Research Experience for Undergraduates
Summer 2013

South Dakota School of Mines and Technology
501 E Saint Joseph St.
Rapid City, South Dakota

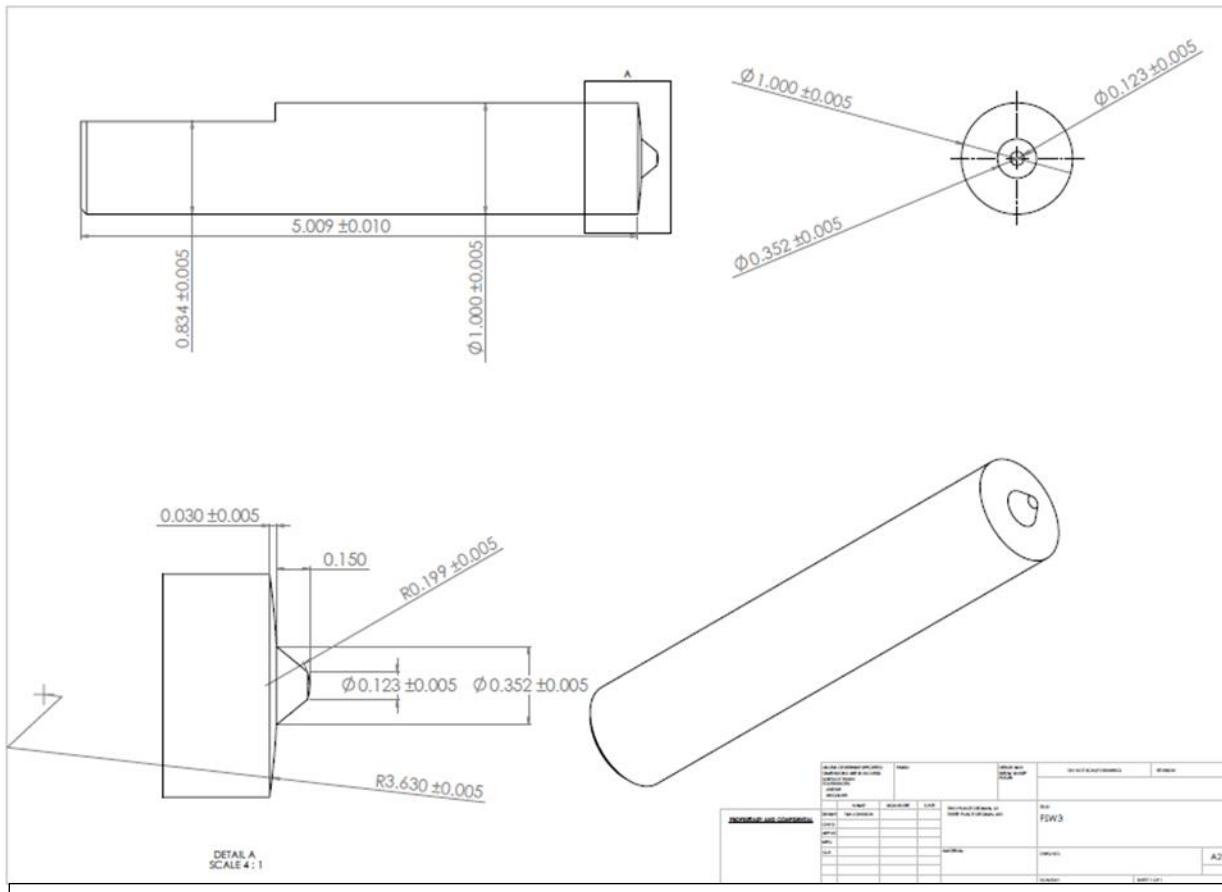
Figure 1. Tungsten-25% Rhenium-4% Hafnium Carbide Pin Tool Technical Drawing. (Photo Courtesy of Todd Curtis)

An Inconel 718 alloy cast plate in final heat treated condition was obtained from a former student. This plate was friction stir processed by this previous student using a Tungsten (W) – Rhenium (25% Re) – Hafnium Carbide (4% HfC) pin tool, and the MTS ISTIR-10 Intelligent Friction Stir Welder, with a Megastir cooling head and argon shroud. The parameters that were used to develop consistent welds were a rotational speed of 200 RPM, a traveling speed of 2 IPM, and a downward force of 5,000 lb forge force. A schematic of the pin tool can be seen in Figure 1. The 718 alloy plate with the friction stir processing can be seen in Figure 2 following, and Table 1 shows the alloying elements that make up Alloy 718.

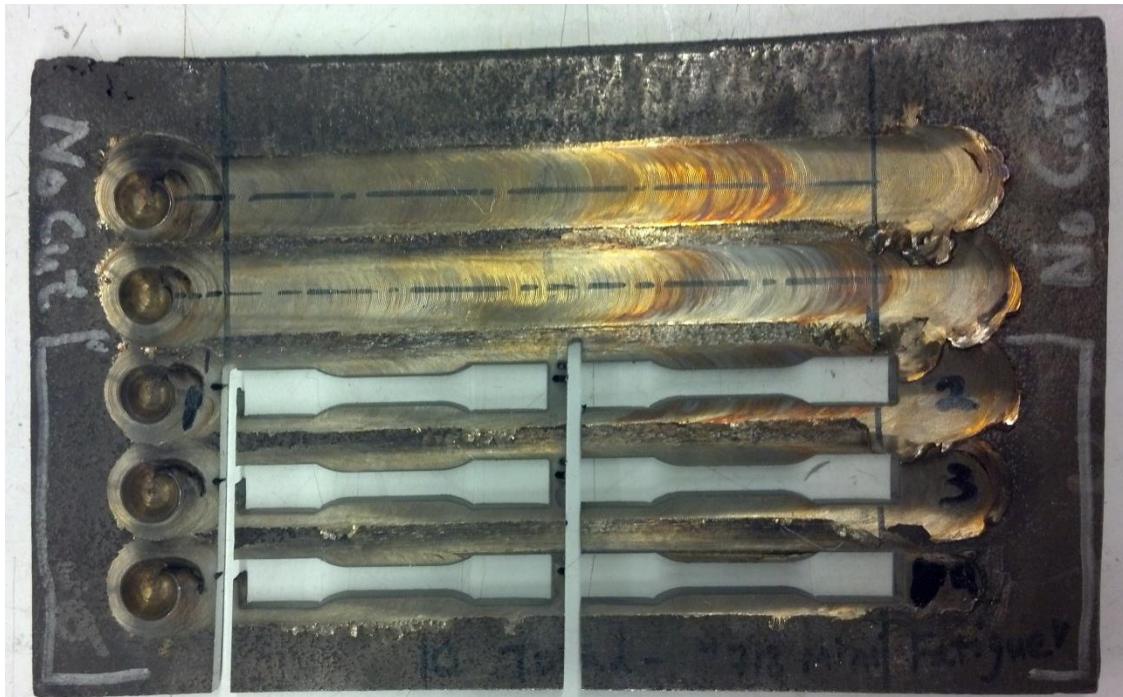
Figure 2. 718 Alloy Plate with Friction Stir Processing zones, and As-Cast zones (Author's Work)

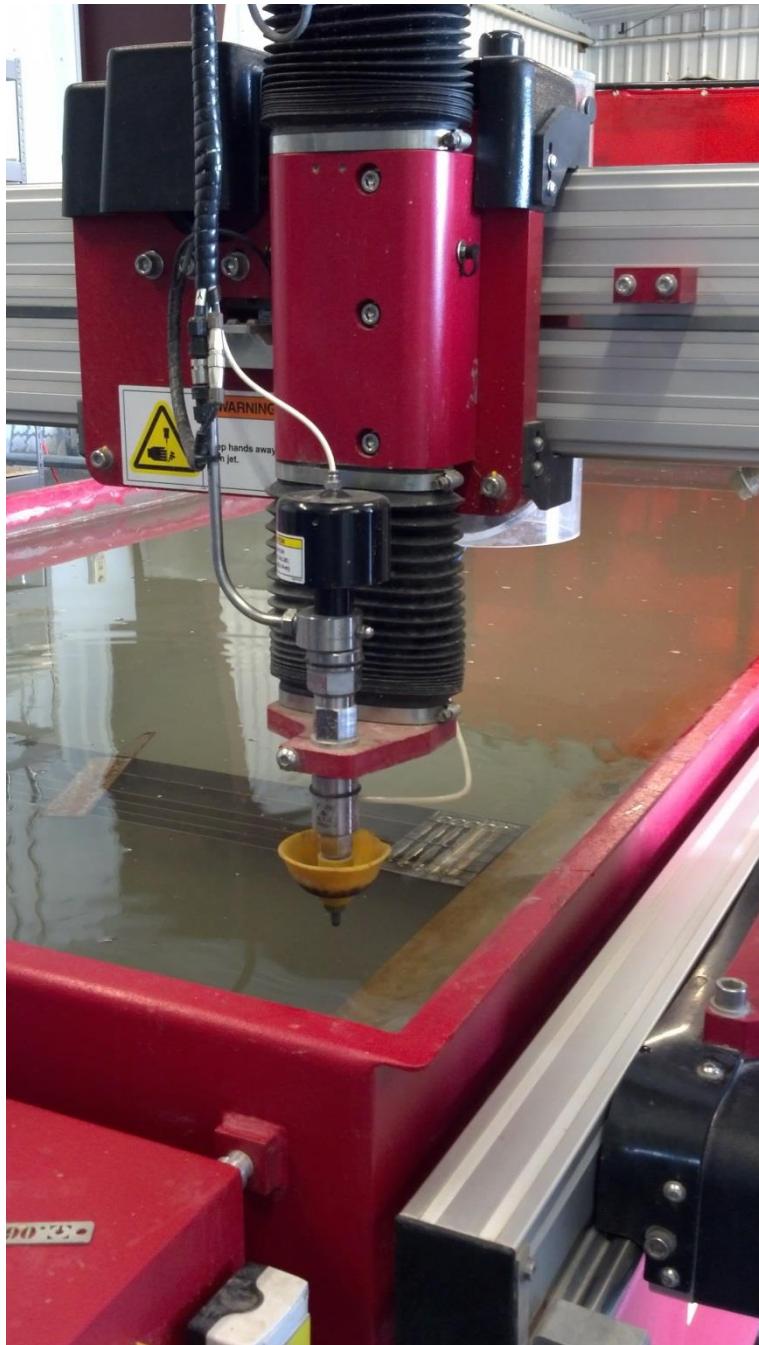
Figure 3. Maxiem 1530 Jet Cutting System, Cutting courtesy of AMP. (Author's Work)

center water jet system. This system with the plate fixed into place can be seen in Figure 3 above.

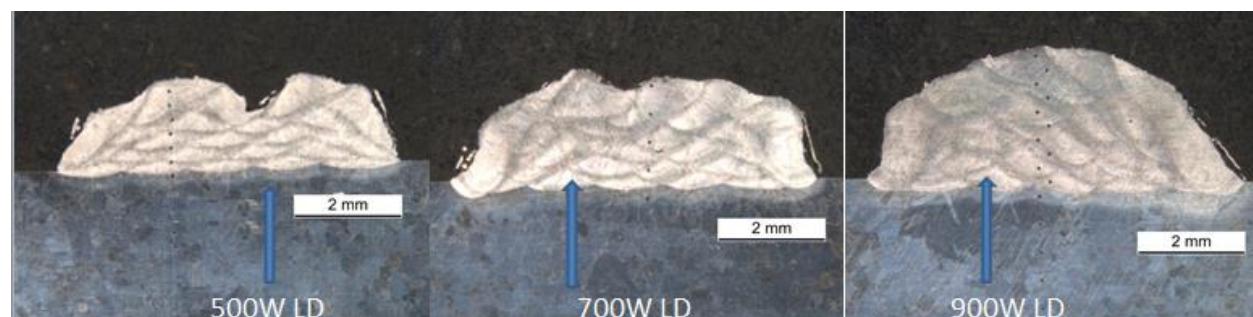
Figure 4. Macrographs of the 718 alloy Laser Deposition buildup on 718 alloy base. (Author's Work)

Once the parent material and the friction stir processed materials had been characterized, six more samples were cut using the water-jet cutting system, three from the parent material, and three from the friction stir processed material. The samples were then individually placed into the Optimec Laser Engineered Net Shaping (LENS) System. The system laser deposited an Inconel 718 powder, developed by Starmet Powders, with a mesh size of -140 +325 (102-45 micron) that ran with an argon carrier gas at 2 L/min, an argon purge gas at 30 L/min, and a powder feed of 15 g/min. The laser deposited 30% overlapping beads, which had a diameter of .066". All parameters that have been stated thus far for the laser deposition were fixed. The only varying parameter was the laser power. The power was varied from 500W to 700 W and finally to 900W. The exact buildup of the beads can be seen in the macrographs in Figure 4 respectively.

The power of the laser had a large impact on the quality of the buildup of the weld. The quality and build height increased as the wattage of the laser increased. This can be seen in the macrographs of the laser depositions above in Figure 4. The power of the laser also seemed to have a small influence on the severity of the liquation cracking on the parent materials. Below is

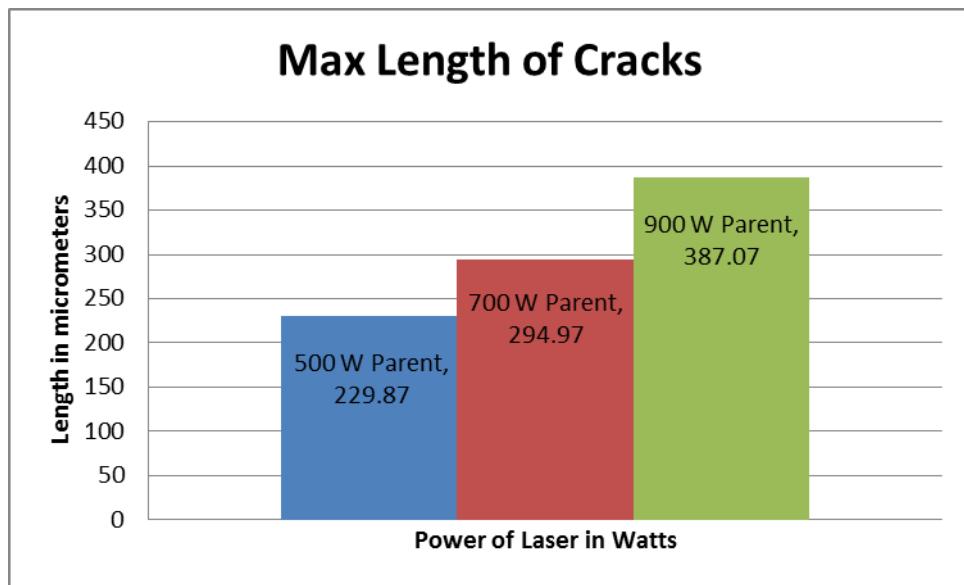
Figure 5. Graph of the Average crack length corresponding to laser power. (Author's Work)

a graph showing the maximum length of cracking on the three different powers. It can be seen that the increasing power led to an increase in maximum crack length. Another aspect of the processing that had an effect on liquation was the post weld heat treatment. The cracking in the cast material with the post weld heat treatment showed a more severe cracking zone and heat affected zone. Figure 6 below shows a liquation crack in a 700W parent material deposition in the pre-heat treated condition and in the post-heat treated condition.

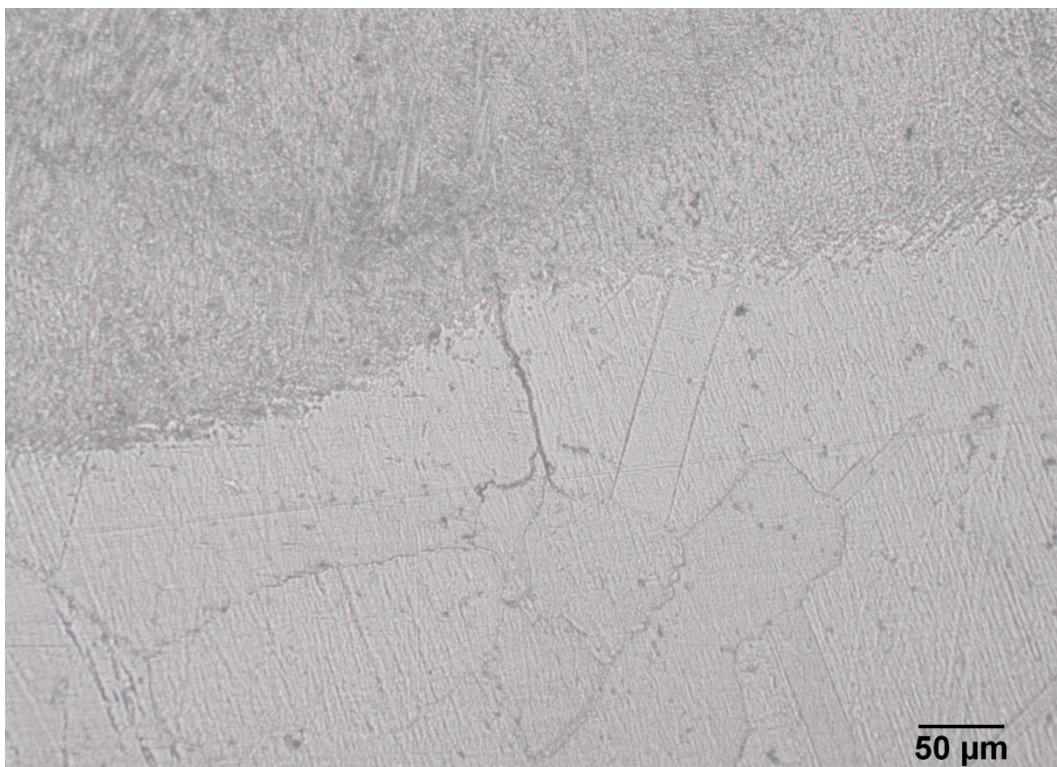
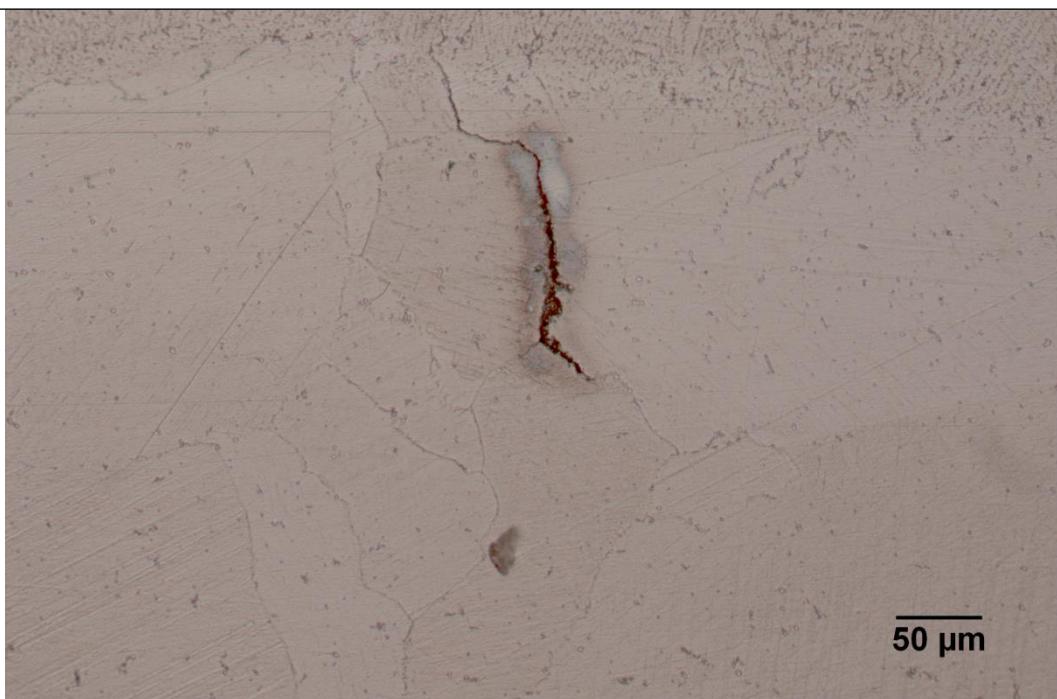
Figure 6. Optical Microscopy of liquation cracking in 700W LD Parent Material before heat treatment above, and post heat treatment below. (Author's work)

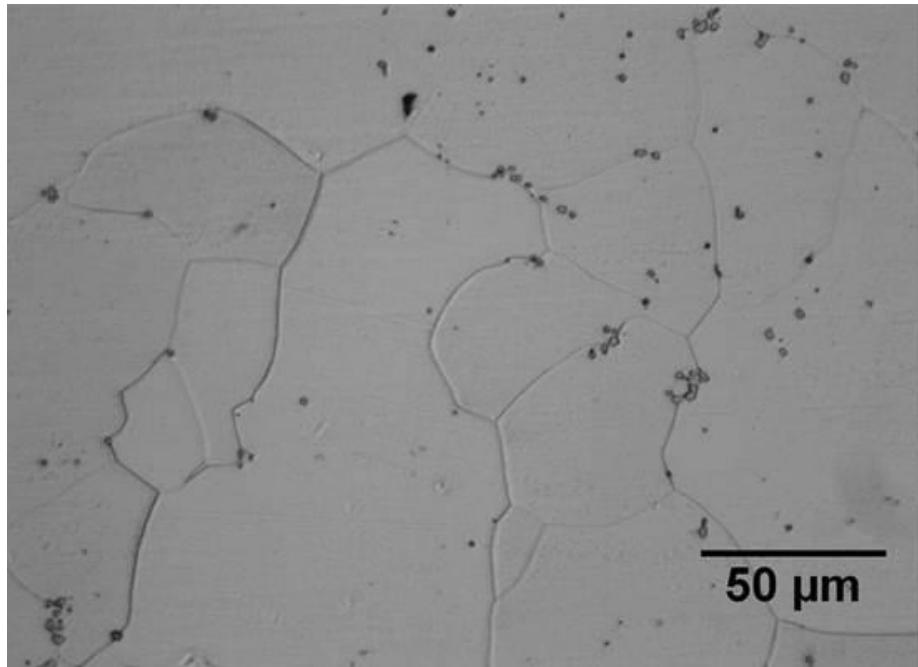
Figure 7. Micrograph of the as cast 718 alloy (Author's Work)

The initial metallography from the parent material and the friction stir processed material showed that there was a large reduction in grain size from approximately $276 \mu\text{m}$ to $< 5 \mu\text{m}$. Figure 7 and Figure 8 shows a macrograph of the decrease in grain size from the parent material to the friction stir processed material respectively.

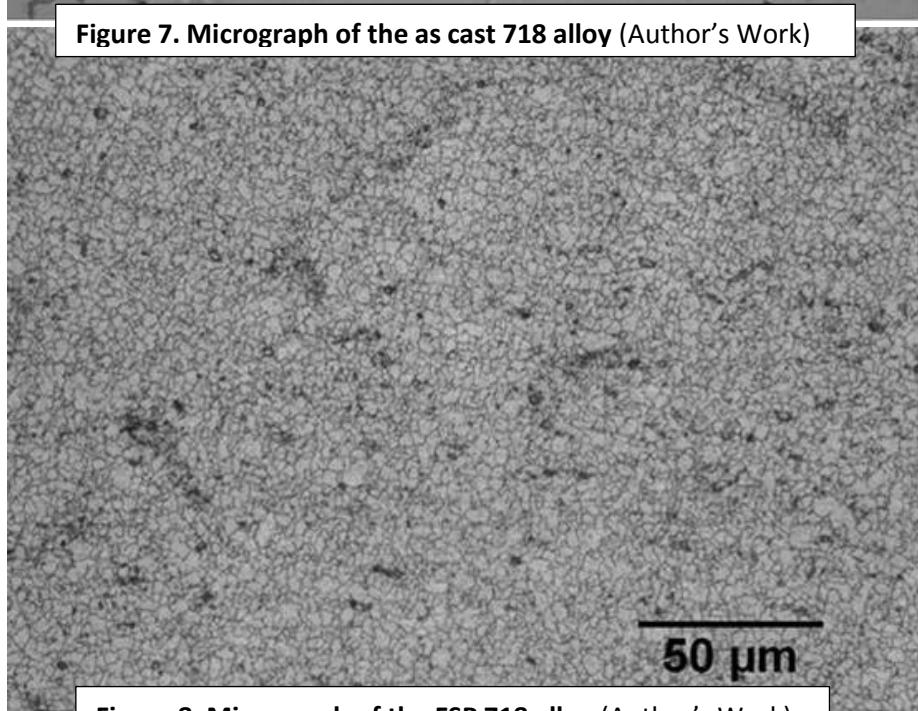
Figure 8. Micrograph of the FSP 718 alloy (Author's Work)

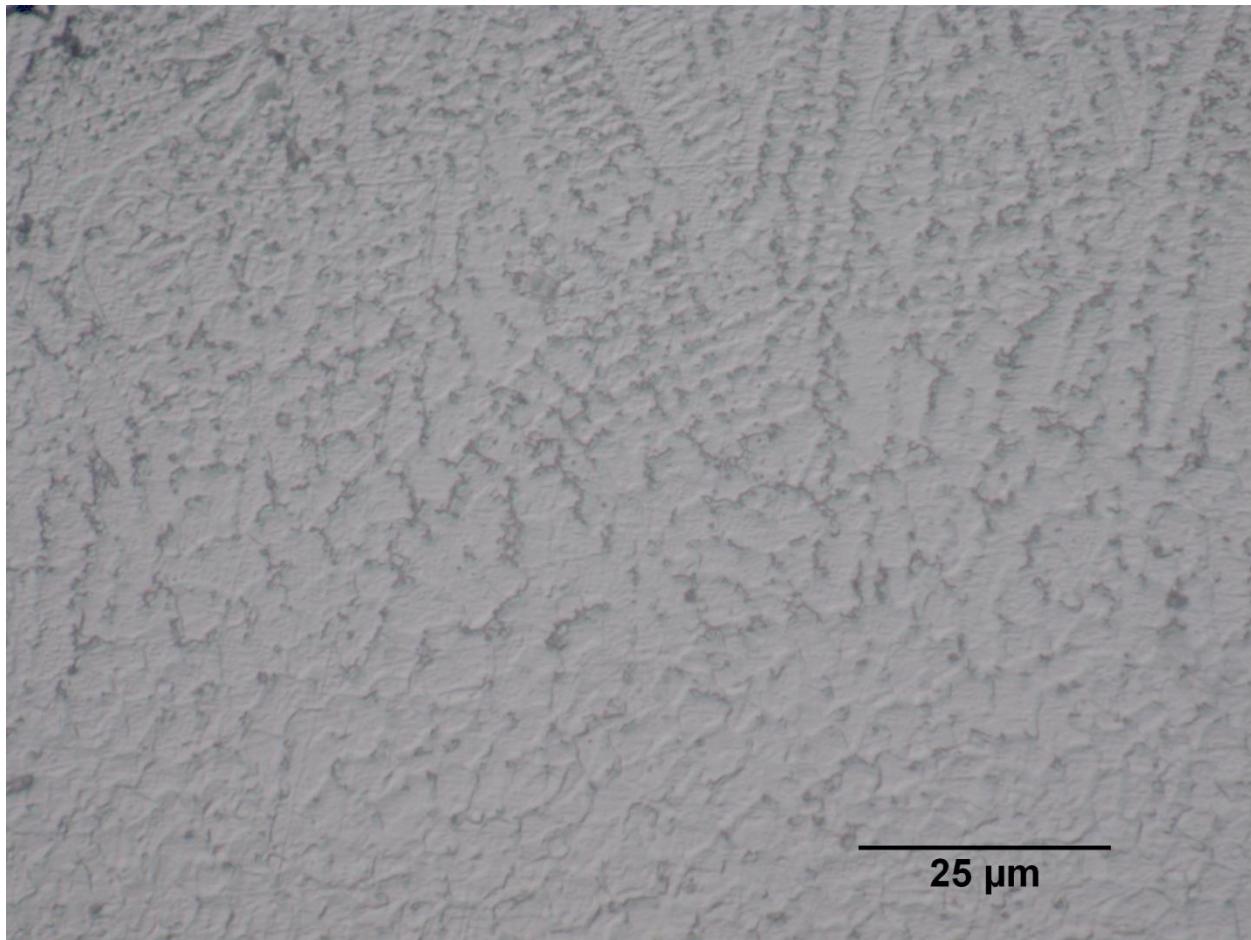
Figure 9. Micrograph of the FSP 718 alloy with 500 W Laser Deposition (Author's Work)

Following the parent materials microstructural examination was the friction stir processed material with the varying laser deposition powers. No liquation cracking was observed in any of the samples that were tested and examined under the optical microscope. This is the outcome that was ultimately the goal of the entire project. The friction stir processing decreased the grain size, decreasing the area for liquation cracking to occur. Figures 9, 10, 11 immediately following show some of the micrographs of the laser deposition on the friction stir processed material.

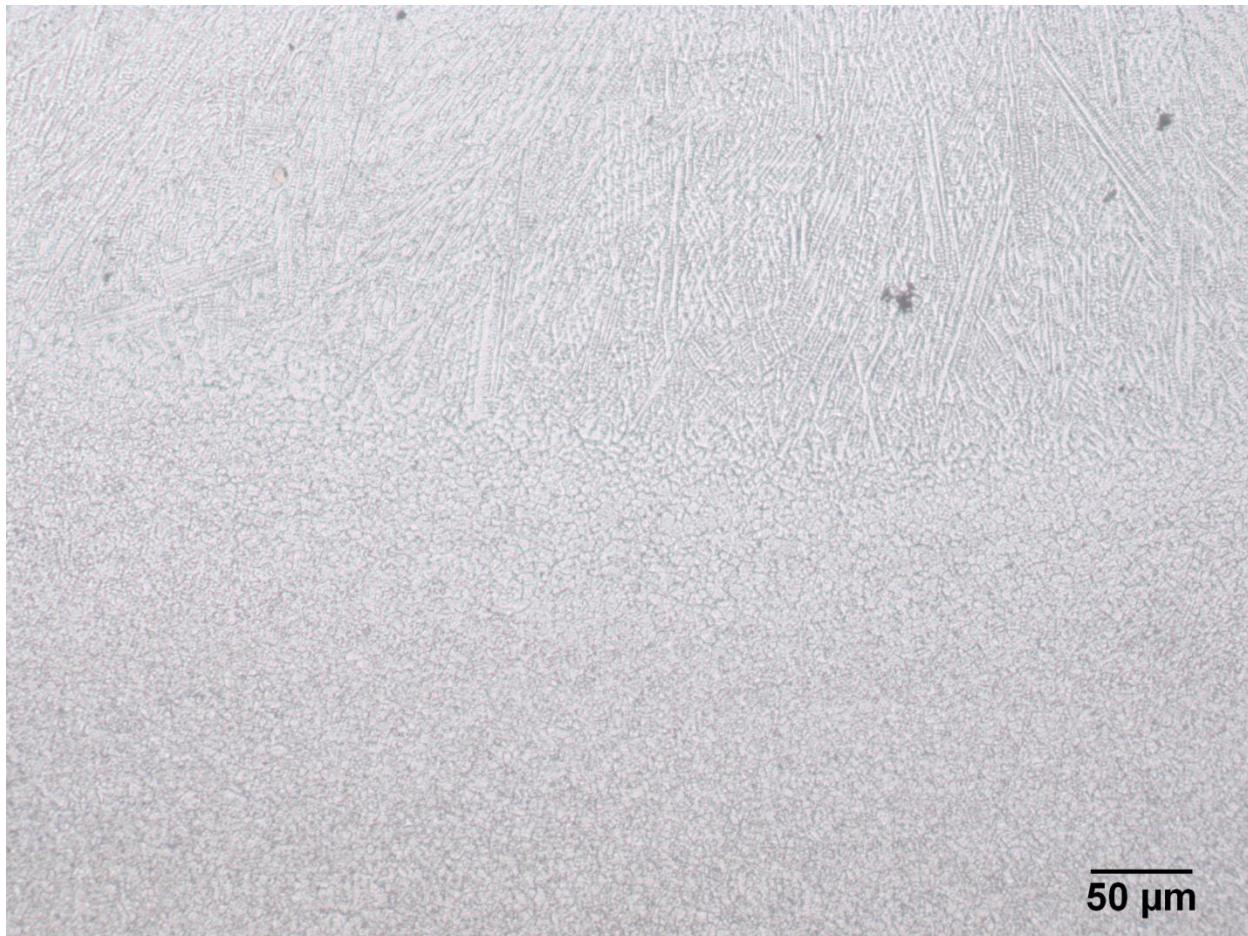
Figure 10. Micrograph of the FSP 718 alloy with 700 W Laser Deposition (Author's Work)

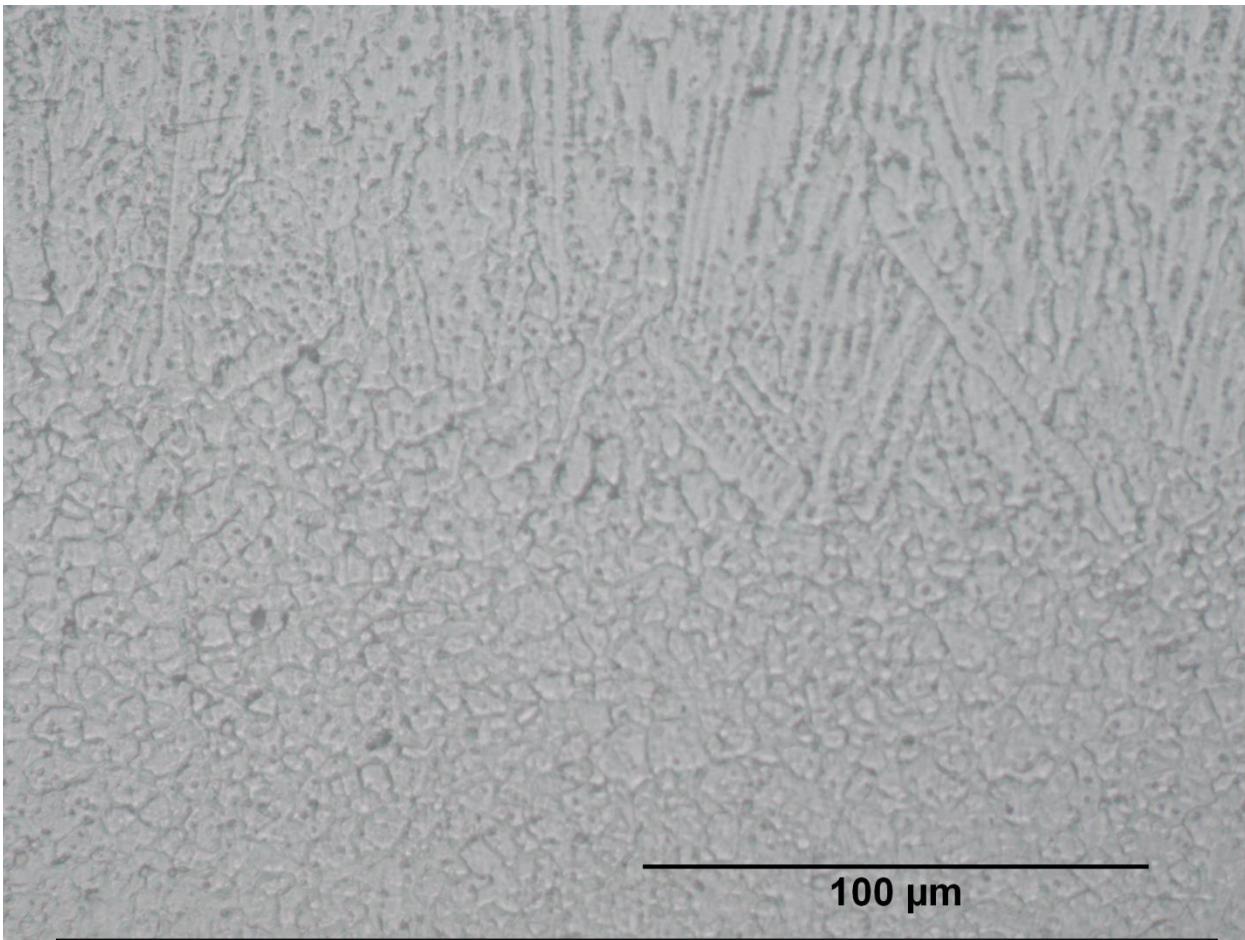
Figure 11. Micrograph of the FSP 718 alloy with 900 W Laser Deposition (Author's Work)

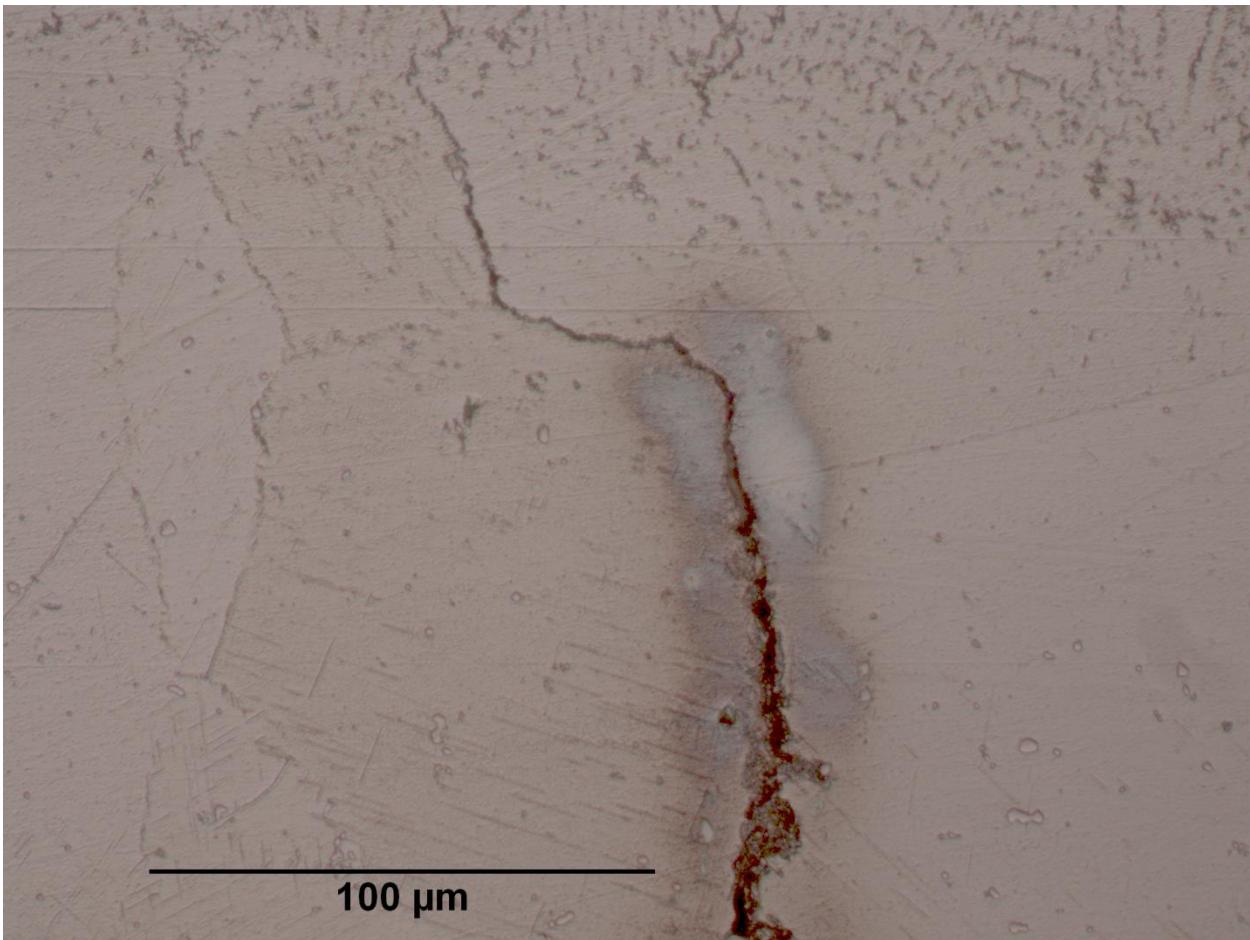
Figure 12. Micrograph of liquation cracking on 718 parent material with 700W Laser Deposition in Post-Weld Heat Treated condition. (Author's Work)

The same examination of the pre-weld heat treated parent and friction stir processed materials were performed on the post-weld heat treated parent and friction stir processed materials. As stated earlier, the liquation in the parent depositions after the heat treatment was greatly affected. The extent of liquation increased after the heat treatment in that the cracks were thicker, and had a large heat affected zone around many of the cracks. Some of the micrographs showing these features can be seen in Figures 12 and 13 following.

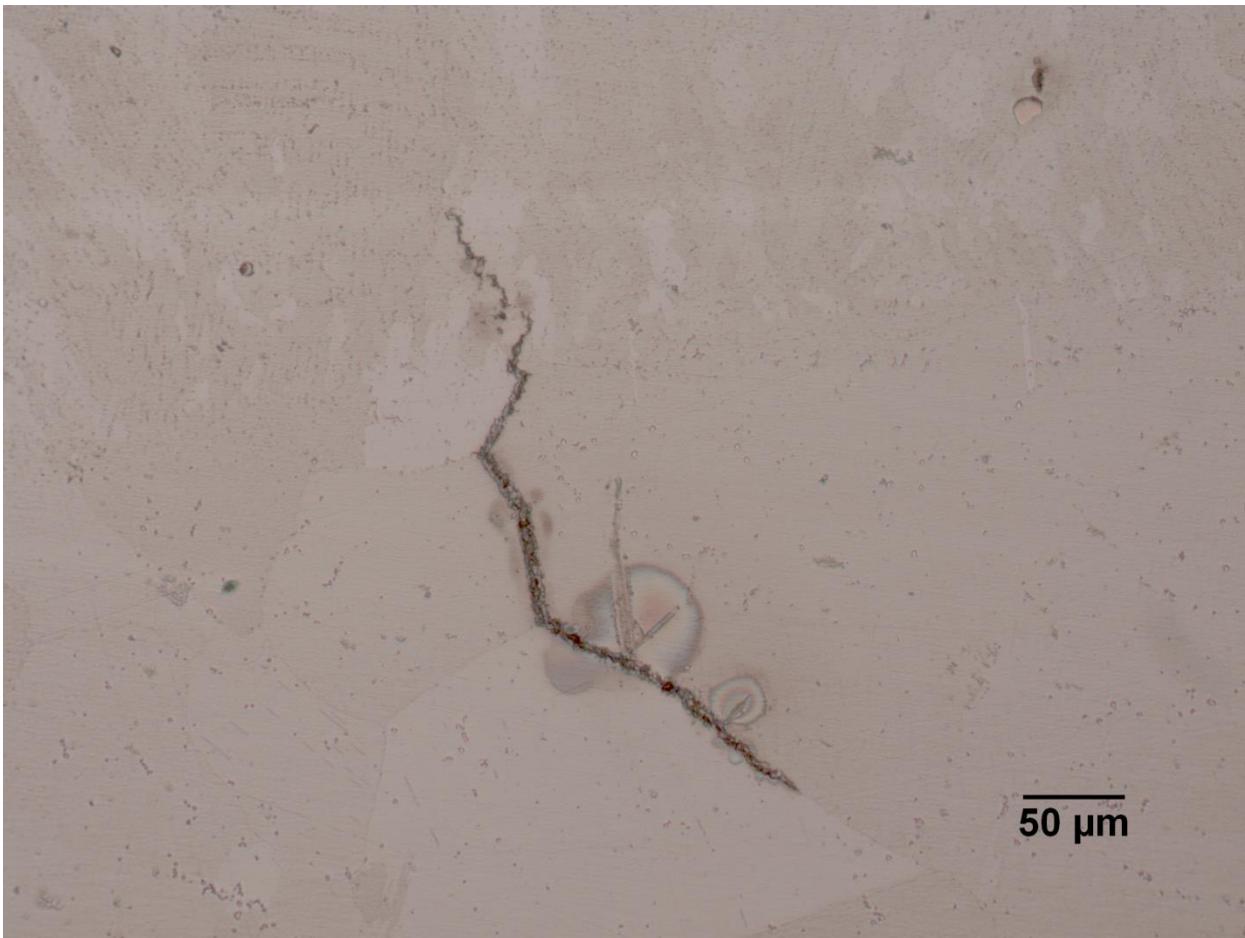
Figure 13. Micrograph of liquation cracking on 718 parent material with 900W Laser Deposition in post weld heat treated condition. (Author's Work)

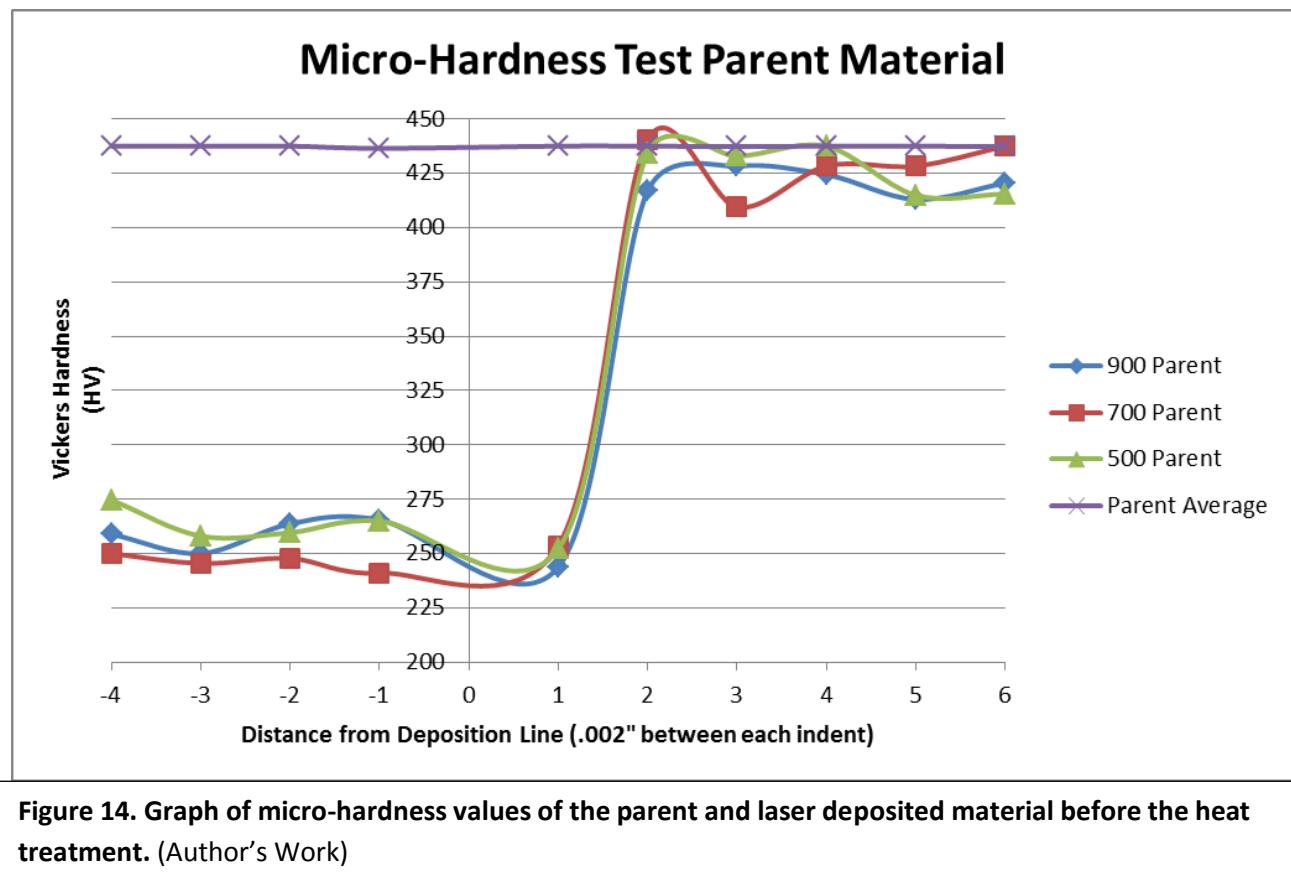
Figure 14. Graph of micro-hardness values of the parent and laser deposited material before the heat treatment. (Author's Work)

Microhardness measurements were taken for the parent material with the varying laser depositions, and were compiled into the graph in Figure 14. The laser deposition showed to be very soft, and the parent material even after the laser deposition still maintained its strength.

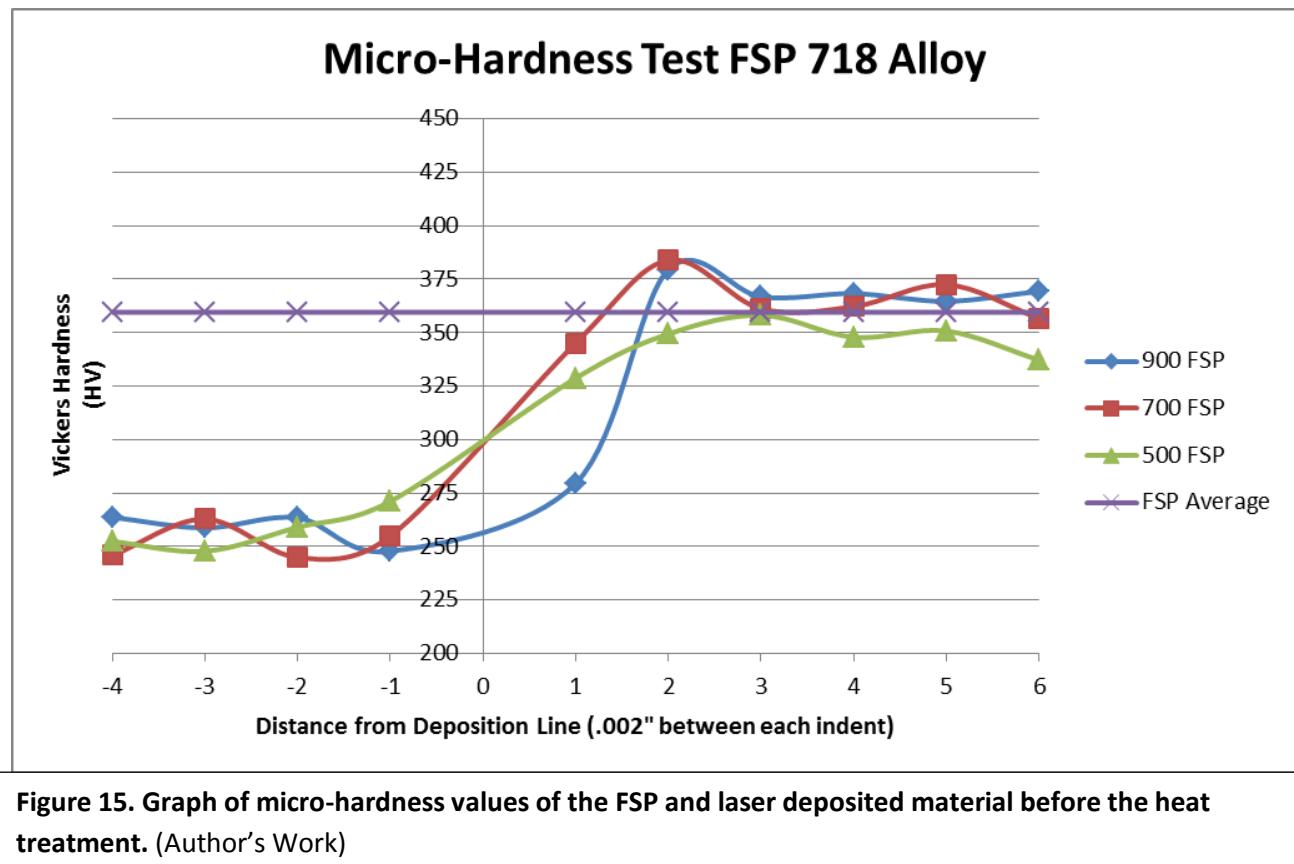
Figure 15. Graph of micro-hardness values of the FSP and laser deposited material before the heat treatment. (Author's Work)

Microhardness measurements were then taken for the friction stir processed material with the varying laser depositions, and were compiled into the graph in Figure 15. The laser depositions again showed to be quite soft, and the graph showed a similar trend to that of the parent material with depositions. The friction stir processed area showed an increase from that of the deposition but not as much of an increase as the parent material.

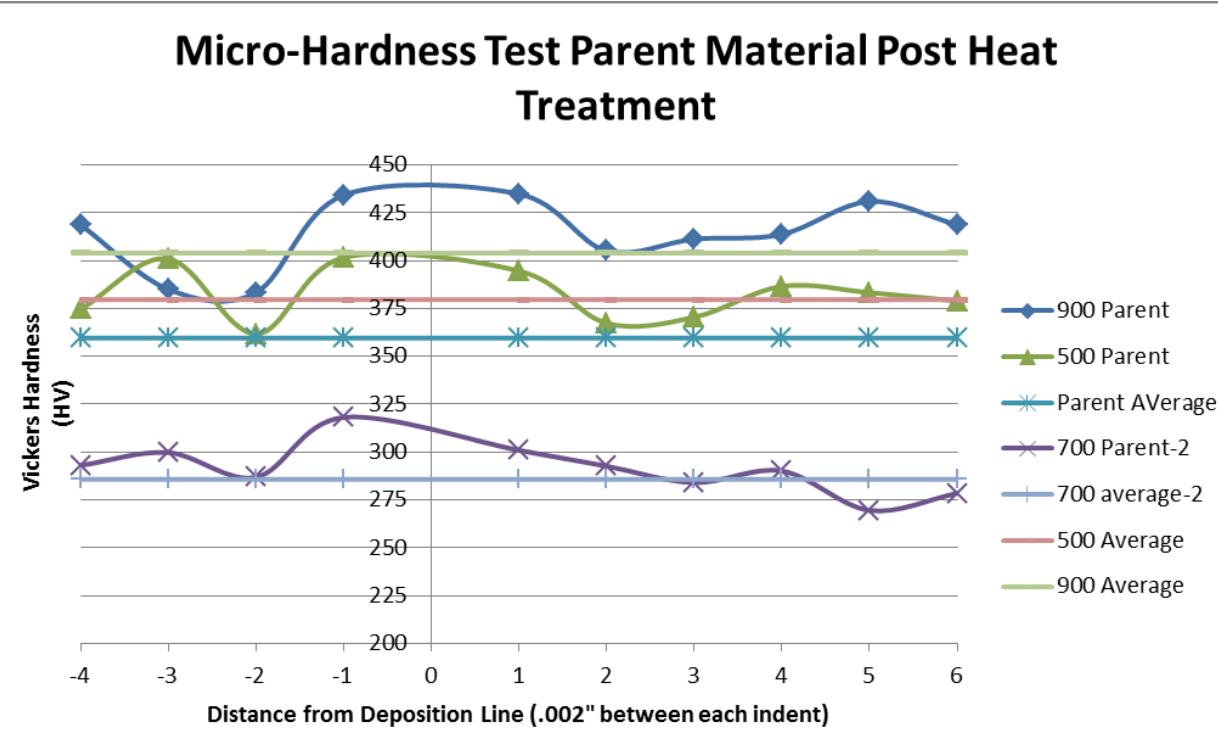
Figure 16. Graph of micro-hardness values of the Parent and laser deposited material after the heat treatment. (Author's Work)

Following was the microhardness characterization of the post-weld heat treated materials. The same procedure was followed as before, except an average was taken for each of the post-weld heat treated parent materials, and only one average was taken for the friction stir processed post-weld heat treated samples. The graphs following in Figure 16 and 17 shows that the heat treatment greatly increased the hardness of the laser deposited material, while maintaining hardness for the most part in the friction stir processed material. Further characterization of the

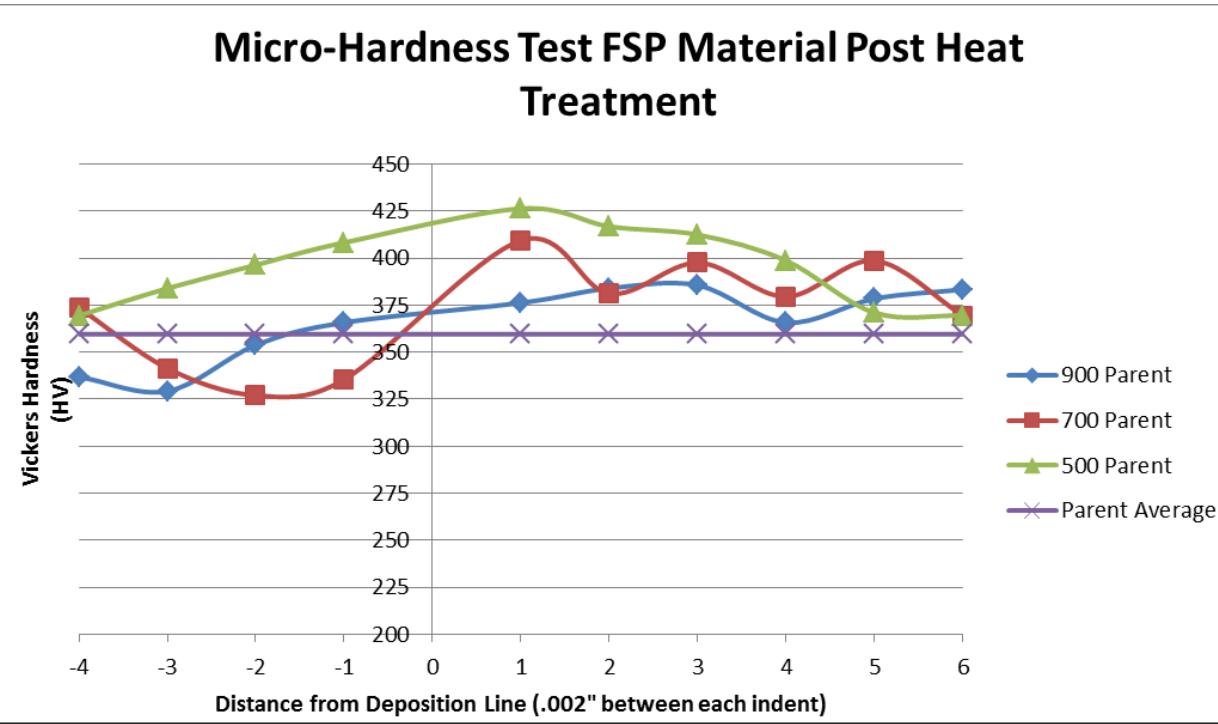
Figure 17. Graph of micro-hardness values of the FSP and laser deposited material after the heat treatment. (Author's Work)
