Refill Friction Stir Spot Weld Repair of a Fatigue Crack

Program Information:

Summer 2009

South Dakota School of Mines and Technology

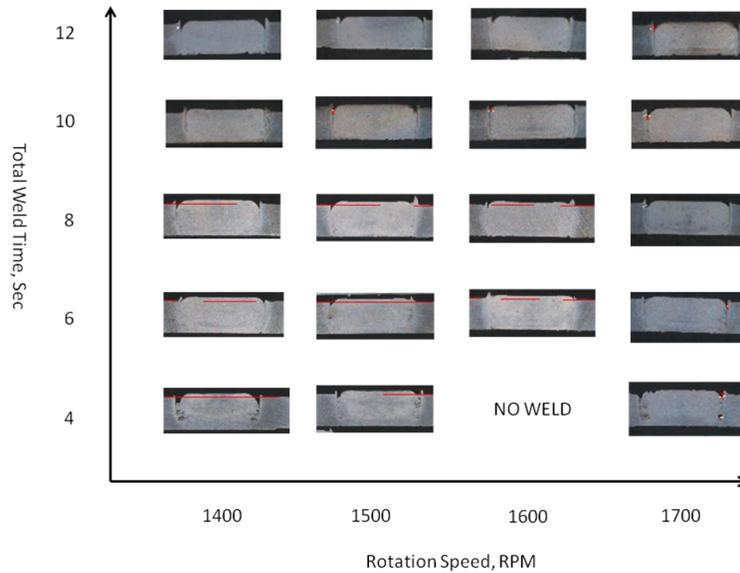
Figure 2: Developmental Matrix

The metallographic pictures are then inserted to show the best parameters for the weld. The parameters we chose were 1600 rpm and a weld time of 12 seconds. Consolidation along the sides and bottom of the weld was good. The cold lap defect was also minimal in this parameter set. With an optimized process for a single weld, we then moved to weld surfacing and depth penetration.
