Objective:

- Develop a procedure to repair fatigue cracks in a 2024 aluminum skin using the Refill Friction Stir Spot Welding process. Also incorporated into this project is the use of cold spray deposition to fill the pre-crack.

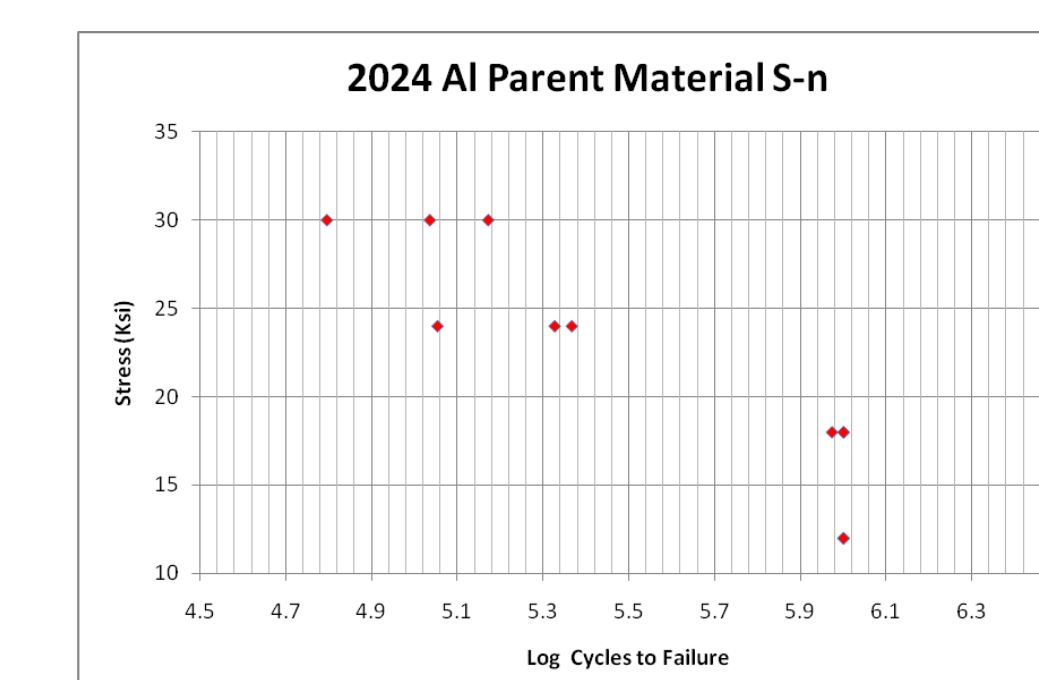
Figure 5 shows current results: The S/N data for the parent material. This will be used as a comparison.
